# Staff Report

## City of Manhattan Beach

**SUBJECT:** Approval of Roof Repairs for City Hall and Appropriation of \$175,000 from the Capital Improvement Fund

# City Hall Roof Repair Project

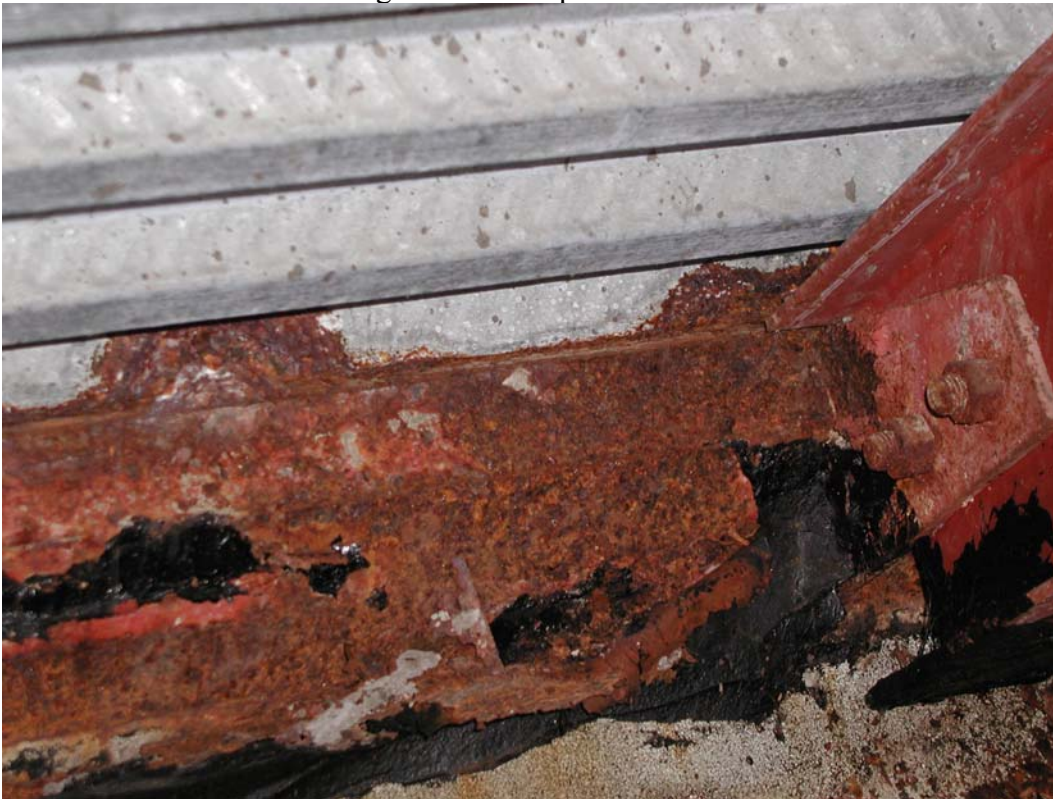
The one remaining original portion of the City Hall Roof structure is the parapet roof. This structure is the portion which is visible above the Administration portion of City Hall. This portion of the roof was constructed with light weight concrete panels that slant and connect to the parapet wall. Over the years the concrete slabs have cracked and the joints between slabs have deteriorated. This condition has allowed rain water to penetrate the interior of the area between the parapet wall and the slanting roof. Over time, with water entering the interior of the covered area, extensive damage has been done to the flat portion of the roof (see attached photos).

Corrosion from water entering the flat roof portion under the slanted roof.

Additional roof material will be added to the corner parapets to have a continuous roof around this entire portion of the building. In addition, we propose to re-coat the flat roof area lying between the parapet wall and the slanted roof with high quality roofing compound.

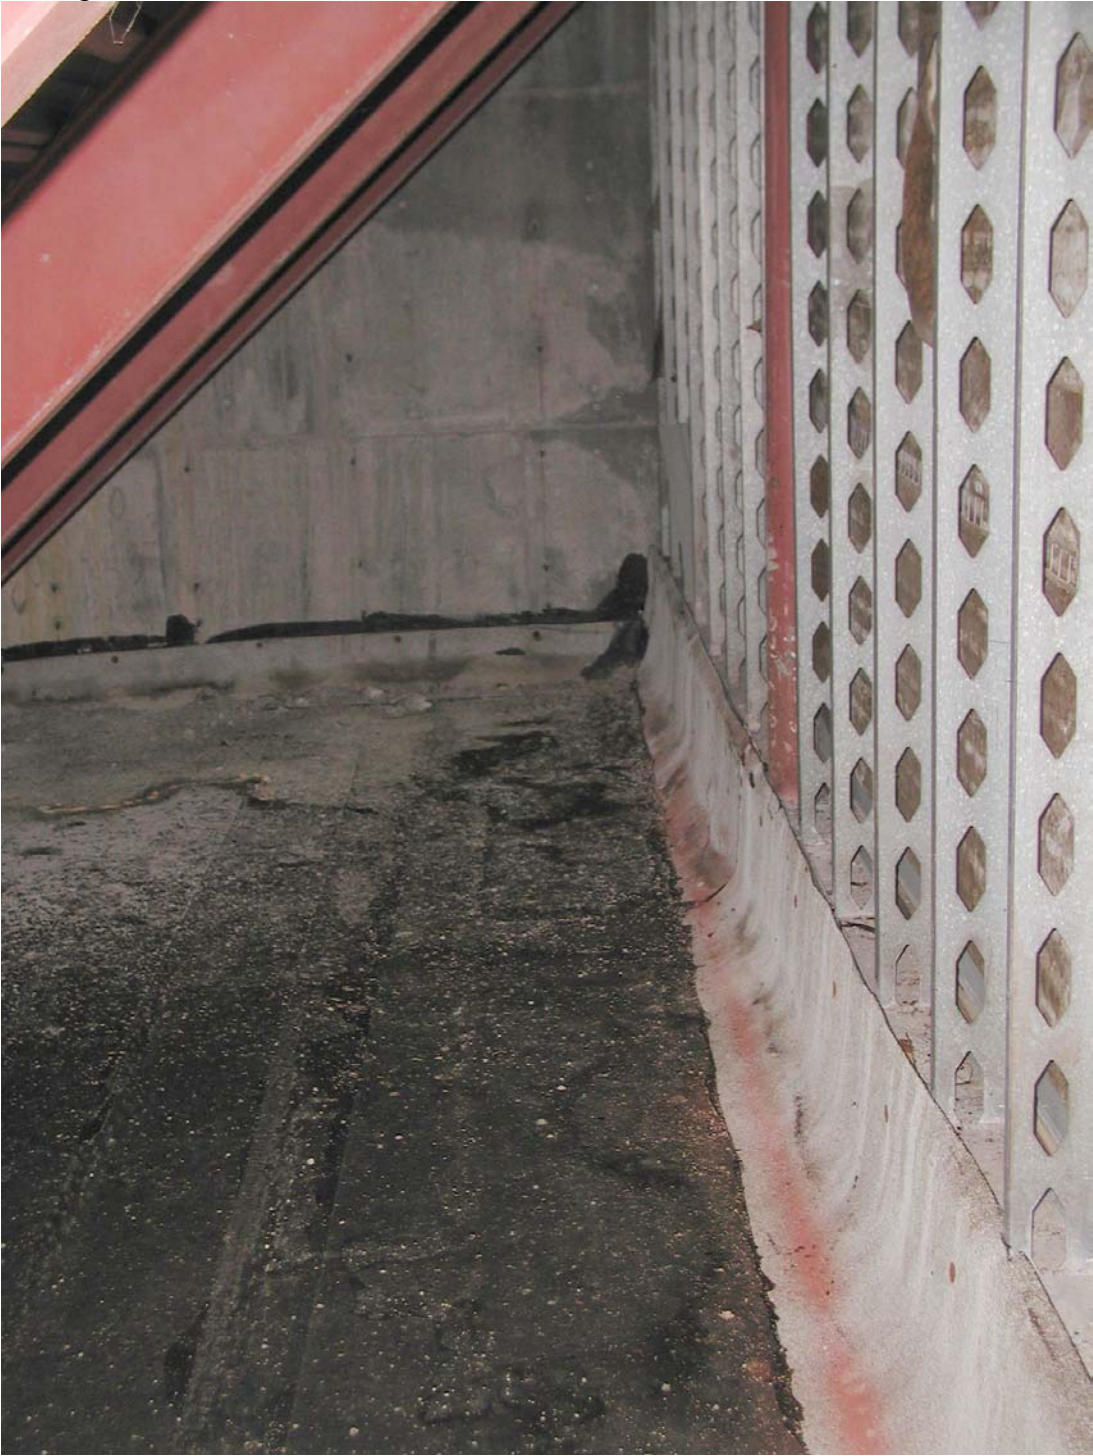
Damaged flat roof area.
