Live Oak Park (aka: Scout House)

Construction Impact Report (Moreton Bay Fig)

APRIL 13, 2022

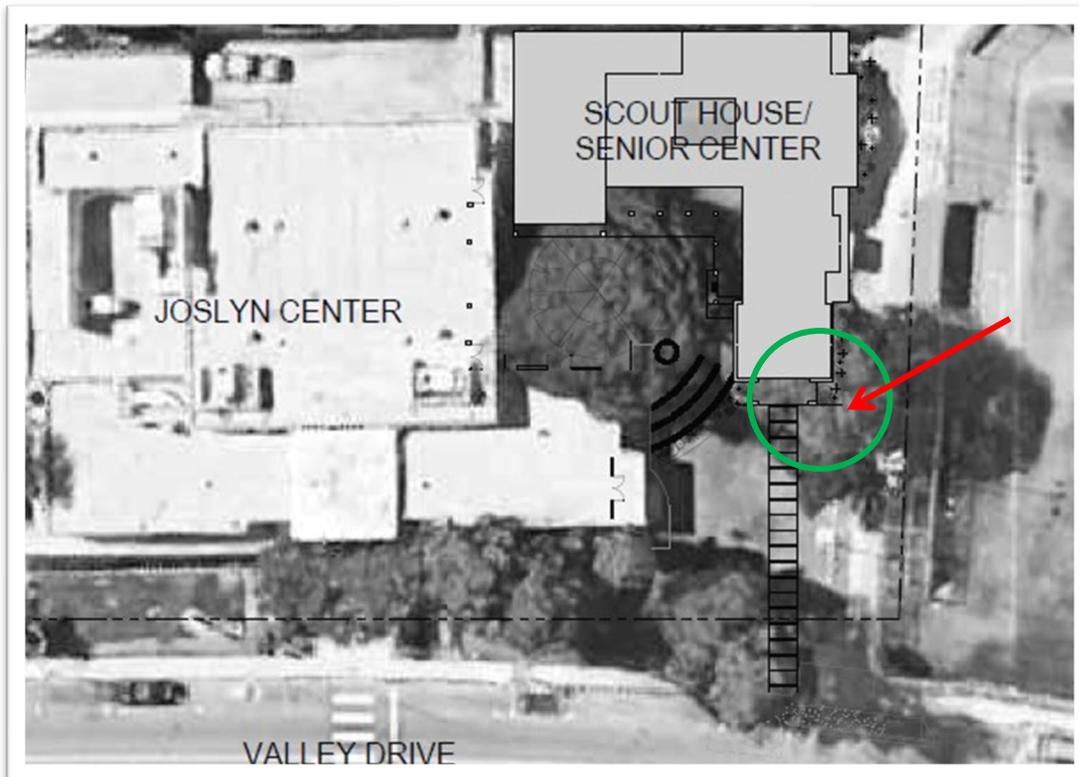
Site Map 2 (below). Provided by the client, showing the location of the fig tree with respect to planned construction. It appears from this image that the roofline of the covered entrance will significantly impact the canopy of the fig tree.

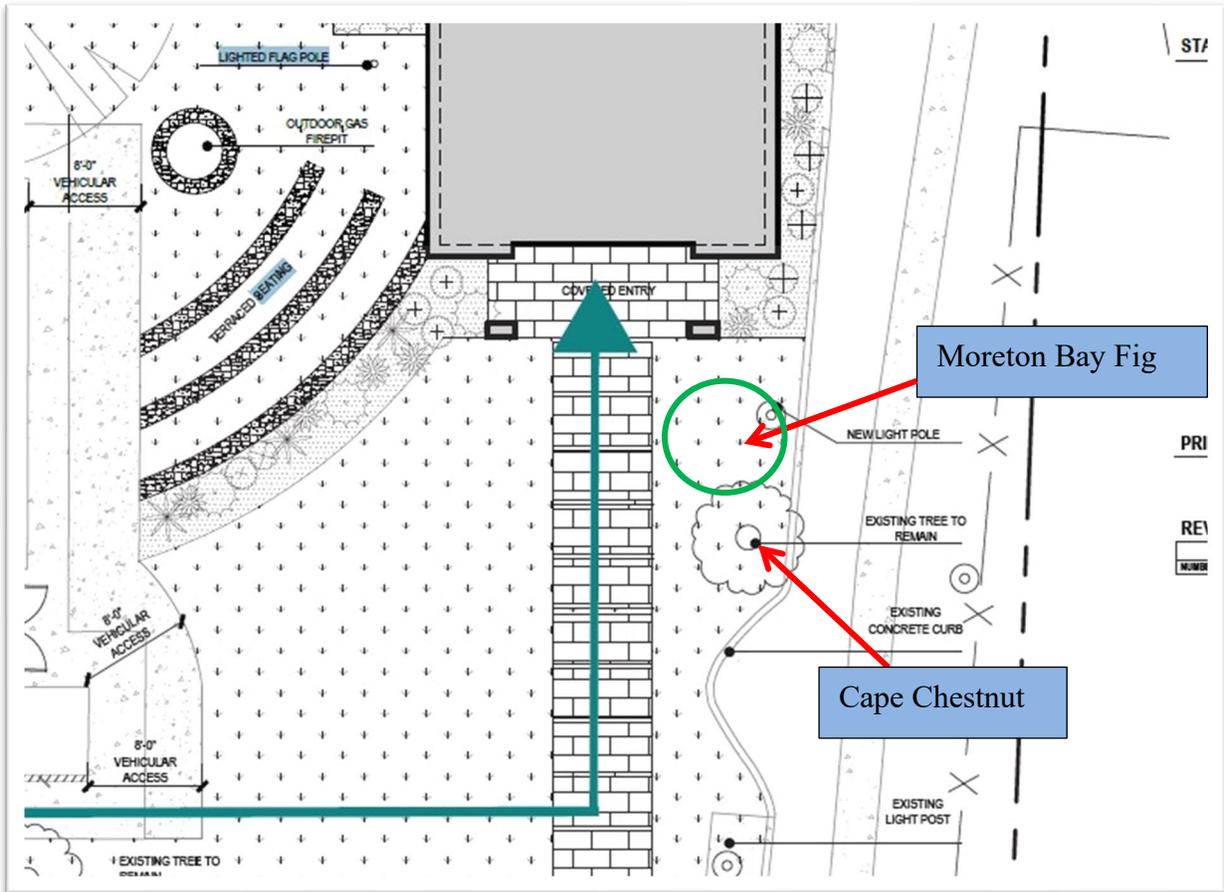
Site map 3, Provided by the client.

Note that in this image, only one tree is shown as “existing tree to remain.” Comparing street views, Google maps, and on-site observations, there are two trees very close to each other, the subject fig tree and a smaller Cape Chestnut. This site plan actually shows the smaller of the two, as it is the one nearest the bowed curb. See Image 5.

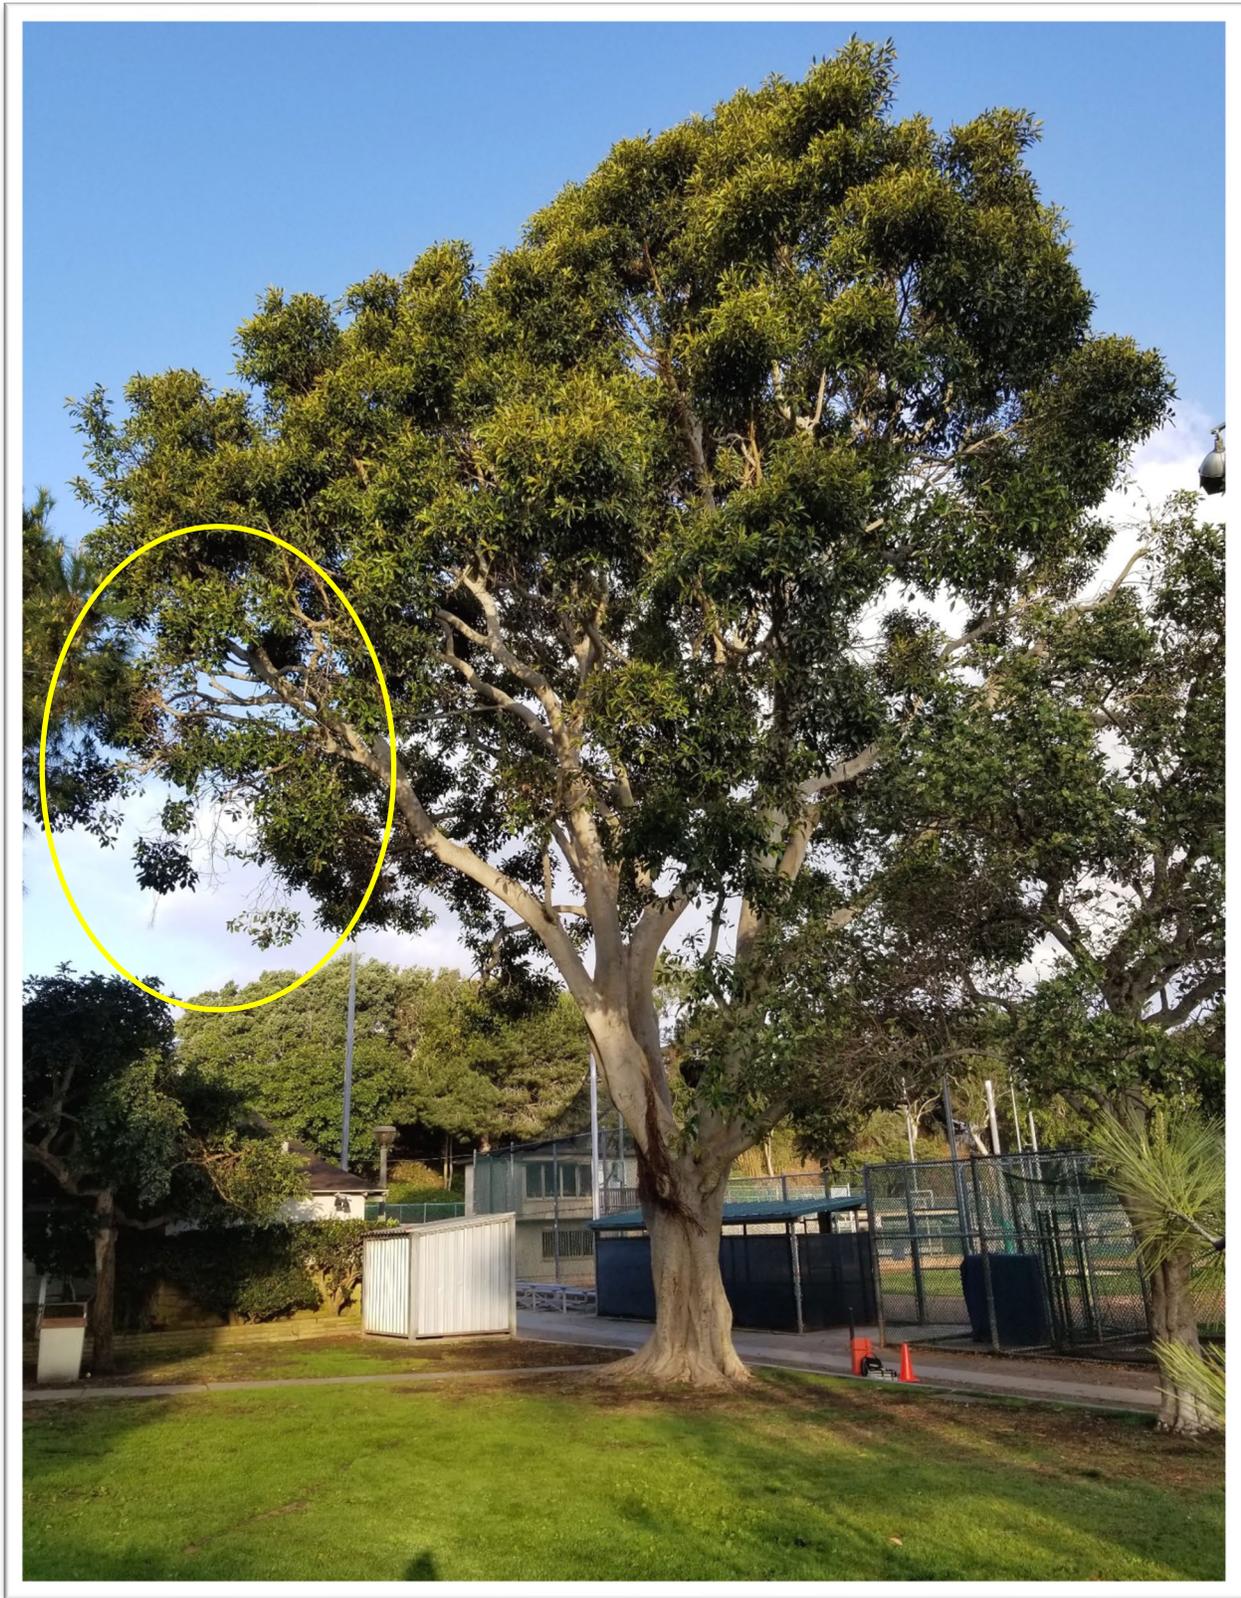
- The tree displays slight canopy-wide twig and small branch dieback, and a thinning canopy on the south side. Plant health is fair, plant structure is good, and plant form is good. Images 1-3. See Appendix B: Health and Condition Components.

Image 1. Showing the subject tree as seen looking west. There is slight canopy dieback on the south side.

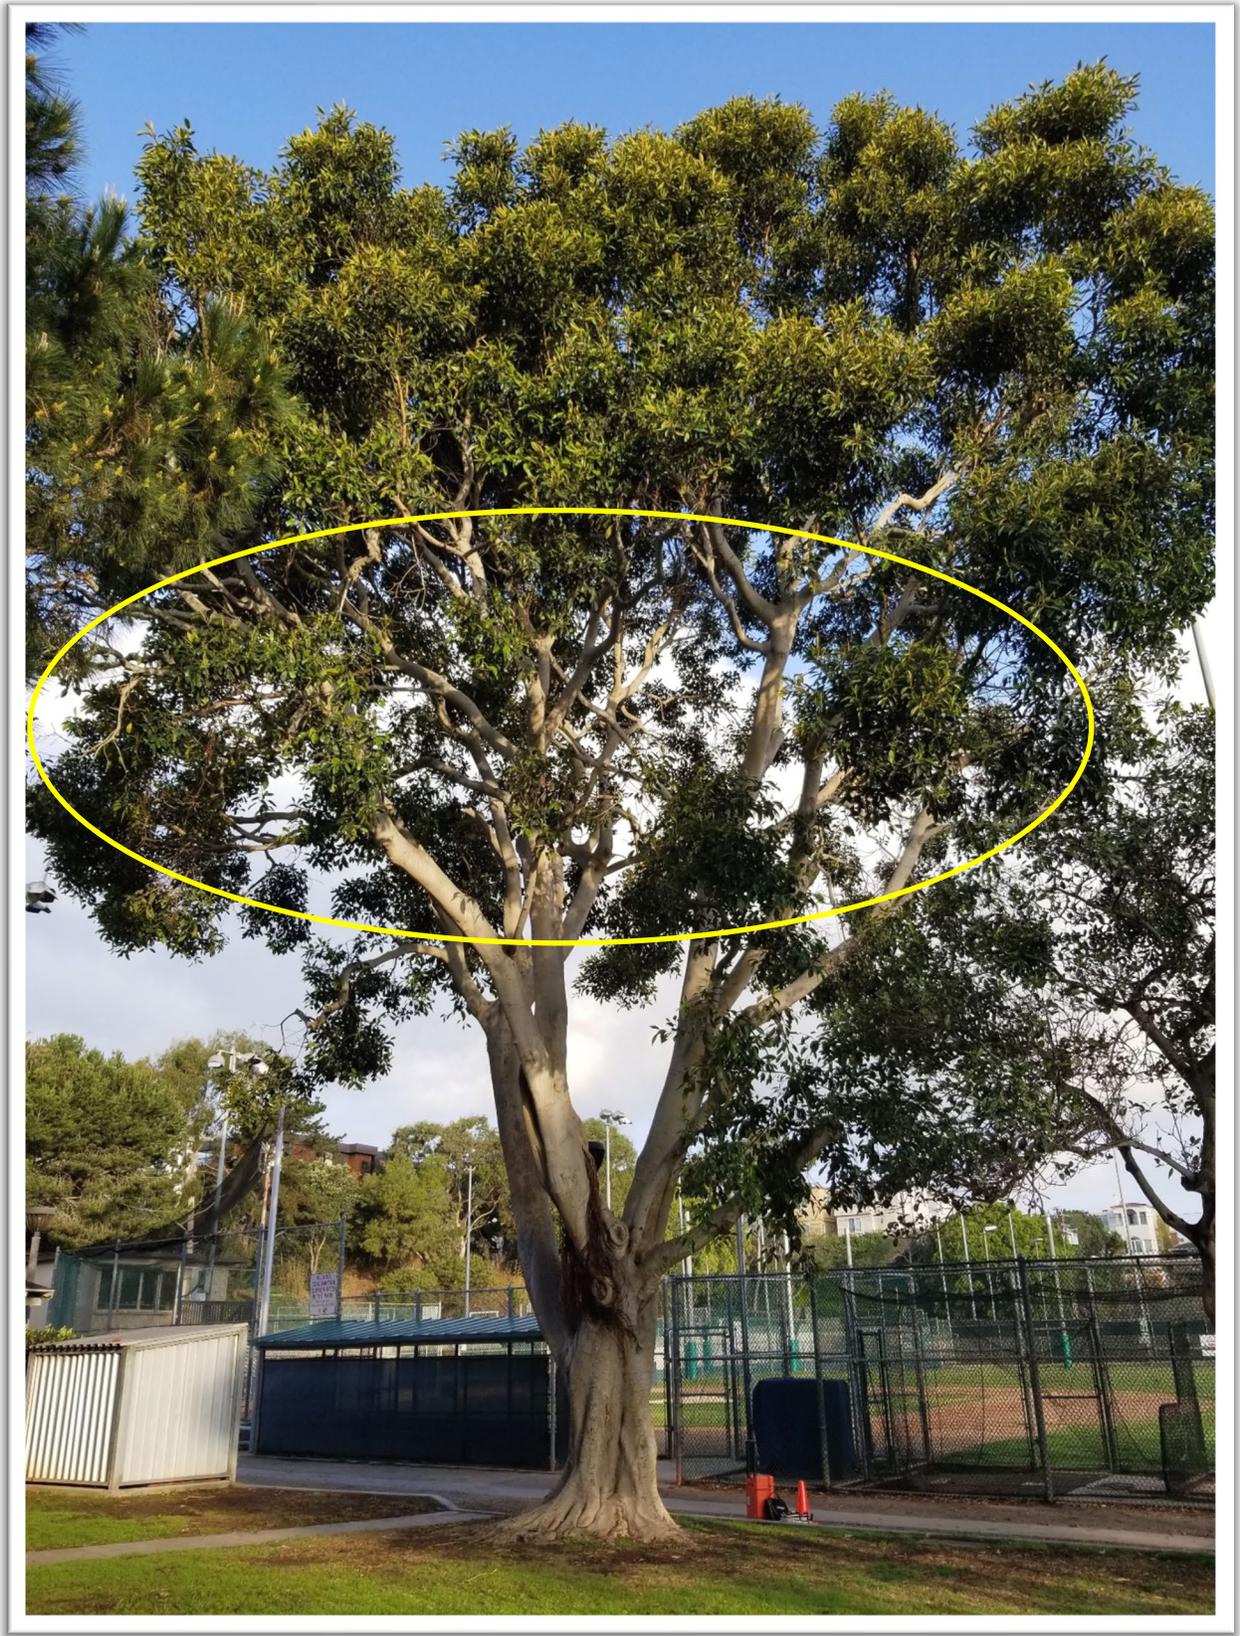
Image 2. Showing the subject tree as seen looking northwest. There is canopy thinning in the mid and lower portions of the crown.

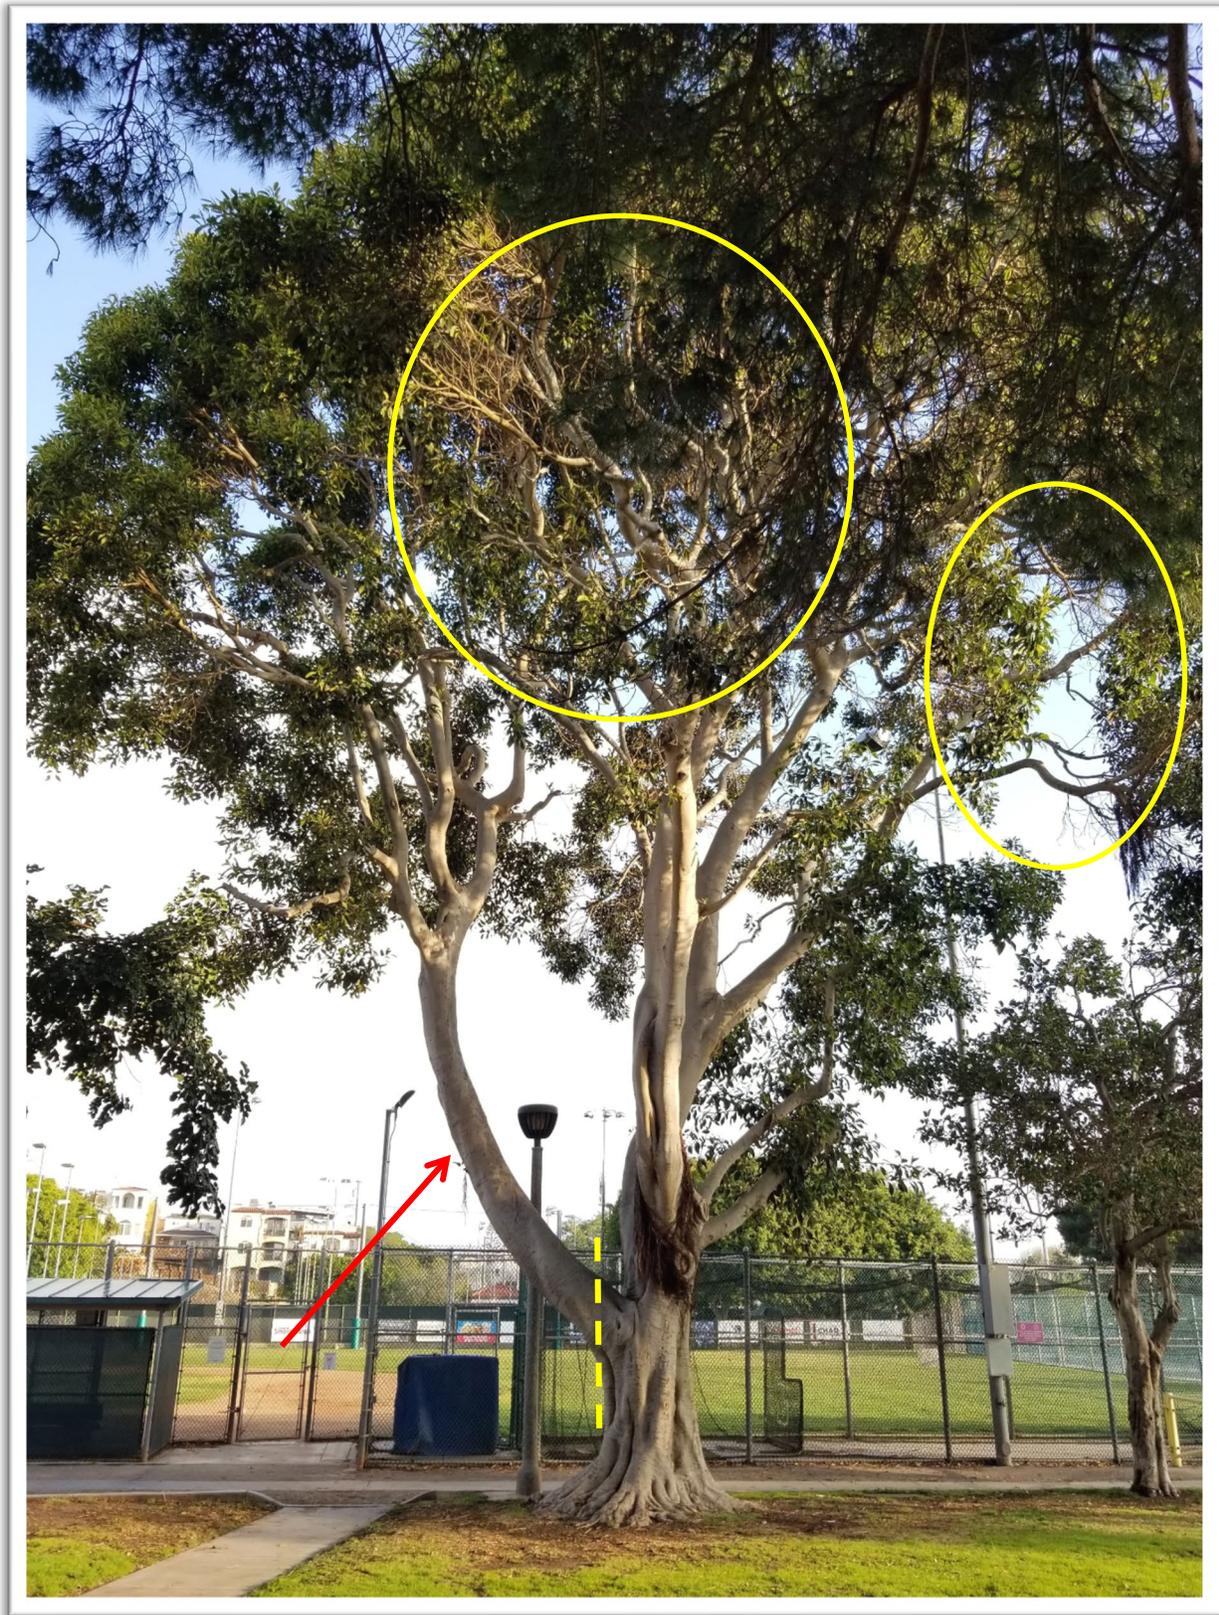
- Additionally, the plans called for a covered entrance way that would directly impact the crown of the fig tree. There is a very large lateral limb on the west side of the tree that would require removal in order to build out the entrance way. This would result in uneven canopy weight distribution.

Image 3. Showing the tree looking north. Note the canopy thinning and twig dieback visible in several parts of the crown. The western lateral limb (red arrow) would also require removal due to the planned new covered entrance, this is not advised.

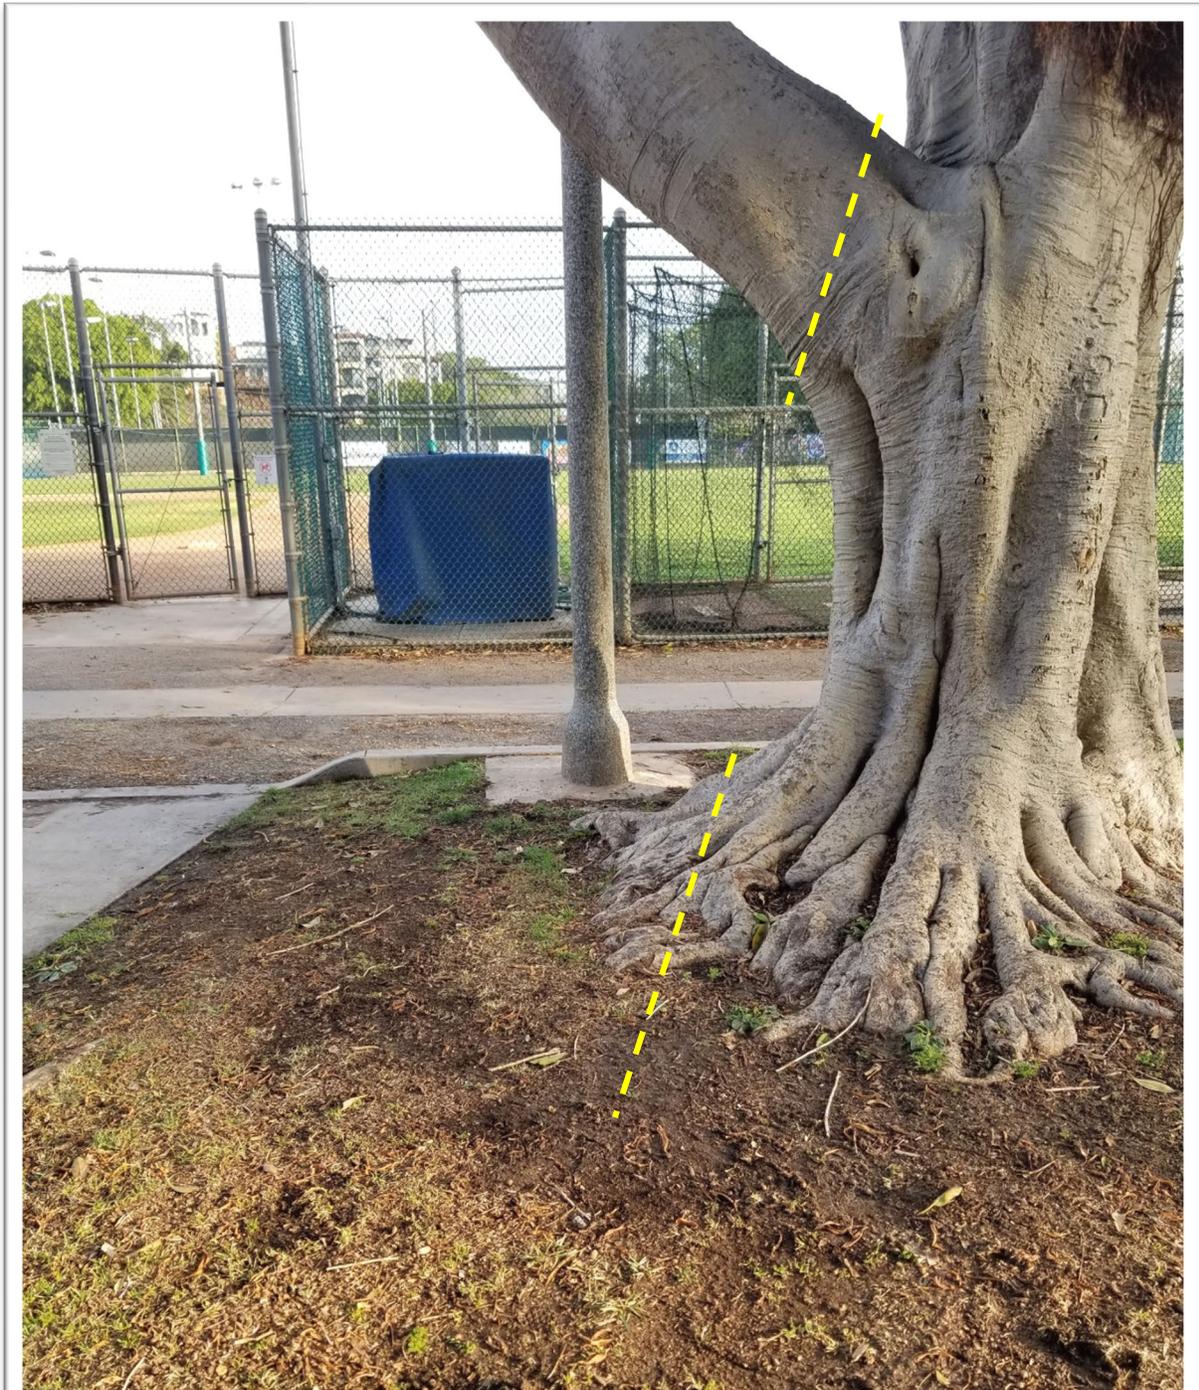
- This tree has a very large root flare extending several feet out from the tree base and several large anchorage roots are extending out into the lawn area. Image 4

- This level of activity will result in damage to more than 50% of the tree's root system via compaction and direct injury.

Image 4. Showing the root flare and how it spreads out significantly from the tree base. Plans call for a new light standard to be installed in the area indicated, this will act to sever all the support roots on the west side. In addition, a covered entrance way is planned that would require the removal of the large lateral. This would result in uneven weight distribution. When combined with the expected root loss, this action could result in a loss of plant stability.

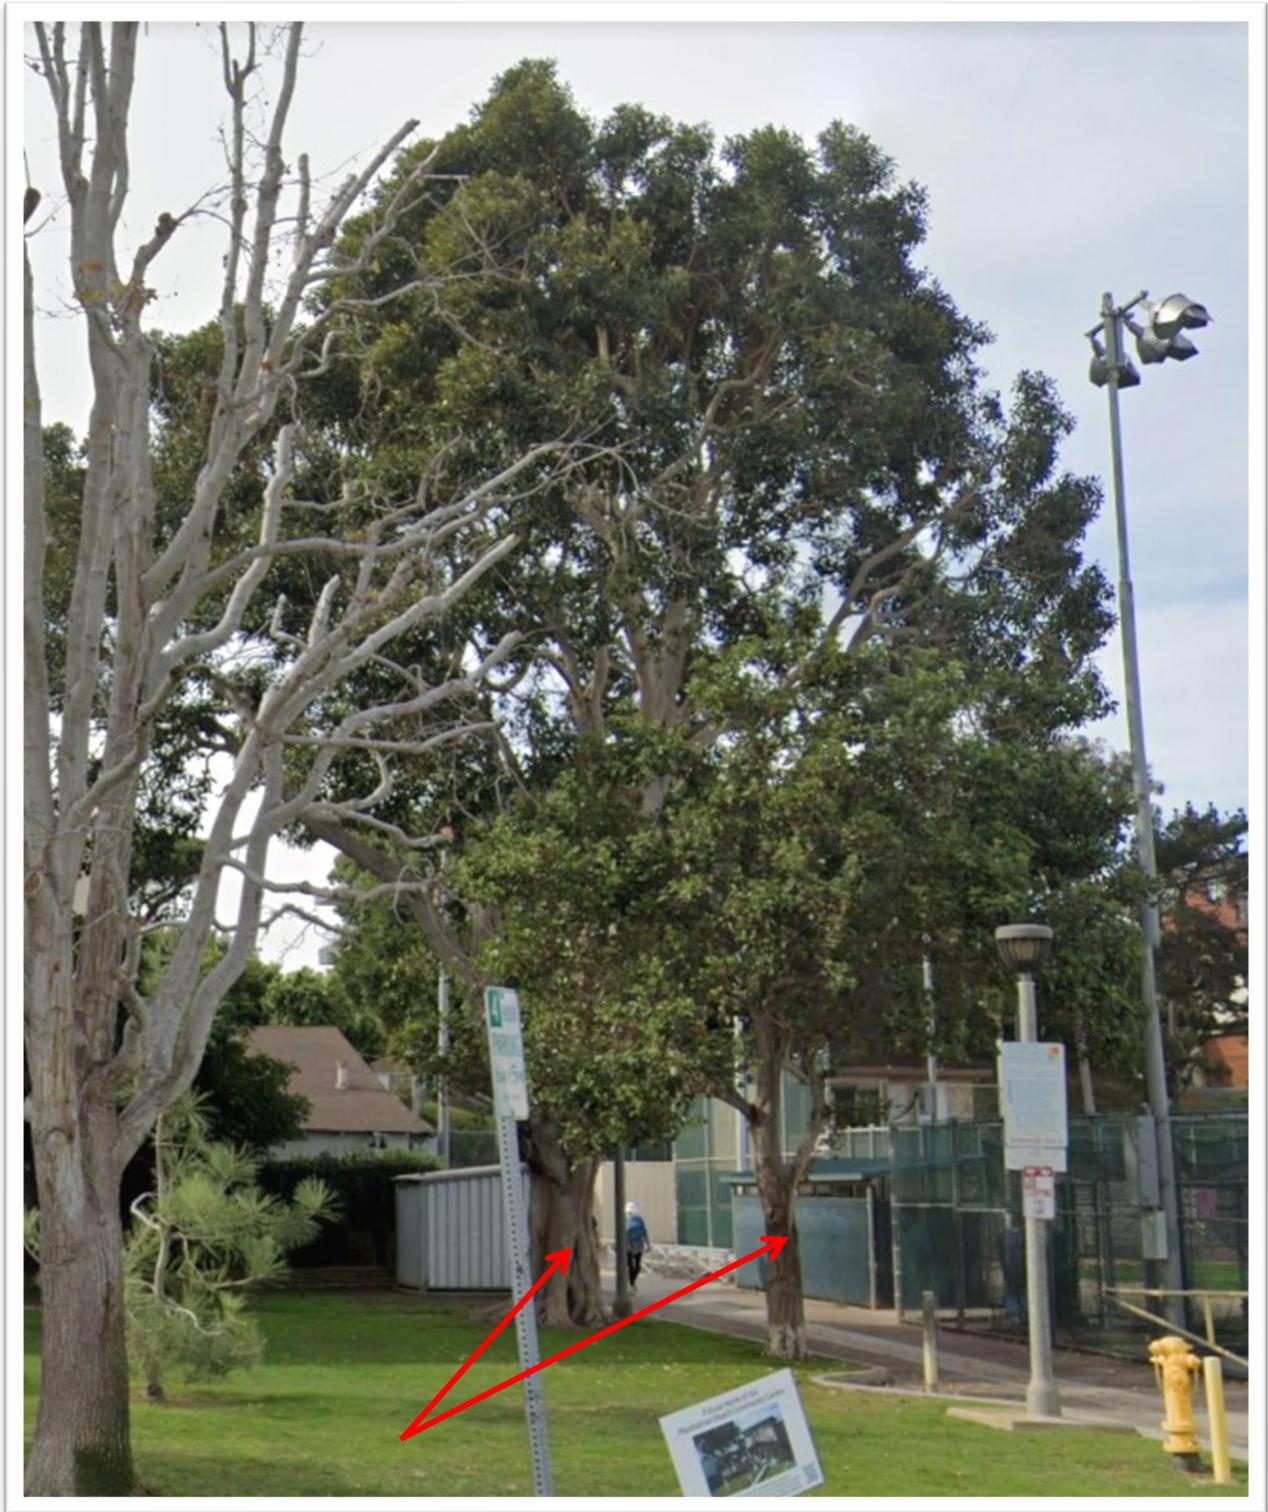
- There is a semi-irrigated lawn on the south side of the tree and an asphalt alleyway to the north.
- There is a Cape Chestnut (*Calodendron capense*) directly east of the subject fig tree. This tree is healthy and does not appear to be impacted by planned construction. Image 5

Image 5. Showing the larger subject fig as well as the smaller Cape Chestnut. The Moreton Bay Fig tree is expected to be highly impacted by planned construction, specifically by root loss and canopy encroachment issues.

Based on overall plant health and proposed construction plans, it is not believed that the Moreton Bay Fig is a good candidate for site retention. The expected level of root loss and canopy encroachment issues will have numerous impacts on both plant health and stability. Given the trunk diameter of the subject tree, a minimum tree protection zone of 11-feet would need to be implemented radially out from the tree base. The large western lateral limb would require removal to accommodate the new covered entrance. This limb makes up a third of the tree's total canopy, and its loss would cause a change in canopy weight distribution. When combined with the expected damage from construction impacts (i.e., equipment driving over the root zone), root loss due to cutting for the light standard and new walkway, and the removal of the large lateral, it is my opinion that the adverse impacts are too great for the tree to successfully survive during and after the proposed construction.
