# MANHATTAN BEACH

## Live Oak Park (aka: Scout House)

### Construction Impact Report (Italian Stone Pine)

APRIL 14, 2022

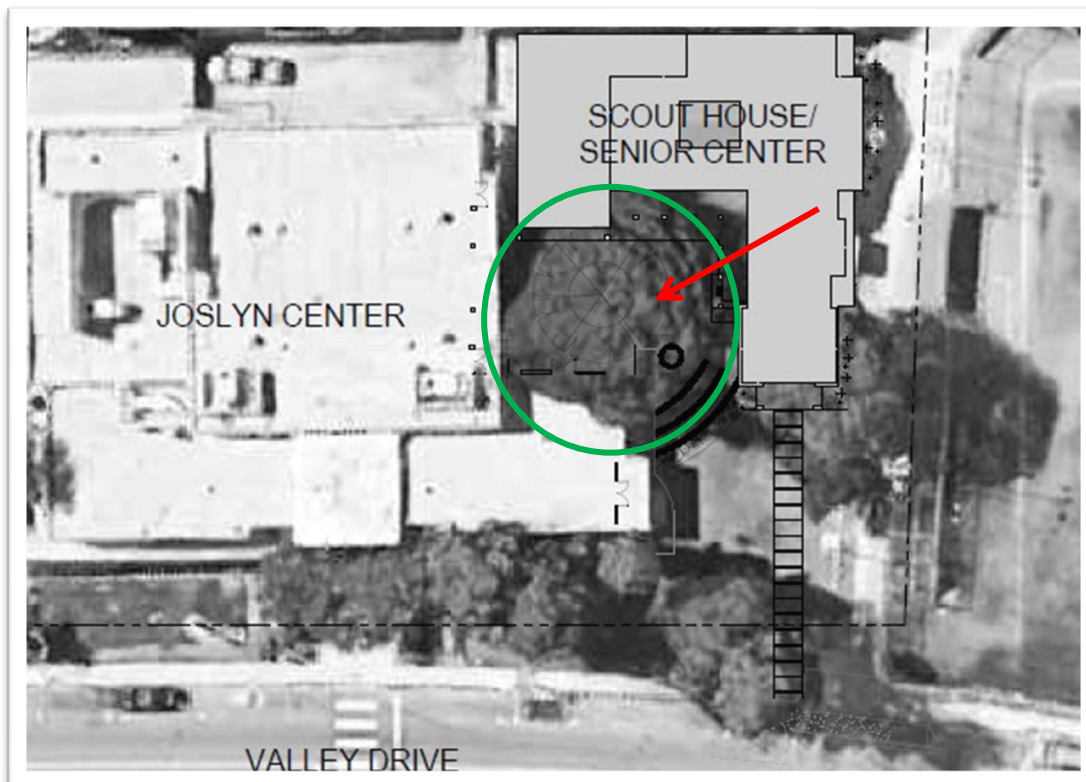
Site Map 2 (below). Provided by the client, showing the location of the pine tree with respect to planned construction. Based on this image, it appears that the roofline of the proposed 2-story building will partially impact the tree canopy.

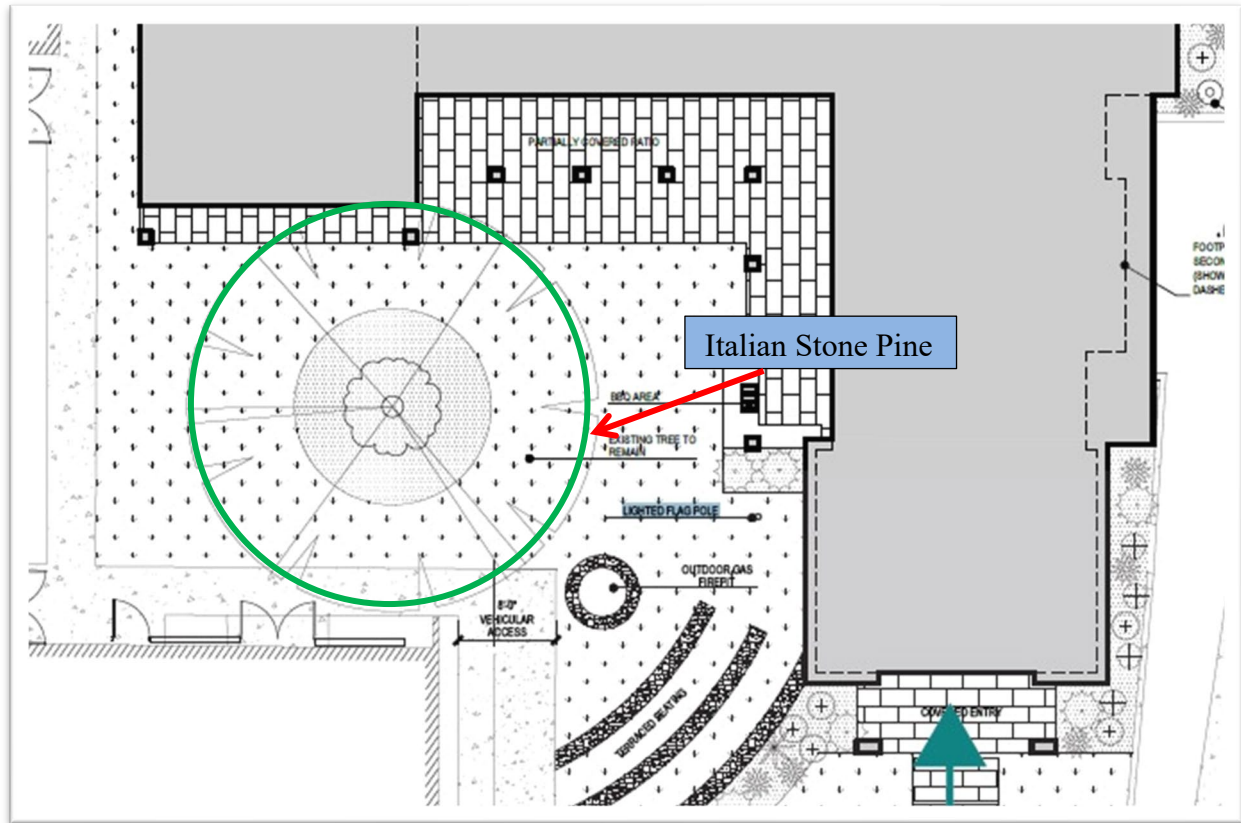
**Site map 3, Provided by the client.**

This site plan shows there will be minimal encroachment into the tree’s root protection zone, with minimal to moderate encroachment into the canopy.

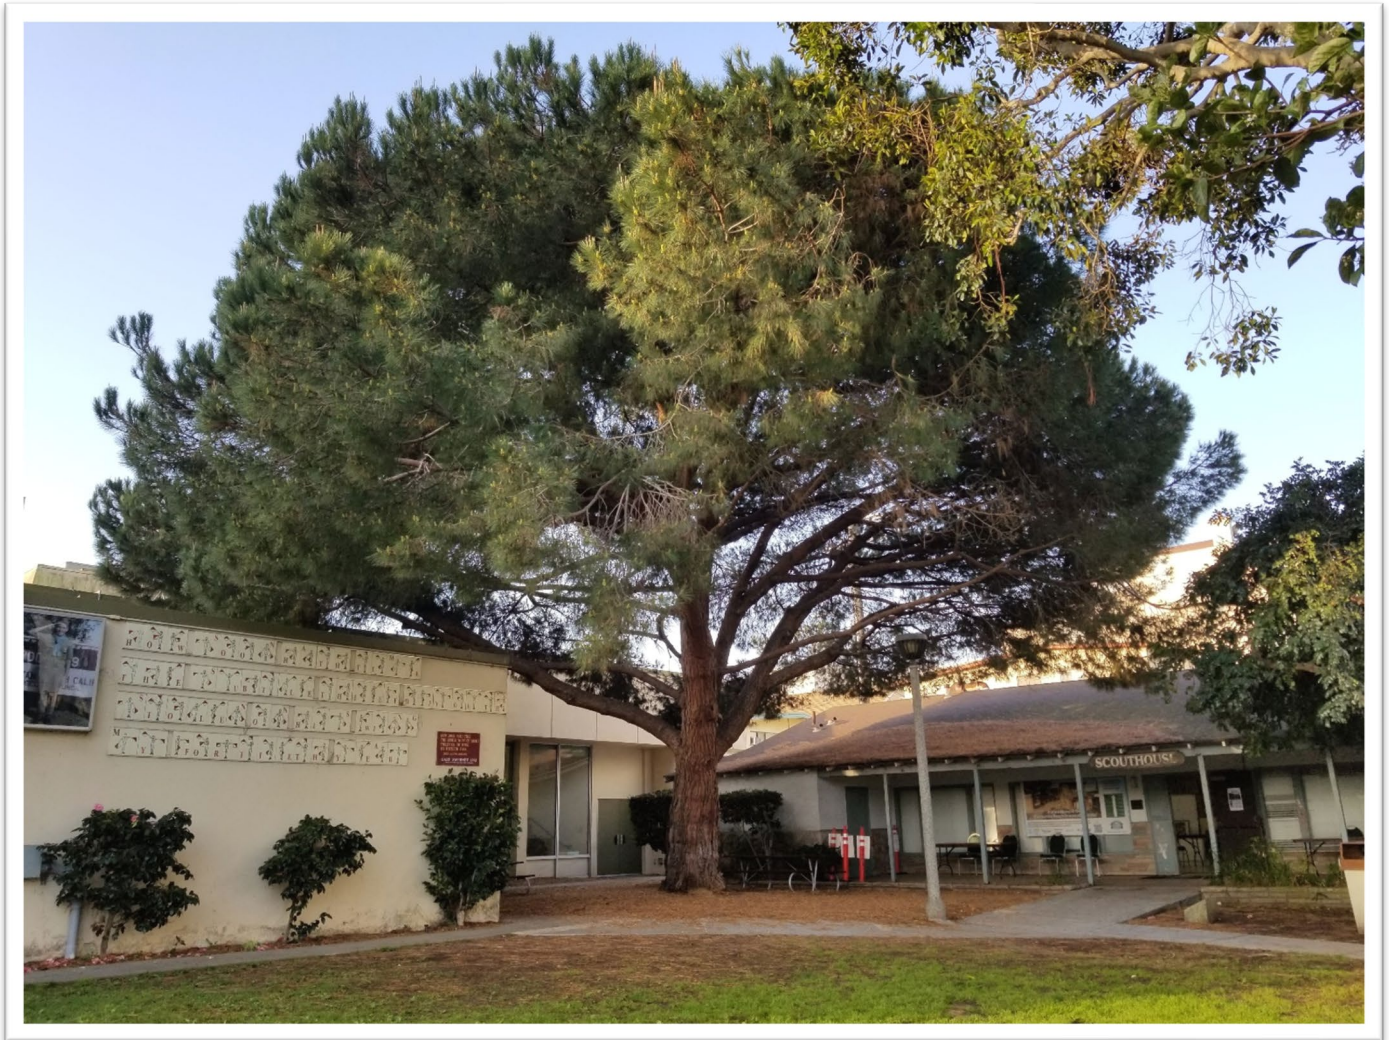
- The subject tree has a trunk diameter of 39-inches, with a height of 50-feet and a canopy spread of 65-feet (east to west) and 65-feet (north to south). Canopy spread was measured by a standard 5-foot pace.
- The tree displays a healthy canopy with no signs of stress. Plant health, structure, and form are all good and consistent with species characteristics. See Appendix B: Health and Condition Components.

Image 1. Showing the subject Italian Stone pine. Note there is already a nice mulched area established within a good portion of the dripline.

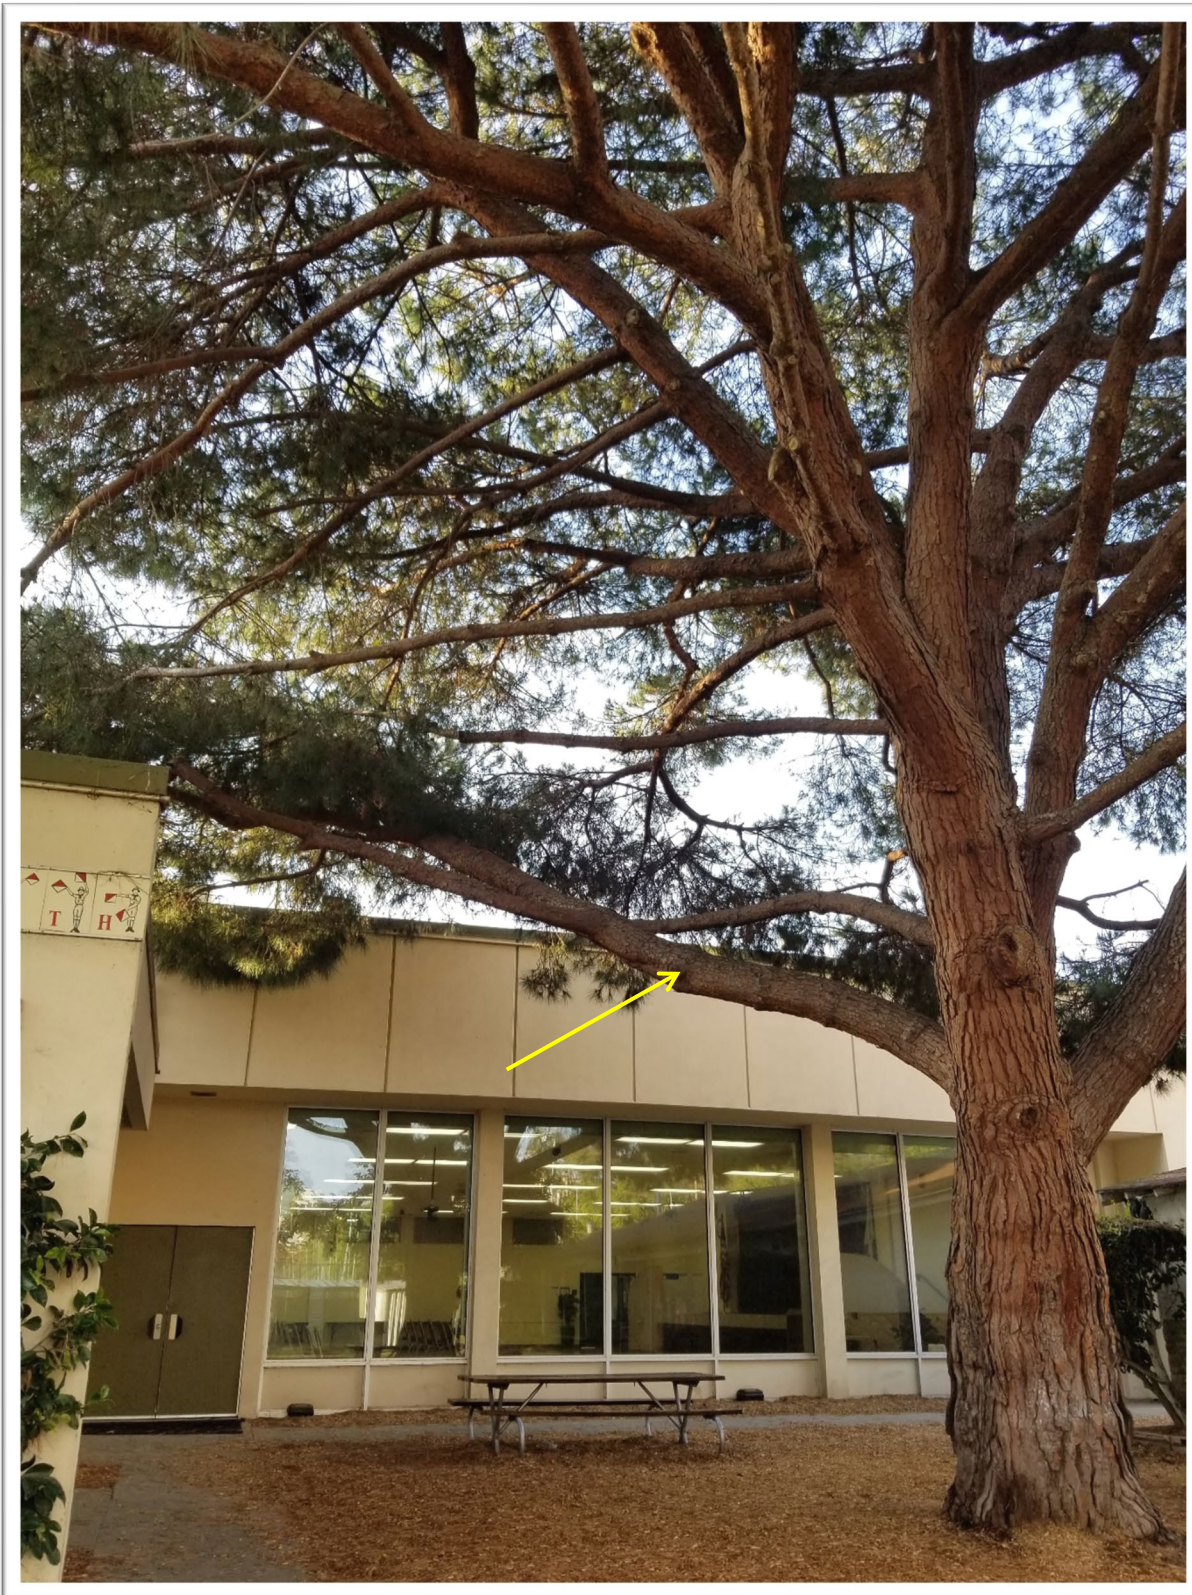
- This tree is growing in the courtyard between the Joslyn Community Center building and the Scout House and is surrounded by a large, mulched area.
- There is one large limb growing over the community building that appears to be in contact with the roofline.

Image 2. Showing the subject tree as seen looking south. Note the limb hanging low over the eastern portion of the community building. Per onsite discussions with city staff, it is recommended that this branch be removed prior to the start of construction activities.

- Remove the large lateral limb that is hanging over the eastern roofline of the community building, as shown in Image 2, This can be done prior to the start of construction activities.

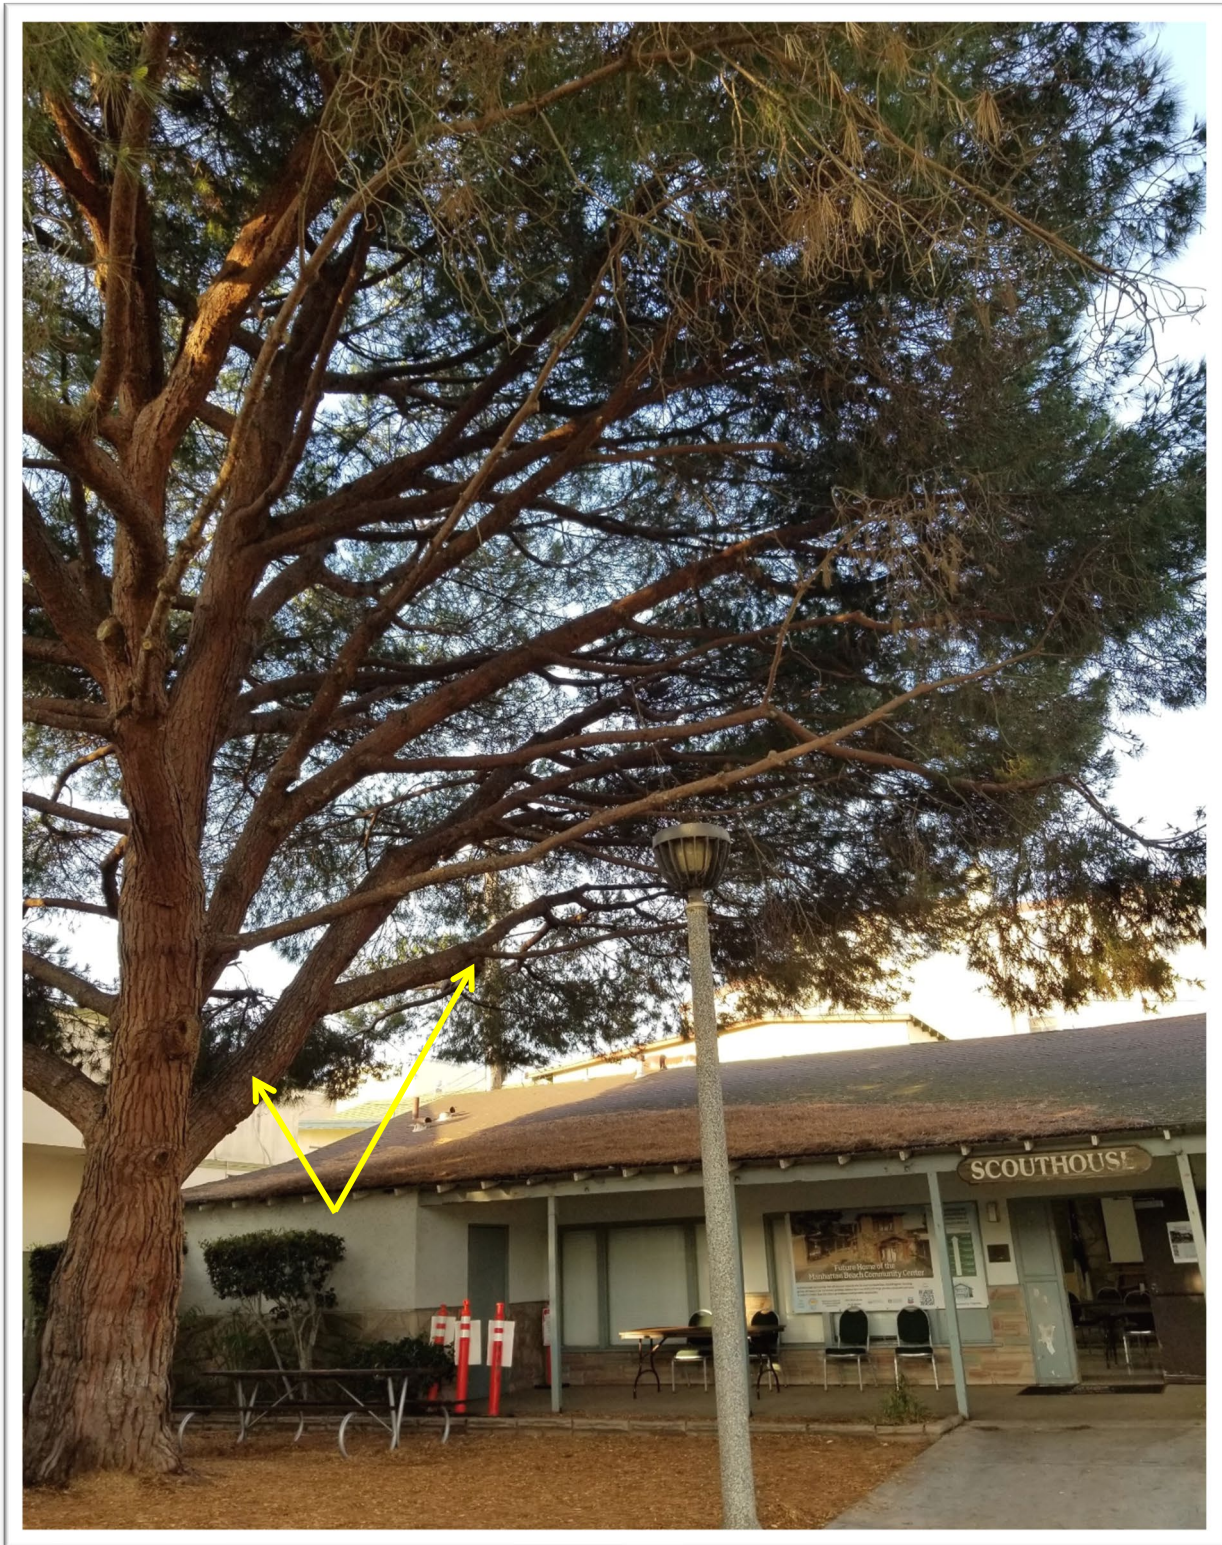
- There is one large lateral over the Scout House that will require removal should the construction of the proposed two-story building be approved.
- Based on the current size dimensions of the mulched area within the dripline of the pine, most of the root protection zone can be maintained.

Image 3. Showing the tree looking southwest. Construction of the proposed two-story building will require the removal of this large lateral. It is recommended that piecing back the limb begin prior to construction. Begin by removing the lower, smaller portion first, then proceed to remove portions of the remaining branch as needed. Full removal may end up not being necessary.

- Begin to cut back the large western lateral that is over the current Scout House building, as shown in Image 3. With the expectation that the proposed plans will be approved, it will be less stressful for the tree if pruning is slowly implemented prior to any construction.

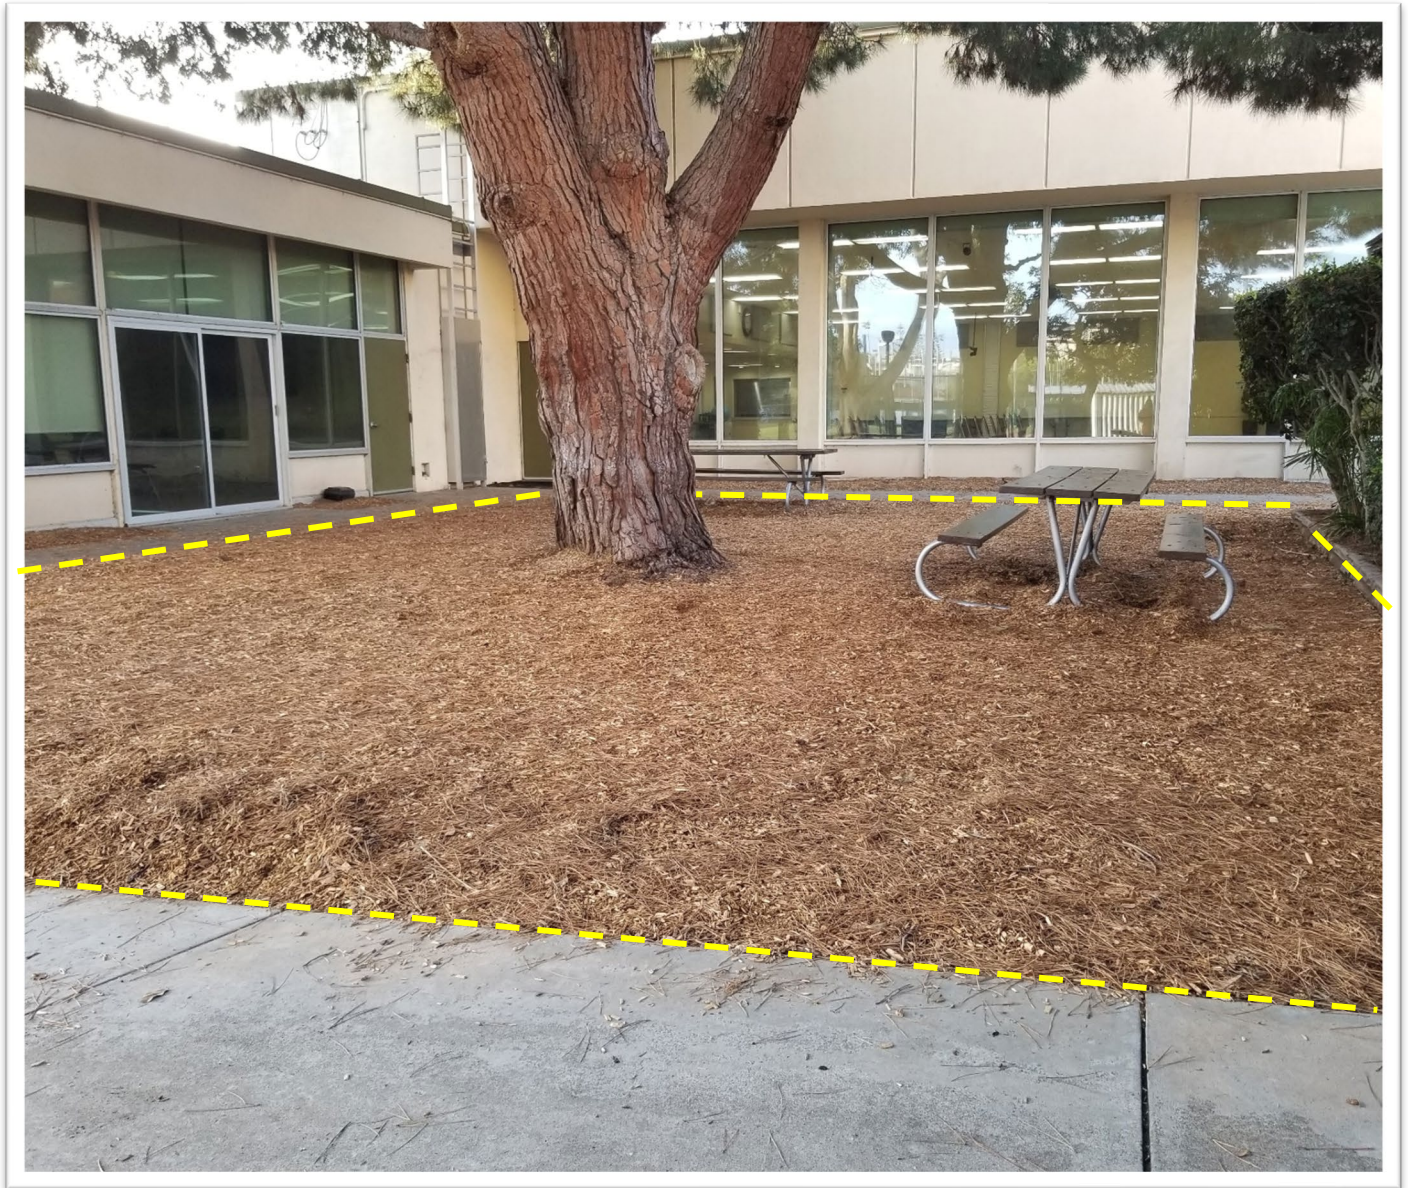
Image 4. Showing the proposed tree protect zone, which should utilize as much of the existing mulch-filled growth space as possible. This area already encompasses the critical root zone. Install protective fencing and restrict the use of construction equipment. Refer to Appendix C for specifications.

- Establish a Tree Protection Zone (TPZ). Based on overall plant size and trunk diameter, an ideal protective barrier would be installed at the dripline. However, due to the current canopy configuration, consider using the planter as the TPZ, see Image 4. The mulched area within the dripline is already protecting most of the critical root zone. Refer to Appendix C, for specifics on where to place protective fencing. Maintain the established TPZ during all stages of demolition and construction.
