Staff Report City of Manhattan Beach

Review of Water and Sewer Capital Improvement Needs

CITY OF MANHATTAN BEACH Water and Wastewater Capital Improvement Programs

July 28, 2009

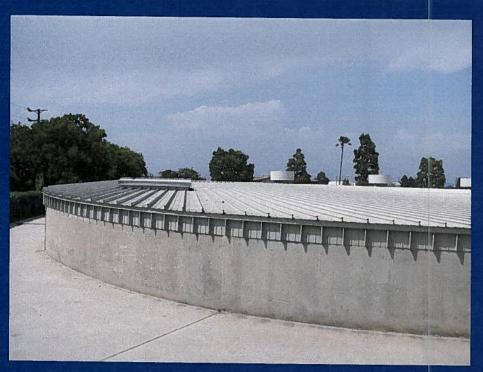
Peck Reservoir, completed in 1957, has a constructed volume of 7.5 million gallons.

Its roof is in fair condition and is projected to reach the end of its useful life around 2020.

- ✓ Replace Block 35 Reservoir with a 4 million gallon facility (\$8.1 M)
- ✓ Replace Peck Reservoir with a 4 million Gallon reservoir (\$8.1 M)

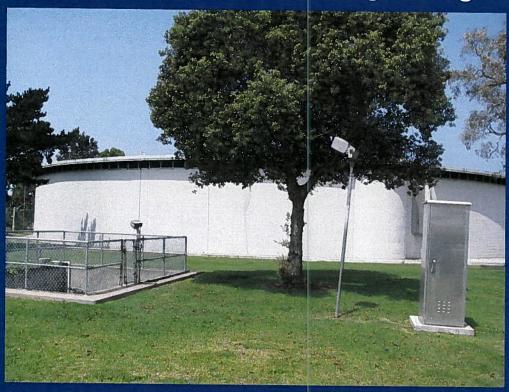
Block 35 Ground Level Reservoir was constructed in 1948.

Although its constructed volume is 2.0 million gallons, it is kept only half full due to leakage at higher levels.

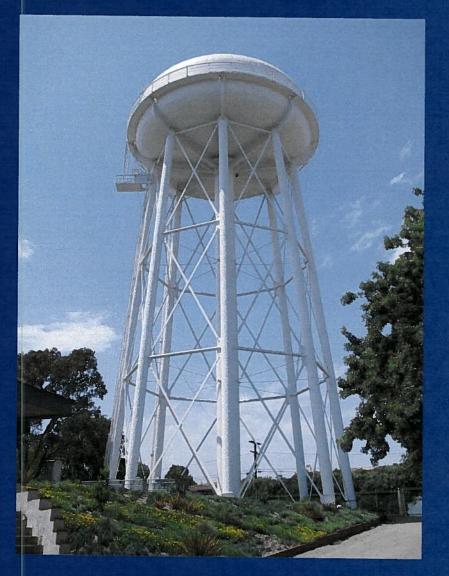
It was constructed in 1948 and was seismically rehabilitated in 2000.

It is in good condition and is expected to last beyond the planning horizon of this master plan.

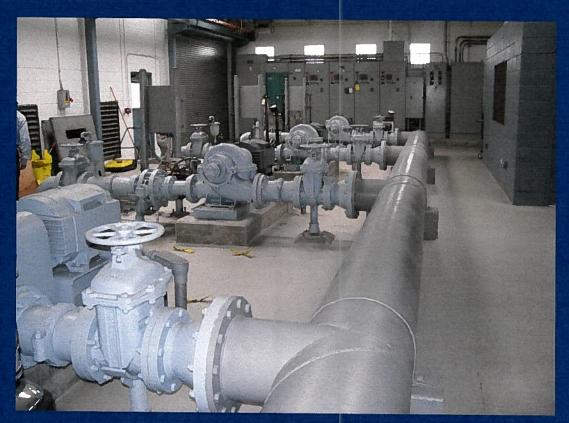
Block 35 Pump Station was upgraded in 2000 and is in good condition.

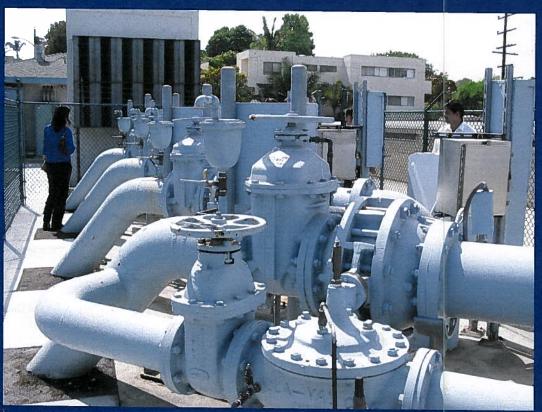
Peck Pump Station was also upgraded in 2000 and is in good condition.

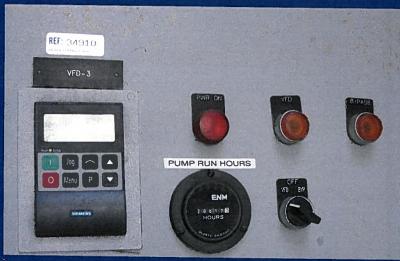
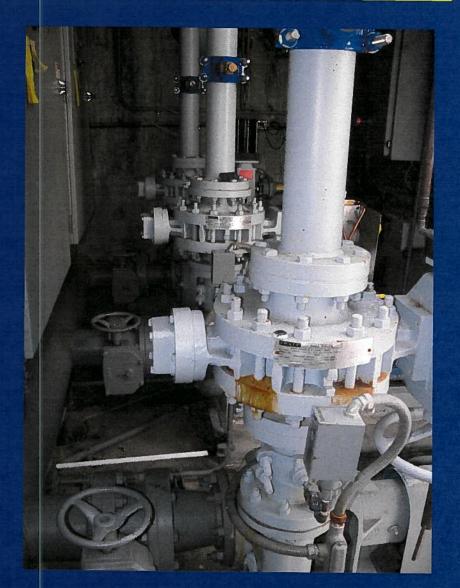
Larsson Street Pump Station requires significant rehabilitation and capacity enhancement. The vault structure is deteriorated and maintenance space in the vault in insufficient. Additionally, all three pumps at the station must operate to provide peak domestic service. When pumps at the station are taken out of service for maintenance, the natural gas engine pump at 2nd Street must run to provide supplemental pressure to the high pressure zone. AKM recommends replacement of the station with a larger vault and with pumps of adequate capacity at the estimated cost of \$2,025,000.

Larsson Pump Station
mechanical and
electrical equipment
was replaced in 2000,
but the structure is in
poor condition.

Replace with a new facility (\$2.025 M)

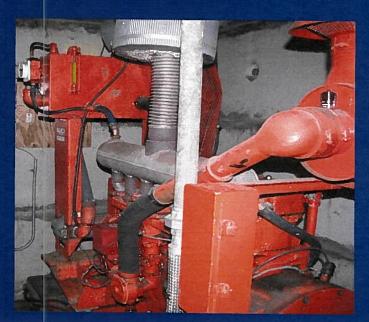
Second Street Pump Station was constructed in 1977 and is in fair condition. The engine is old, and spare parts are hard to find

Pump controls need to be upgraded to eliminate frequent pump starts. Engine should be replaced and vibration isolators should be installed.

Upgrade control system (\$0.27 M)
Replace engine install vibration isolators (\$0.4 M)

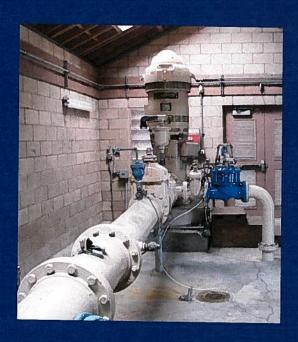
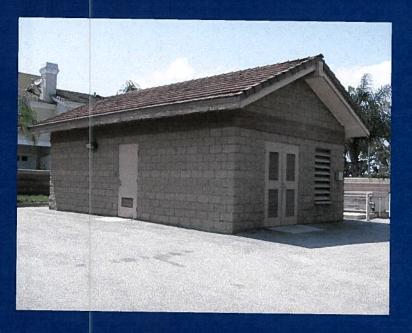
It is in good condition.

It has a capacity of 2,300 gallons per minute.

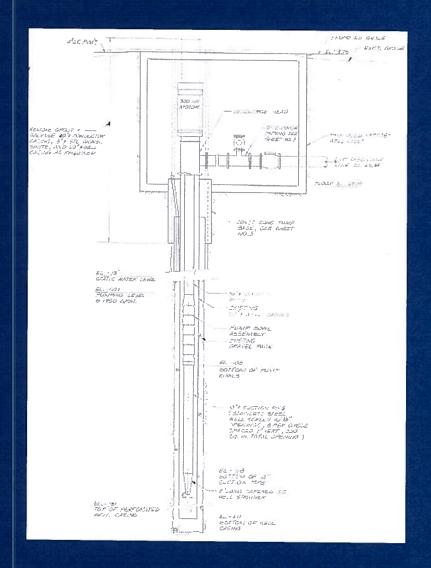
Its mechanical equipment needs to be replaced.

Its discharge pipe, constructed in 1979, is too small to for Well 15 to operate simultaneously with Well 11A.

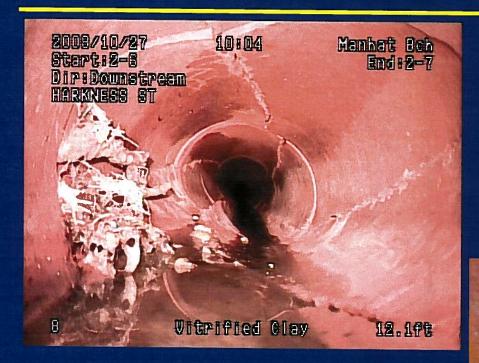
Broken Pipe

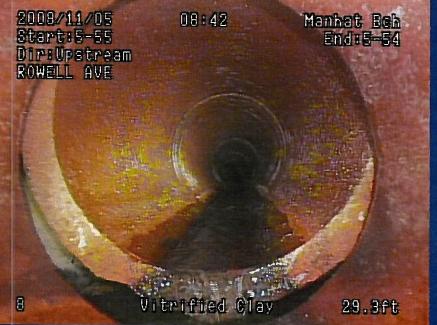
Large Offset Joint

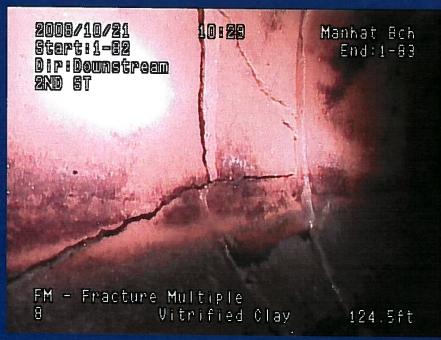
Multiple Fractures

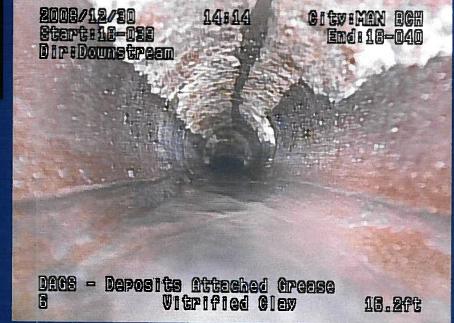
Grease Deposits

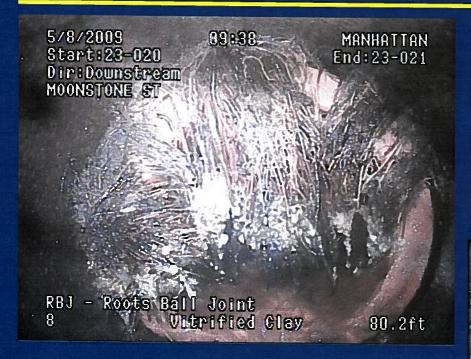
Roots

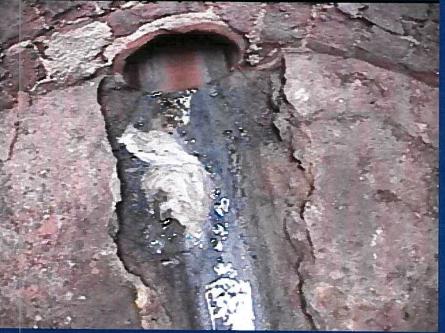
Eroding Channel in Manhole

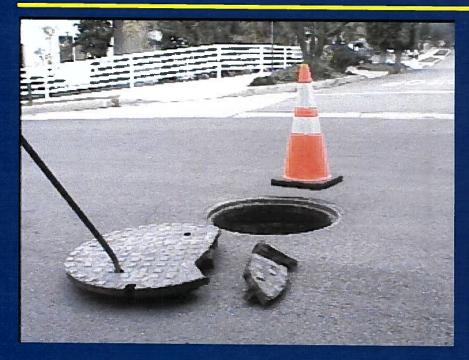
Broken Manhole Cover

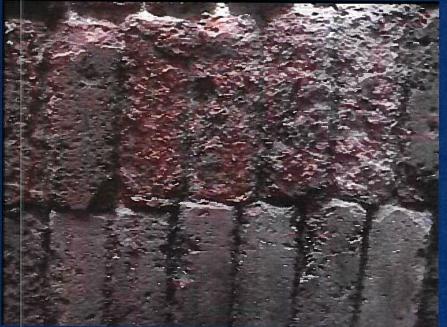
Corrosion in Manhole

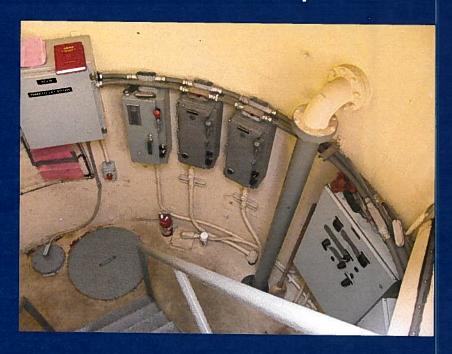
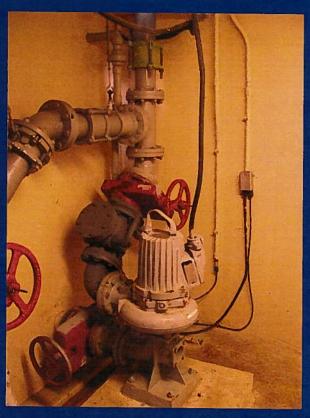
✓ Poinsettia Pump Station and its force main was built in 1949

and is in need of replacement.

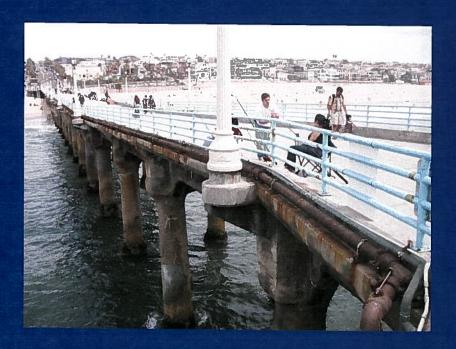
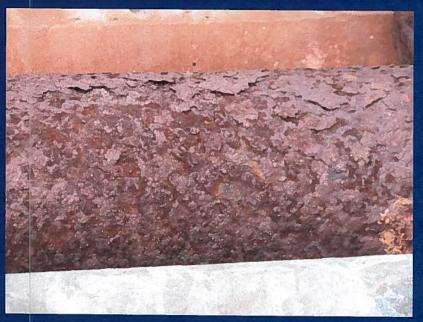
✓ The Pier Pump Station force main is in need of replacement.

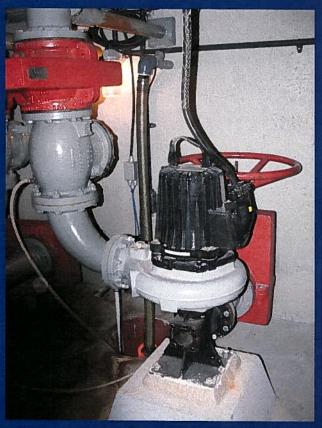
✓ The force mains for Pacific, Voorhees, Meadows, Palm, and Bell Pump Stations should be replaced when the pump

stations are upgraded
