SECTION 8

COLLECTION SYSTEM CONDITION ASSESSMENT

CITY OF MANHATTAN BEACH
WASTEWATER MASTER PLAN

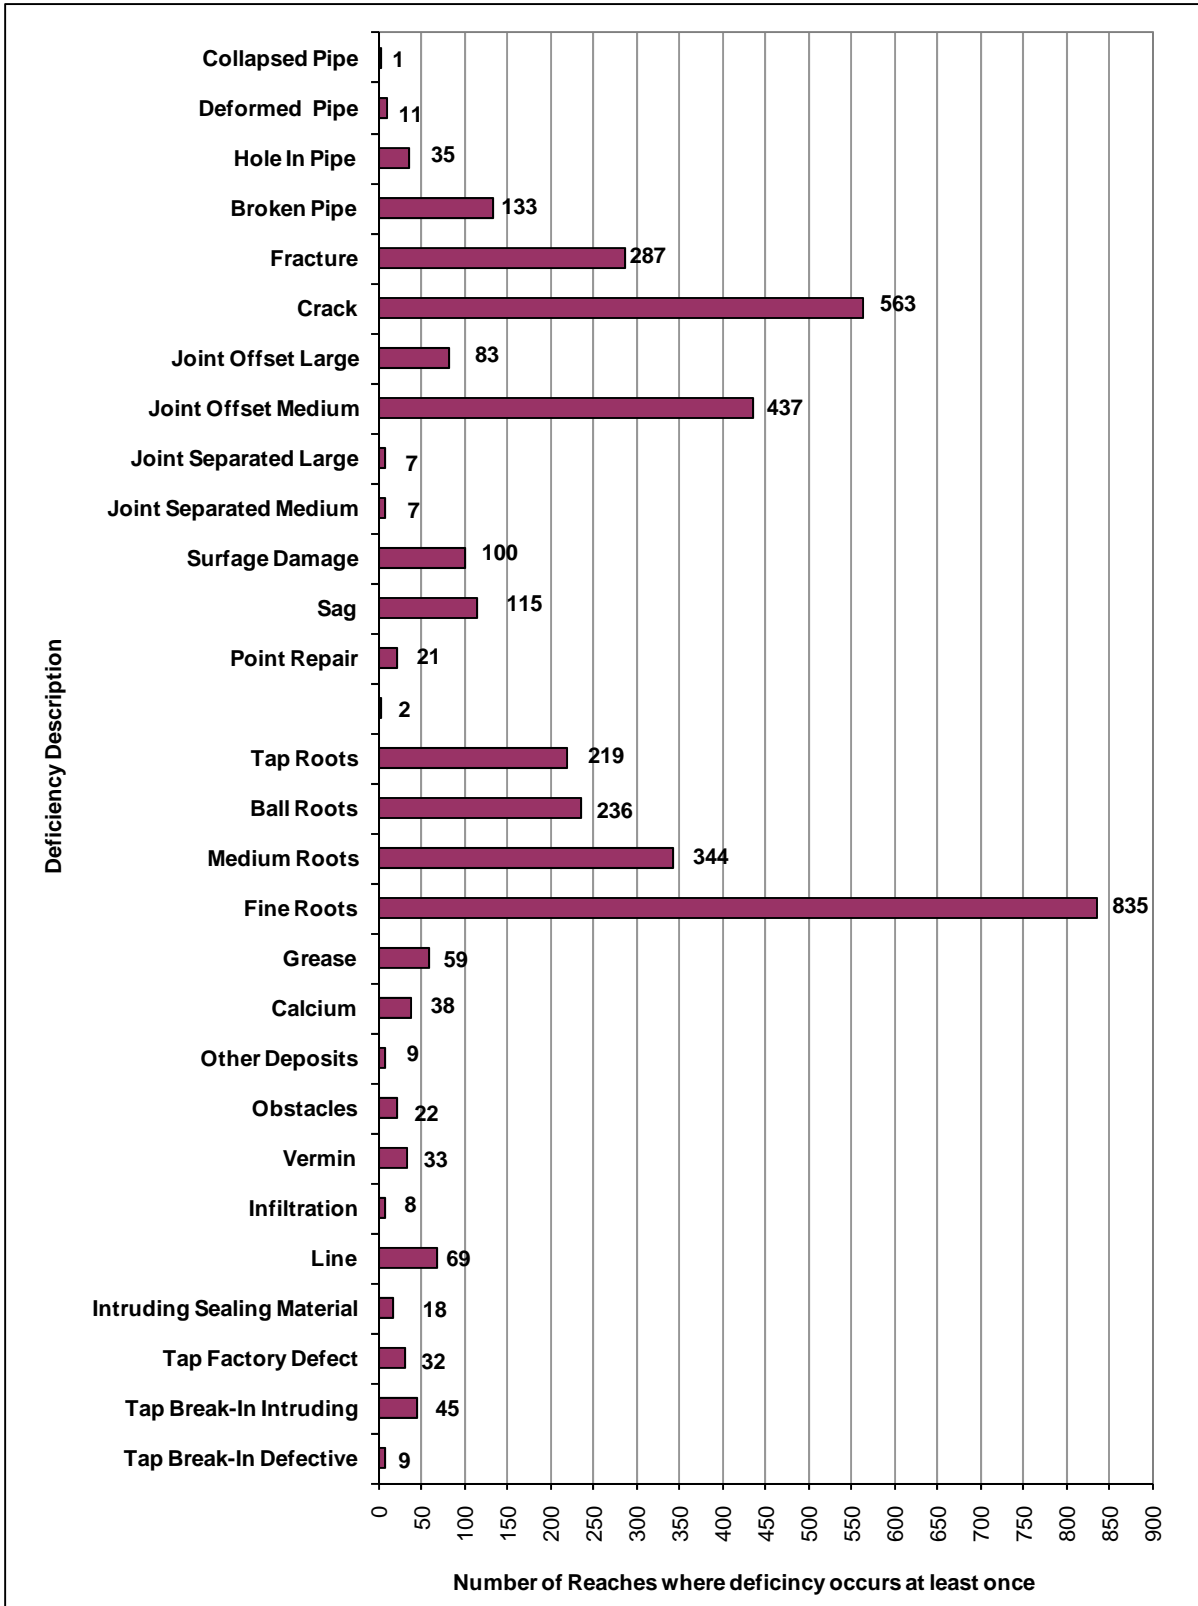
**Figure 8-2
Sewer Reaches with Identified Deficiencies**

Figure 8-2 shows the number of reaches where an identified deficiency was found at least once within the reach. It provides a general sense of the magnitude of the problems that were found in the City’s collection system. The problems identified most often were fine roots (835 reaches, 22% of total), cracks (563 reaches, 15% of total) and joint offset medium (437 reaches, 12% of total).

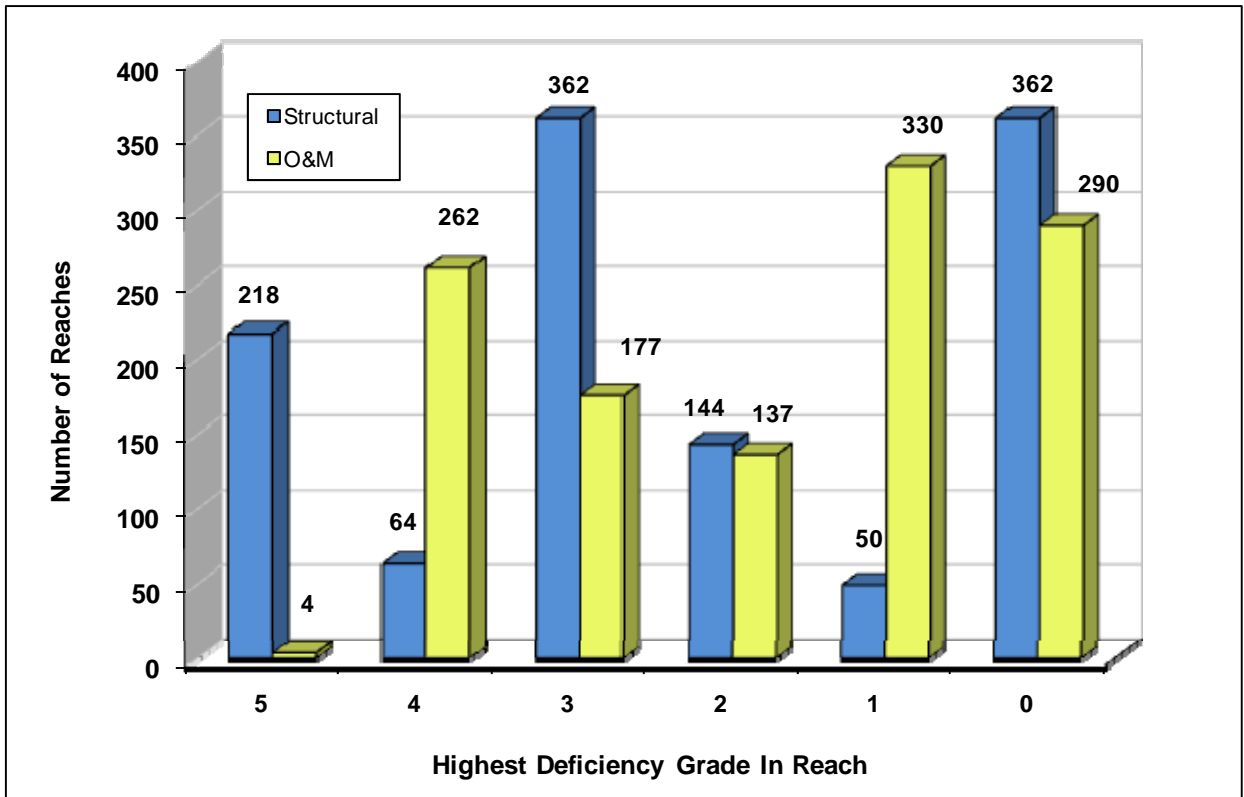
Figure 8-3
Deficiency Grades

Figure 8-3 is a plot of the number of reaches versus the highest deficiency grades found in each reach. For example, there were 218 reaches found with at least one structural deficiency grade of 5 and 4 reaches found with at least one operation and maintenance deficiency grade of 5.

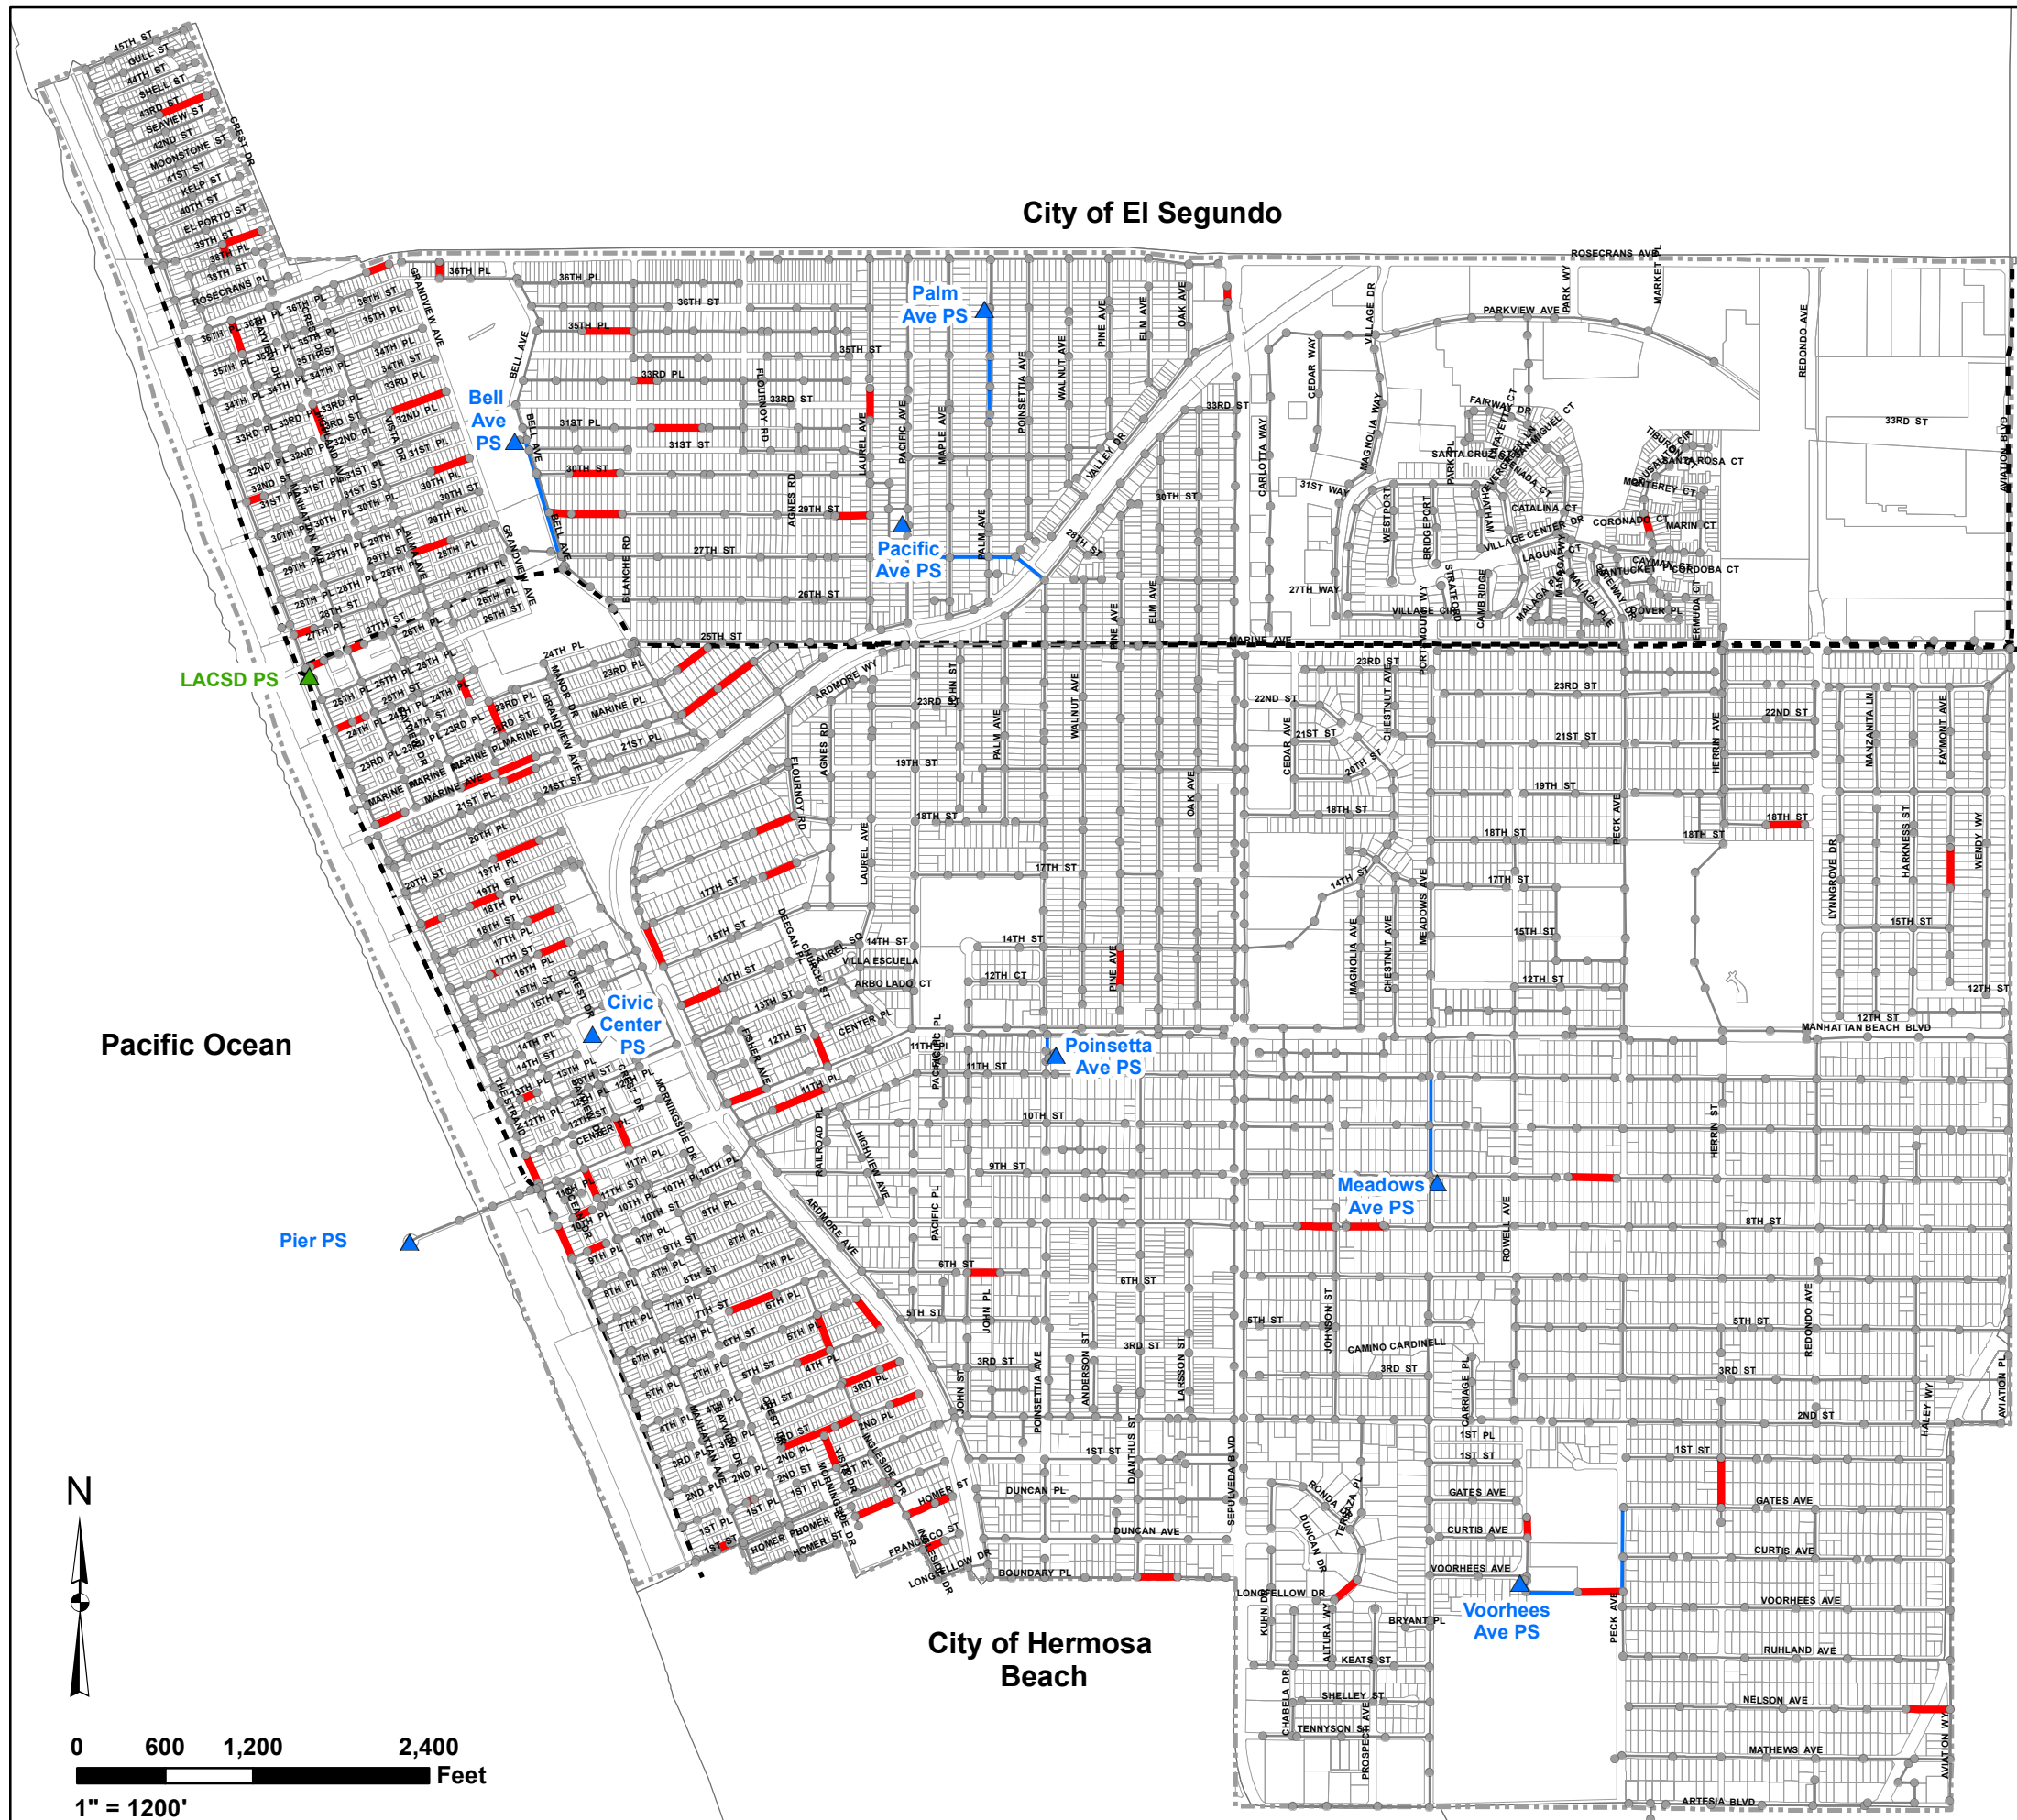
Figure 8-6

Figures 8-4 through 8-6 illustrate the locations of the reaches with significant structural defects such as broken pipe, holes in pipe, and large joint offsets.

CITY OF MANHATTAN BEACH WASTEWATER MASTER PLAN
		Large Offset Joints <small>PROJECT NO: 1640901.10</small> <small>DATE: September 2010</small>

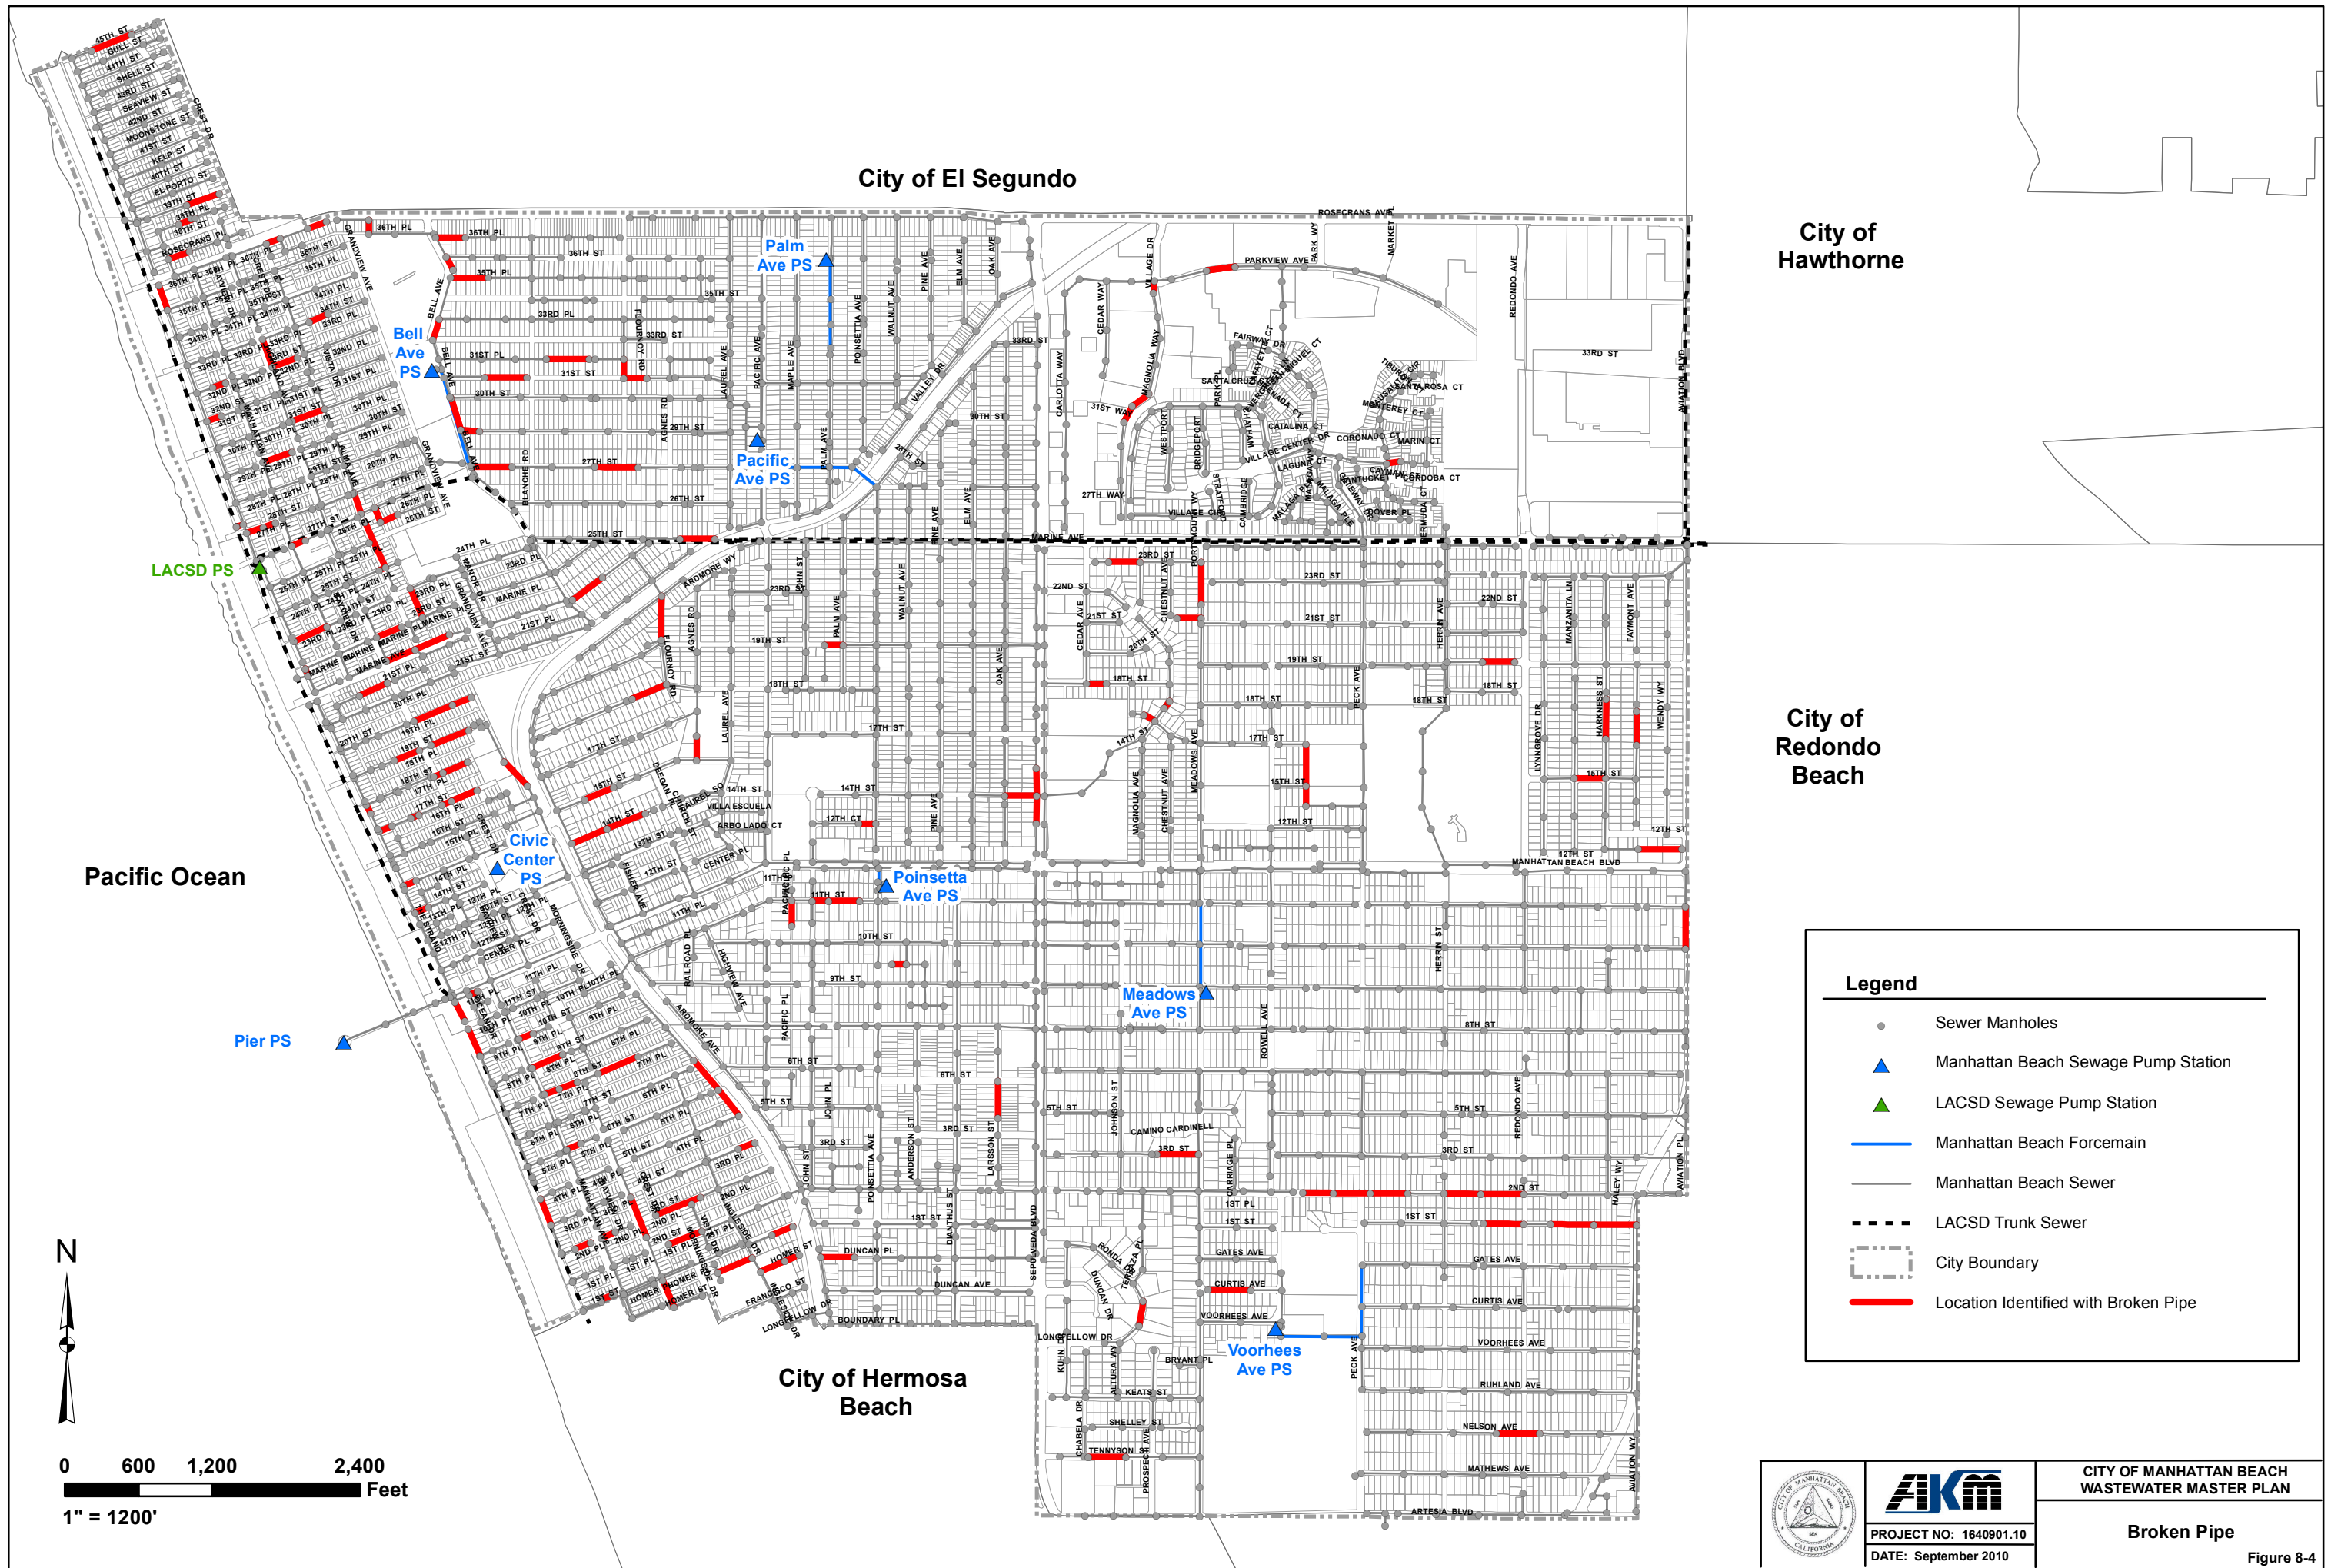
Figure 8-4

Broken Pipe

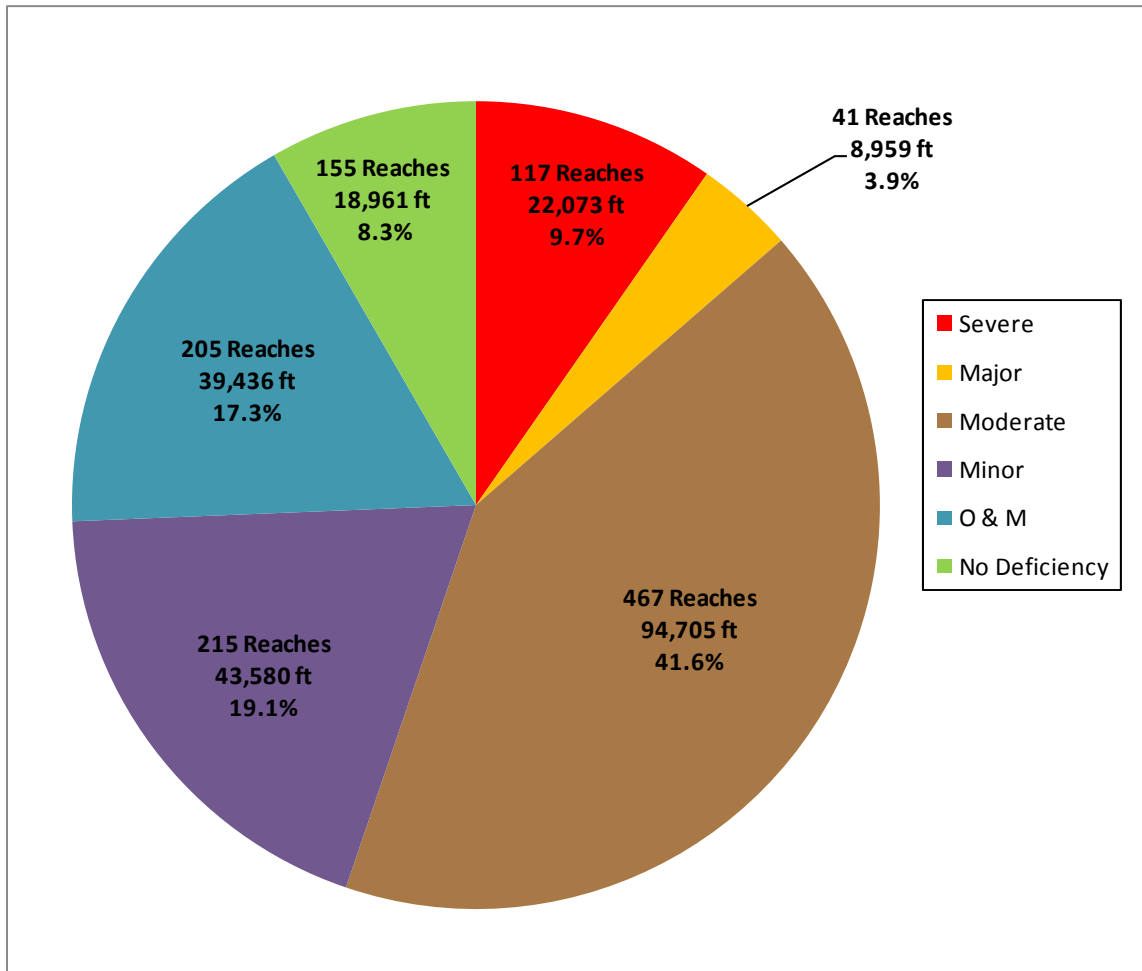
Figure 8-7
CCTV Inspection Priorities

Figure 8-7 shows the distribution of the condition priorities assigned to the pipes with completed inspections. Figure 8-8 shows the CCTV locations, color coded by rehabilitation/replacement priority.

The City of Manhattan Beach will address the “Severe” and “Major” collection system deficiencies. Table 8-2 lists the project priorities assigned to the 87 reaches of collection system identified as in “Severe” or “Major” condition, as well as planning level implementation costs based upon August 2010 dollars. The collection system construction estimates are based upon replacement at \$45 per diameter inch per foot of pipe. Implementation cost is determined by adding 35 percent of construction cost to cover engineering, inspection, and administration. The total estimated cost of upgrading the sewers with severe or major condition priorities is \$15,330,000. This is based on the assessment of 43.1 miles of pipe or 52.9 percent of the total gravity sewer system. Assuming that similar deficiencies will be identified when the remainder of the system is CCTV inspected, the total cost for rehabilitation and replacement of the remaining gravity sewer pipes is estimated at approximately \$13,600,000.

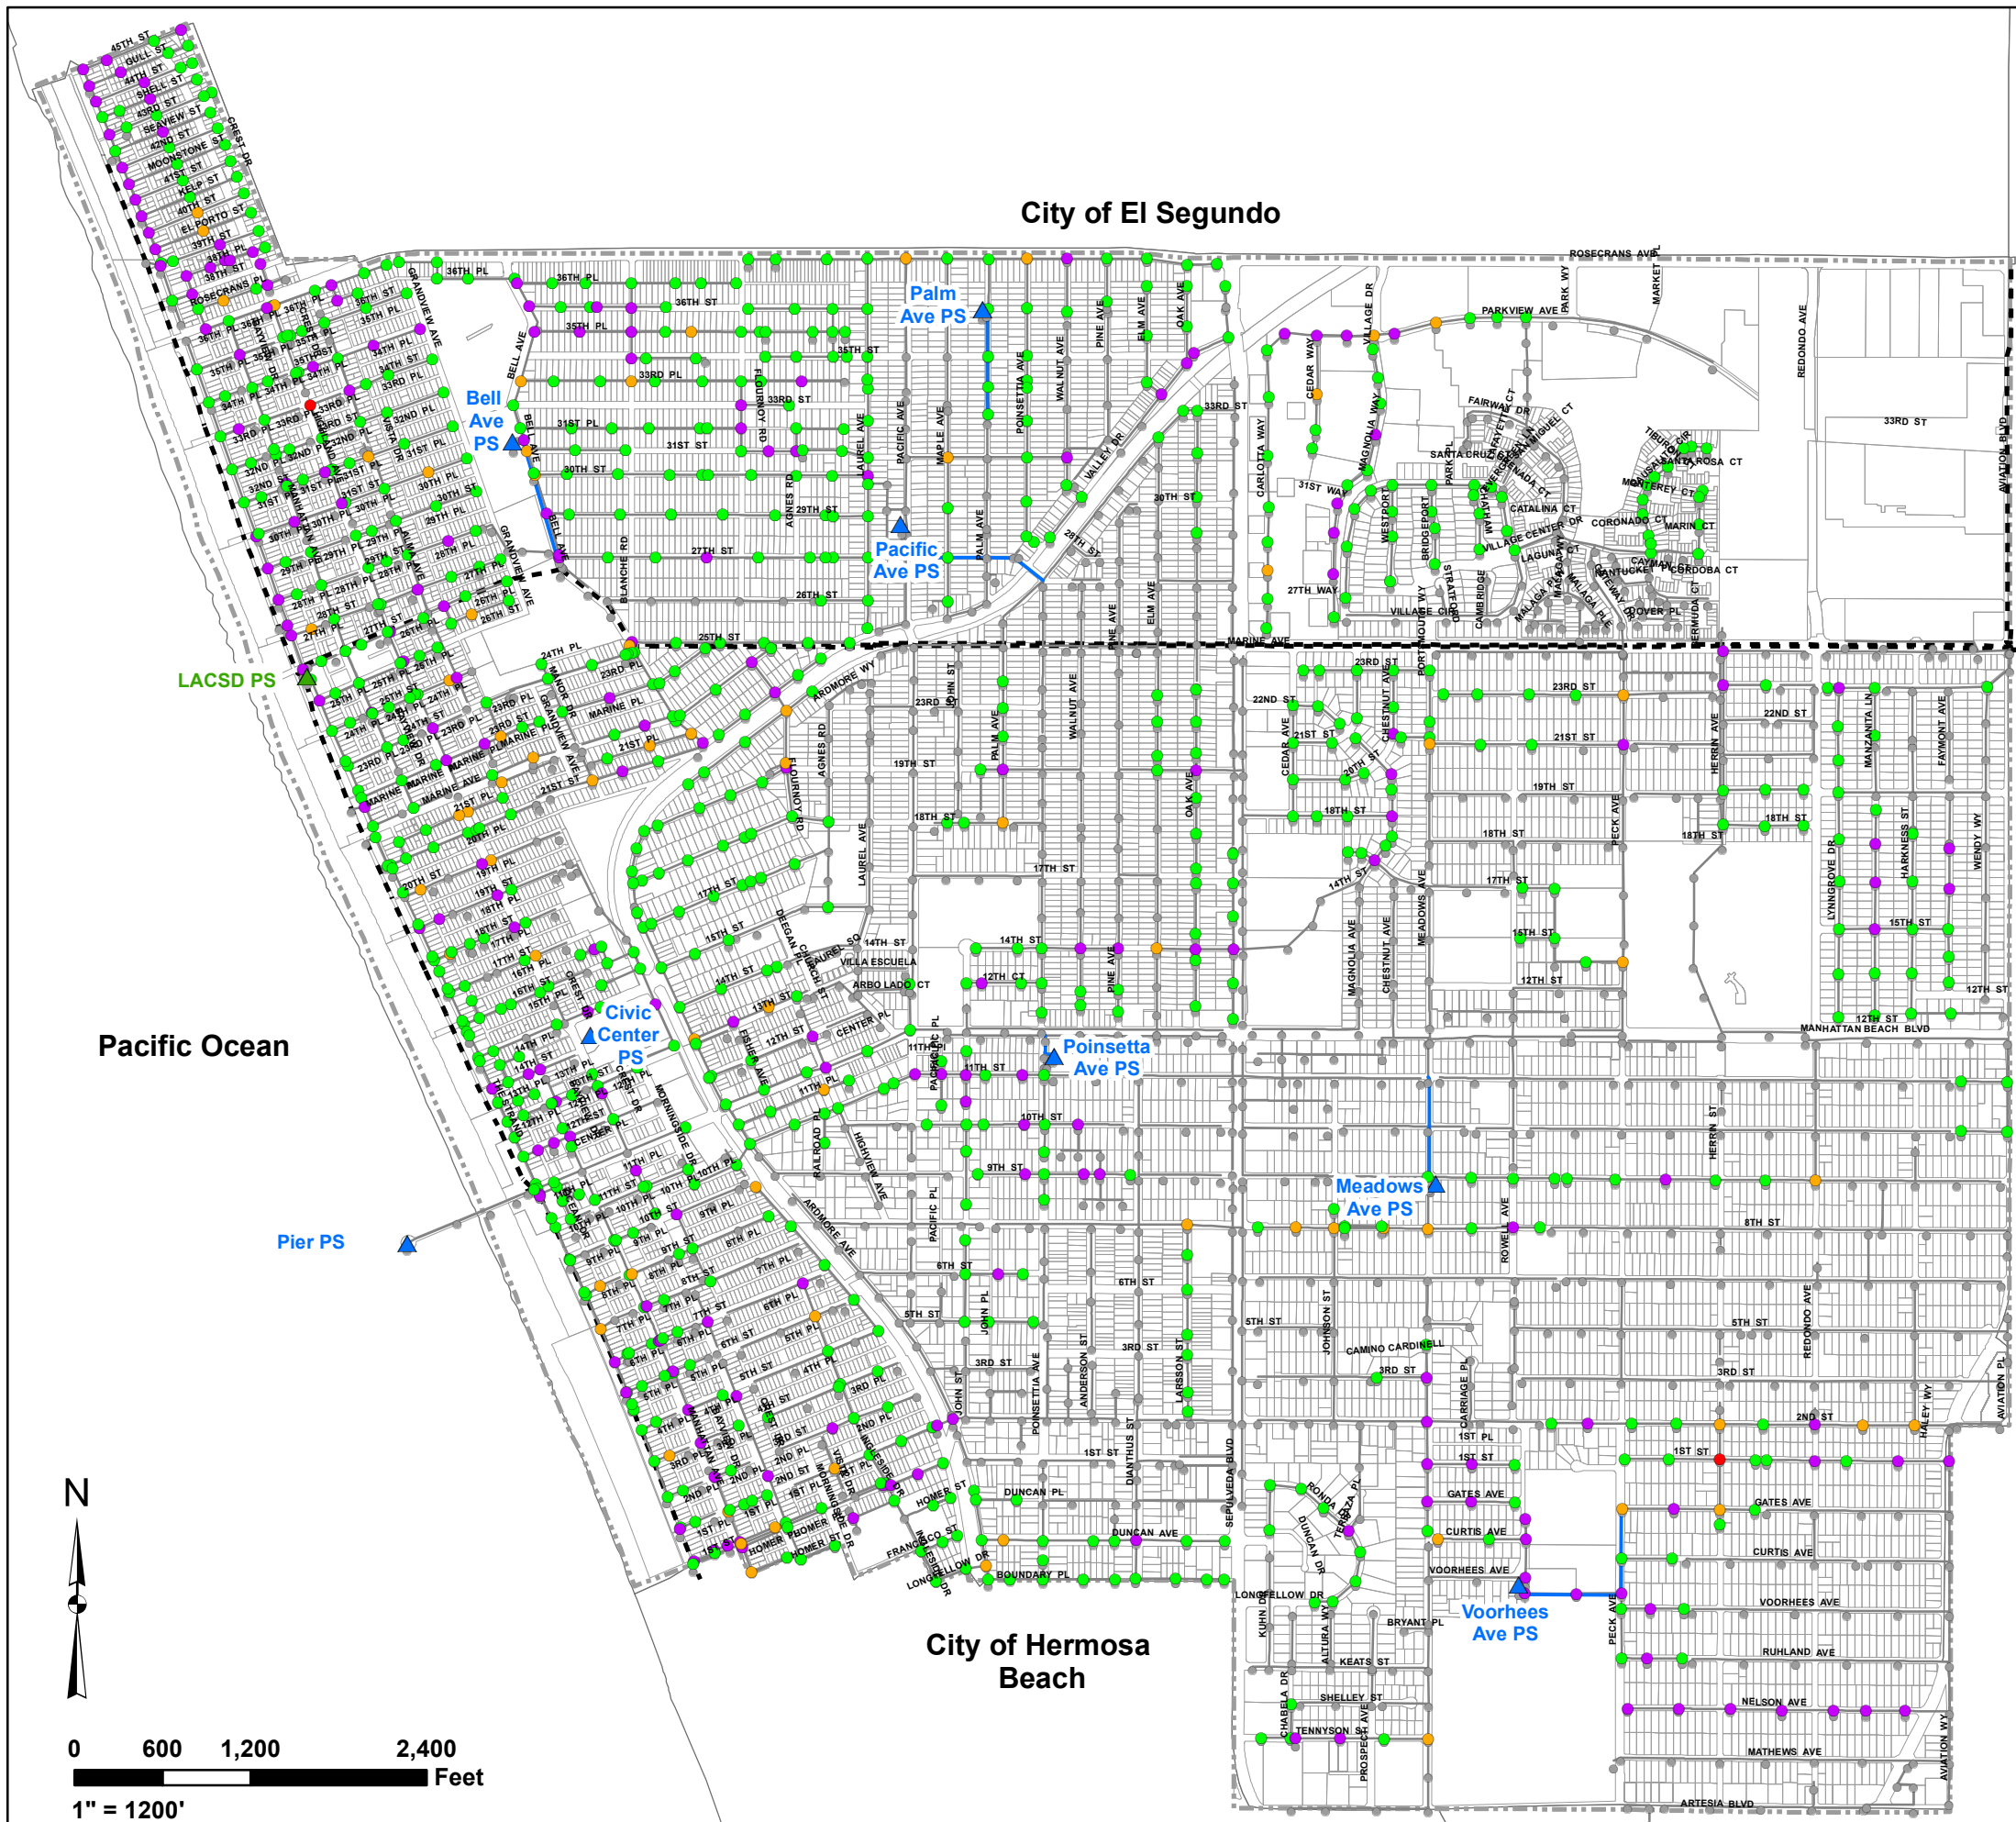
Figure 8-9

Rungs are not considered as urgent a problem since the City no longer uses them to access manholes. If City staff must enter a sewer manhole, tripods are utilized. The detailed manhole condition inspection summary, sorted by priority can be found in Appendix 6, Manhole Condition Inspection Summary. Manhole locations colored by total point value are shown on Figure 8-9.
