#### **SECTION 1**

#### **EXECUTIVE SUMMARY**

#### 1-1 INTRODUCTION

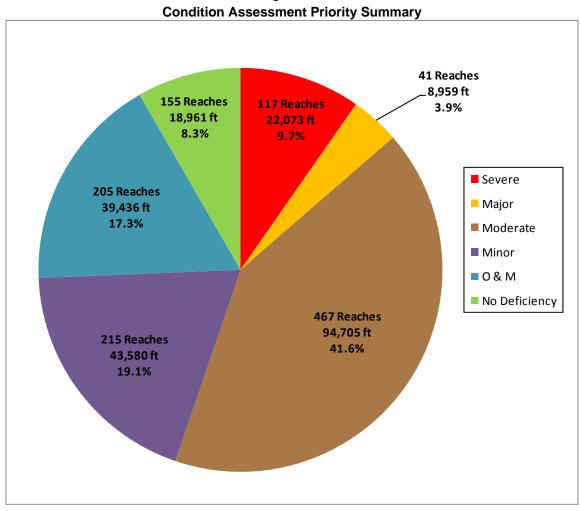
# Figure 1-2

Figure 1-2 shows the distribution of the condition priorities assigned the pipes with completed inspections.
