**CITY OF MANHATTAN BEACH**

**SUBJECT: Highland Avenue at 38<sup>th</sup> Street  
Pedestrian Crossing Treatment Evaluation**

# Manhattan Beach Mobility Plan Pedestrian Crossing Enhancements Policy

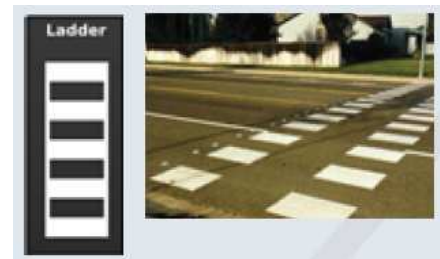
#### **High-Visibility Marked Crosswalk – Exhibit A**

A high-visibility marked crosswalk could be painted on the north and/or south leg of Highland Avenue and supplemented with pedestrian warning signs. However, this crossing location would be unexpected to many drivers due to its proximity to Rosecrans Avenue and turning movements. These multiple driving tasks increase reaction times, and drivers may not perceive a pedestrian in an uncontrolled crosswalk until too late. Further, pedestrians would be required to cross four lanes of traffic in one movement, which results in greater exposure to traffic and fewer gaps in traffic flow. Most importantly, it was shown that a high pedestrian collision rate occurred when painted crosswalks existed prior to 1995. Also, crosswalk markings at 38<sup>th</sup> Street would not be expected to significantly reduce the number of mid-block crossings. Based on the above evaluation, crosswalk markings alone or with standard crosswalk signs are not advised.

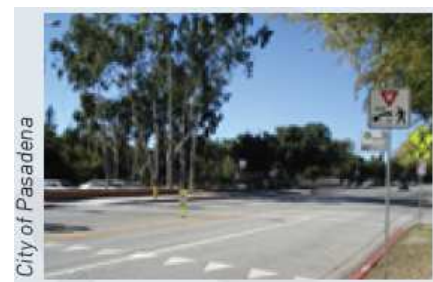
#### **Advance Yield Limit Line – Exhibit A**

This measure could be used to supplement a marked crosswalk, and would enhance driver awareness of the crossing. It also reduces the occurrence of second lane pedestrian collisions, in which a car stopped in one lane blocks the view of the crossing pedestrian from the second lane. This measure is recommended if marked crosswalks are painted.

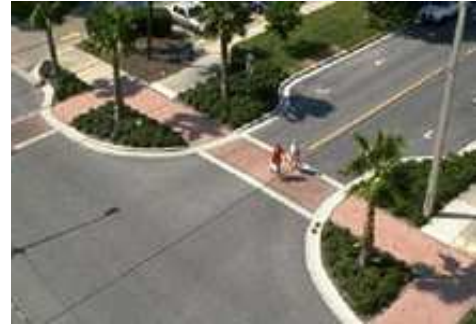
### **Curb Extensions – Exhibit B**

This measure could be used in conjunction with a marked crosswalk, and would enhance the driver awareness of the crossing and the pedestrian's view of approaching vehicles. It reduces the crossing distance which then reduces the pedestrian's exposure to cross-traffic. It also has a traffic calming effect. One disadvantage is that curb extensions at this location would eliminate one or more curb parking spaces. Also, they would not be expected to significantly reduce the number of mid-block crossings.

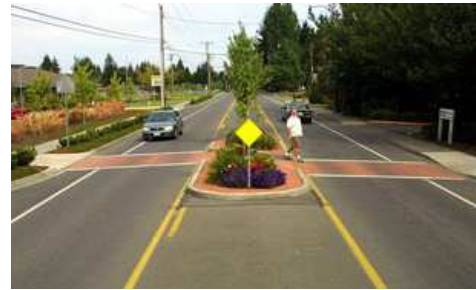
### **Pedestrian Refuge Island – Exhibit C**

This measure could be used in conjunction with a marked crosswalk, and would enhance the driver awareness of the crossing and the pedestrian's view of approaching vehicles. It reduces the crossing distance by giving the pedestrian a waiting area between opposing lanes in which to cross shorter distances in separate movements. It also has a traffic calming effect, reducing prevailing speeds through the crossing. A refuge island should be part of a landscaped center median between Rosecrans Avenue and 38<sup>th</sup> Street to eliminate midblock crossings and redirect pedestrians to the crossings at either end. It would not require removal of any parking.

One disadvantage is that pedestrian refuge island would require the elimination of the part-time second northbound lane in the morning peak, which then merges north of 38<sup>th</sup> Street at other times when curb parking is allowed. However, a single northbound lane has sufficient capacity to handle peak traffic in this segment and would reduce the potential for merging sideswipe type collisions. It would also eliminate left turns in and out of the lower parking structure driveway. Access would be right turn in/out only.

This measure would provide the opportunity for street beautification in the business district as well. The median would also provide a location for a pedestrian activated beacon mounted in the center of the street, further improving driver awareness of pedestrian crossings.

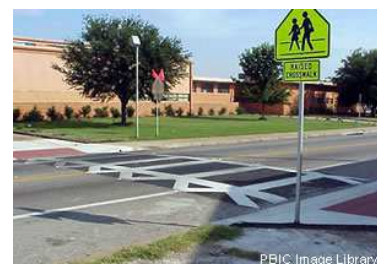
### **Raised Crosswalk – Exhibit D**

A raised crosswalk could be constructed on the north and/or south leg of Highland Avenue with pedestrian warning signs. While this measure would offer greater driver awareness of pedestrians than a marked crosswalk only, it would have similar disadvantages to a marked crosswalk identified above. In addition, a raised crosswalk may alter surface drainage and accessibility. Based on the above evaluation, a raised crosswalk is not recommended.

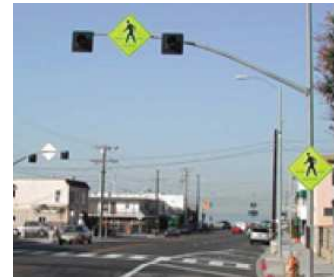
### **Overhead Flashing Beacon – Exhibit E**

This measure could be used in addition to a marked crosswalk, and would enhance the driver awareness of the crossing. Overhead flashing beacons would be preferred over side mounted beacons due to the proximity to a traffic signal with overhead indications. However, overhead flashing beacons would not be expected to significantly reduce the number of mid-block crossings.

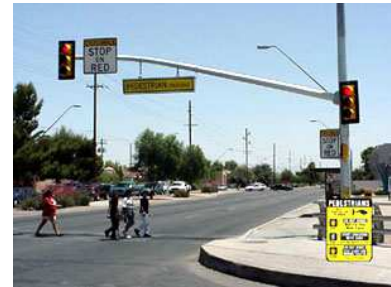
### **Pedestrian Actuated Traffic Signal – Exhibit G**

A pedestrian actuated traffic signal could be constructed to provide a fully controlled crossing. Since this crossing is located at an intersection, a traffic signal would include both vehicle and pedestrian traffic. Pursuant to the Draft guidelines, this measure is recommended at locations with a speed limit of 30 miles per hour, four or more lanes, and greater than 15,000 vehicles per day. It should be noted that a traffic signal at 38<sup>th</sup> Street would need to be fully coordinated with the traffic signal at Rosecrans Avenue because of its proximity. A traffic signal would attract more pedestrians that would otherwise cross midblock, and any midblock crossings would be illegal pursuant to the California Vehicle Code. It is also the only Toolbox measure that provides a fully protected crossing for pedestrians.

Several disadvantages would be anticipated if a traffic signal is constructed, including the following:

- Potential traffic diversion onto 38<sup>th</sup> Street due to improved access to/from Highland Avenue
- Increased traffic volume on Crest Drive and Ocean Drive due to cut-through traffic
- Vehicle queuing and intersection blockage through both intersections at Rosecrans Avenue and 38<sup>th</sup> Streets caused by red lights.
- Left turn traffic blocking through traffic due to absence of a left turn pocket.
- Potential increase in rear-end collisions by drivers navigating closely spaced traffic signals
- Conflicts between ingress/egress traffic at parking structure driveway and intersection movements.
- Reduced sidewalk width and accessibility due to traffic signal poles.

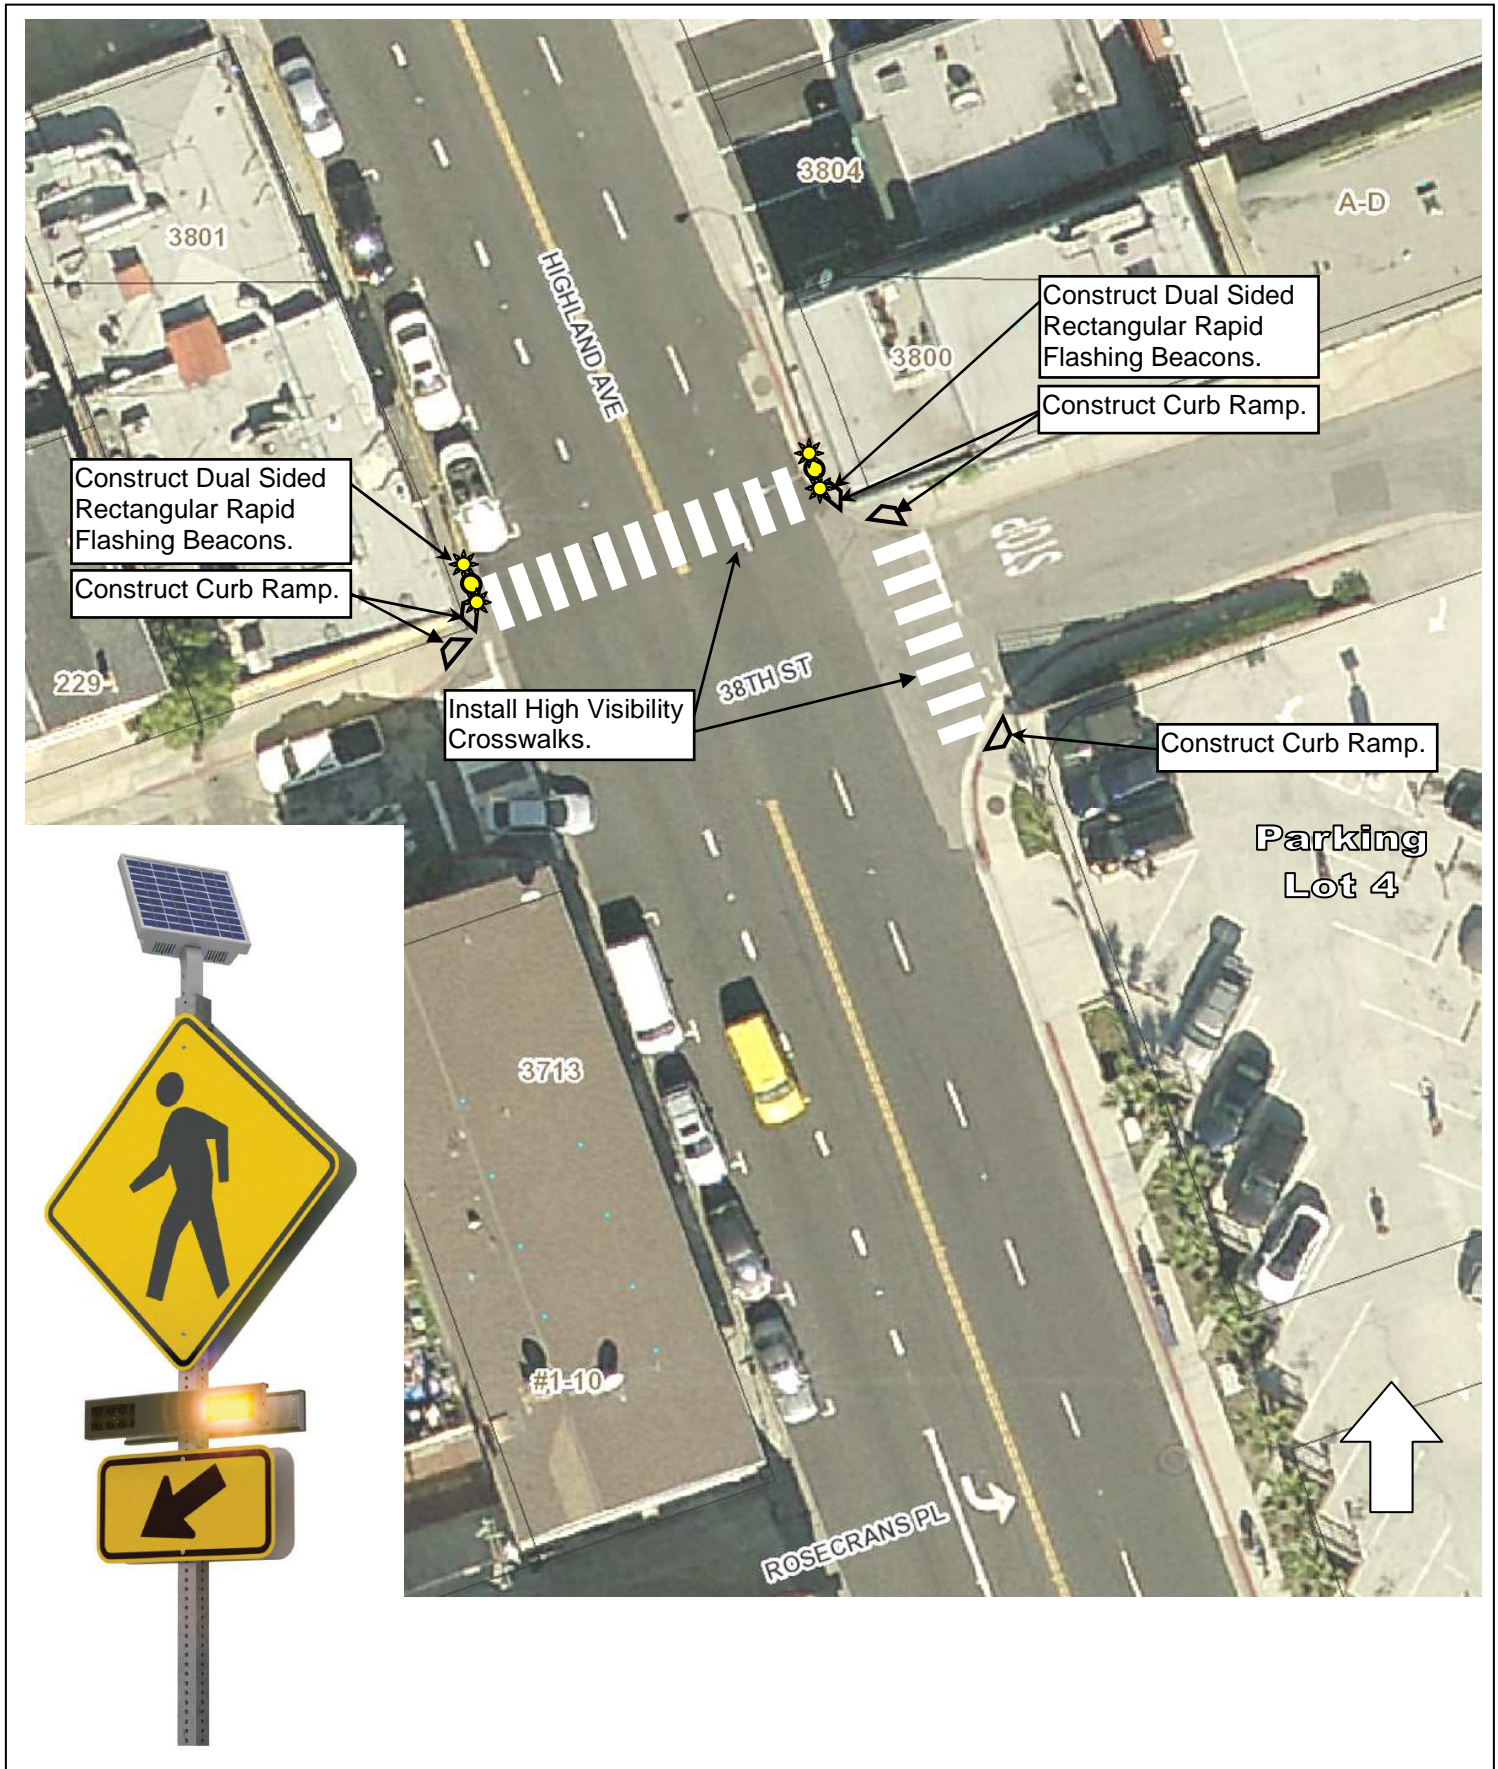
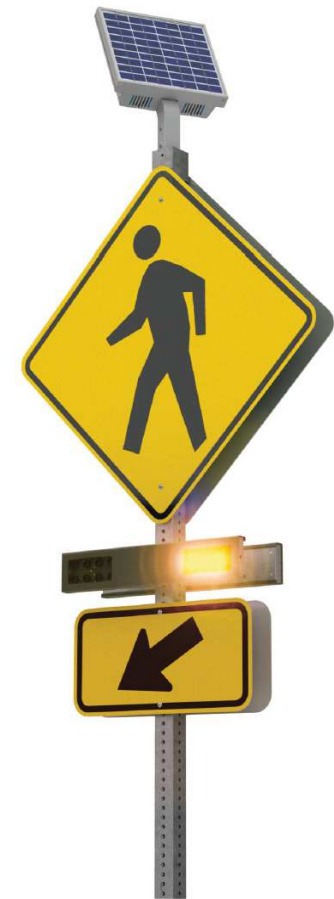
**Exhibit F**  
**Highland Avenue at 38<sup>th</sup> Street**  
 Rectangular Rapid Flashing Beacons Concept

This measure could be used in conjunction with a marked crosswalk, and would enhance the driver awareness of the crossing. The rapid flash pattern has been shown to achieve greater driver compliance over standard round beacons. The beacons are highly directional, so they are not as visible from the roadside or adjacent properties. However, they would not be expected to significantly reduce the number of mid-block crossings.

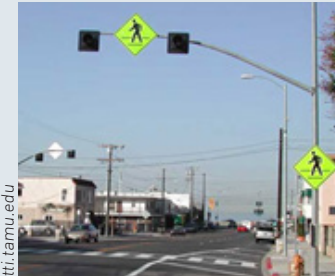
TREATMENT	IMPLEMENTATION GUIDANCE		
	SPEED LIMIT		
	30MPH OR LOWER	35 MPH	40 MPH+
<p><b>OVERHEAD FLASHING BEACON</b></p> <p><b>[Signal Treatment]</b> Flashing amber lights are installed on overhead signal arms in advance of the crosswalk or at the entrance to the crosswalk. Typically overhead beacons are pedestrian push button actuated and are most appropriate on multi-lane, signalized streets.</p>

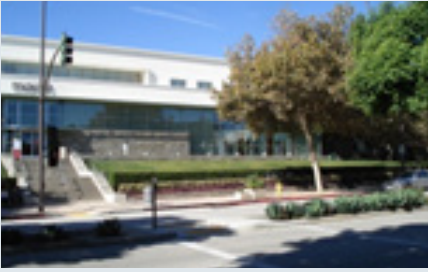
**REFUGE ISLAND**

Raised islands are placed in the center of the roadway, separating opposing lanes of traffic with cutouts or ramps for accessibility along the pedestrian path.

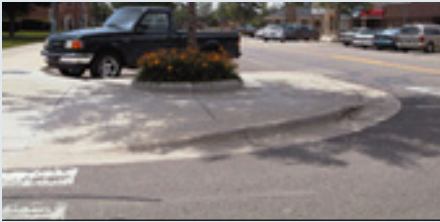
**CURB EXTENSION/BUS BULBS/SHORT RIGHT-TURN LANE ELIMINATION**

Also known as a pedestrian bulb-out, this traffic-calming measure is meant to slow traffic and increase driver awareness of pedestrians. It consists of an extension of the curb into the street, making the pedestrian space (sidewalk) wider.

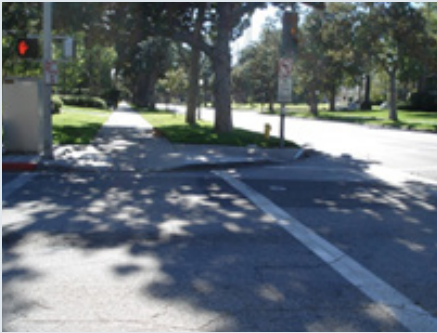
High-visibility markings include a family of crosswalk striping styles such as the "ladder" and the "triple-four." Stop bars should be striped in advance of the crosswalk on approaches controlled by a stop sign.

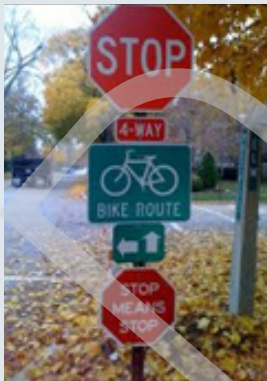
**REMOVAL OF SIGHT DISTANCE OBSTRUCTIONS**

If objects impede sight distance, it may result in an unsafe condition when motorists and pedestrians are unable to see each other. Items such as parked cars, signage, landscaping, fencing, and street furniture should be placed in a location that will not obstruct sight distance.

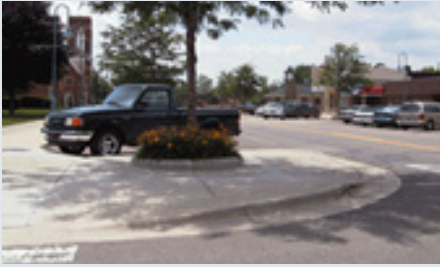
### **CURB EXTENSION/BUS BULBS/SHORT RIGHT-TURN LANE ELIMINATION**

Also known as a pedestrian bulb-out, this traffic-calming measure is meant to slow traffic and increase driver awareness of pedestrians. It consists of an extension of the curb into the street, making the pedestrian space (sidewalk) wider.

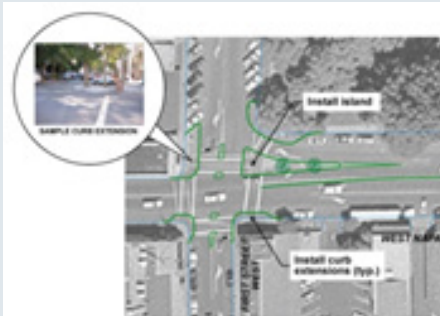
### **IMPROVED RIGHT-TURN SLIP-LANE DESIGN/PORK CHOP REDESIGN**

Right-turn slip lanes (aka channelized right-turn lanes) are separated from the rest of the travel lanes by a pork chop-shaped striped or raised median area. This measure separates right-turning traffic and streamlines right turning movements. Improved right-turn slip lanes provide pedestrian crossing islands within the intersection and are designed to optimize the right-turning motorist's view of the pedestrian and of vehicles to his or her left.

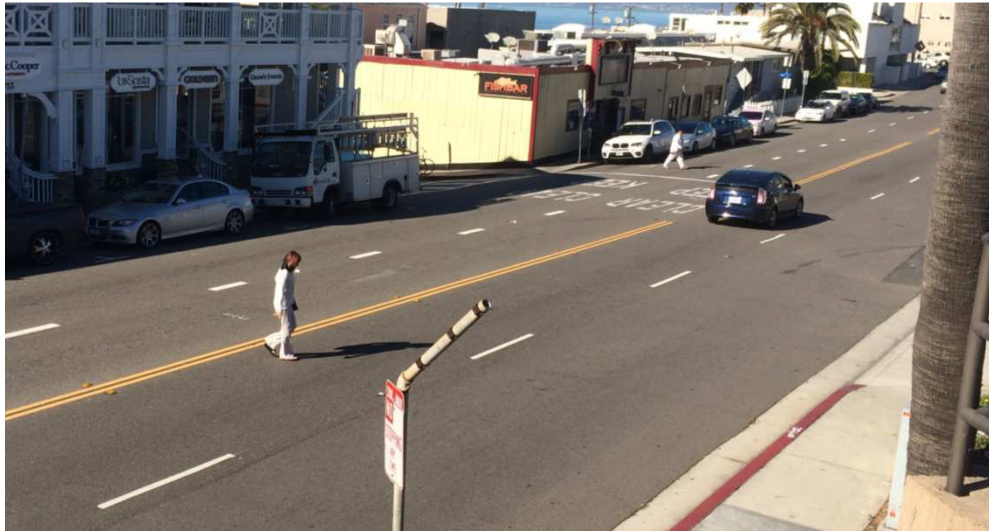
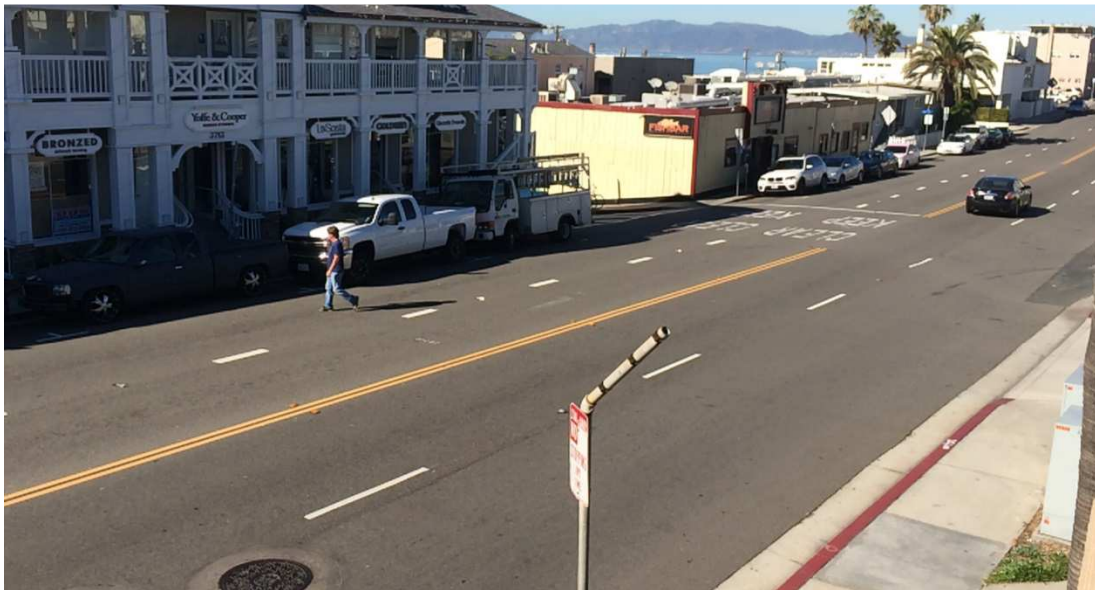
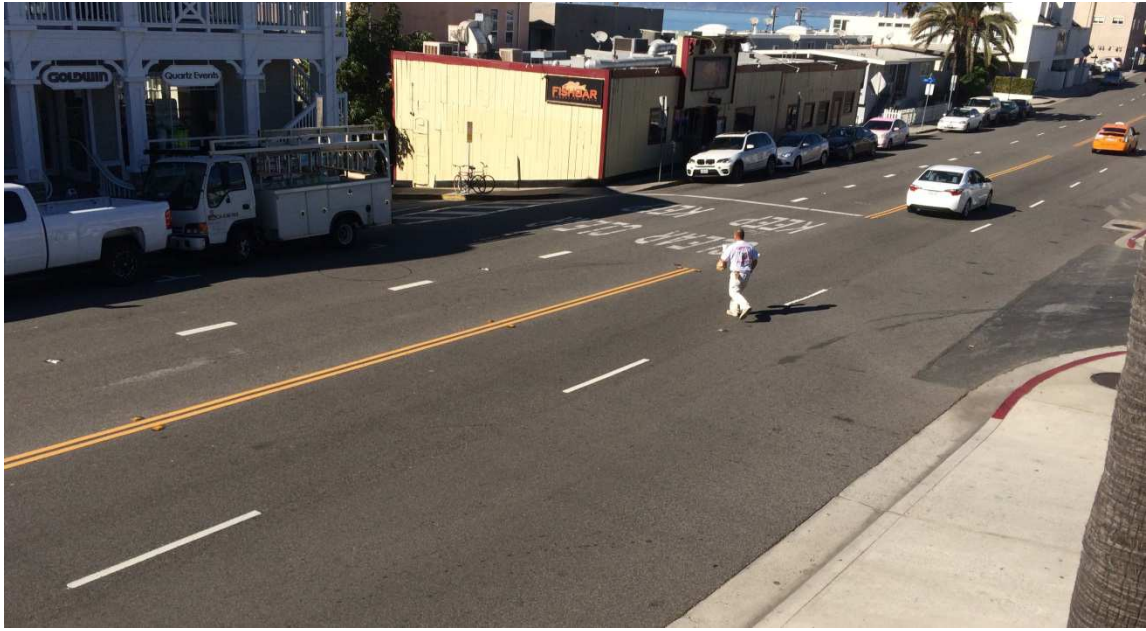
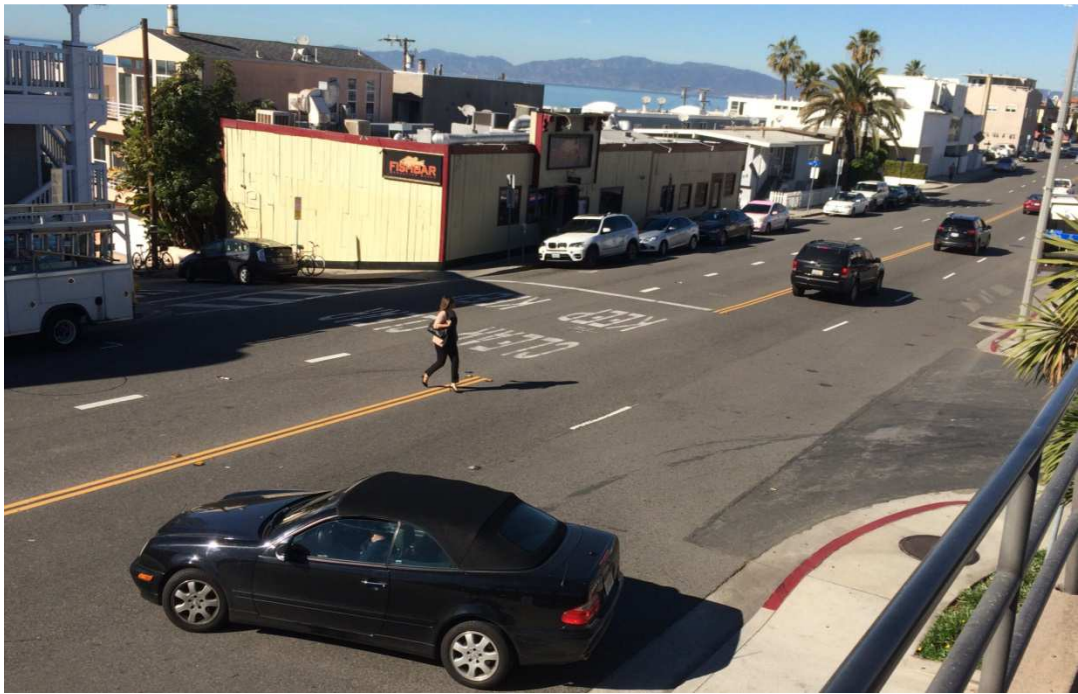
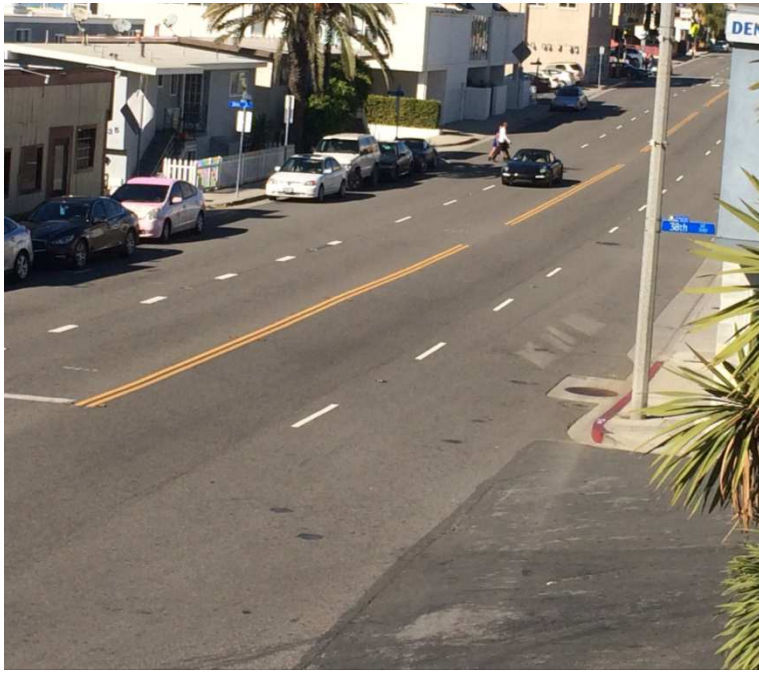
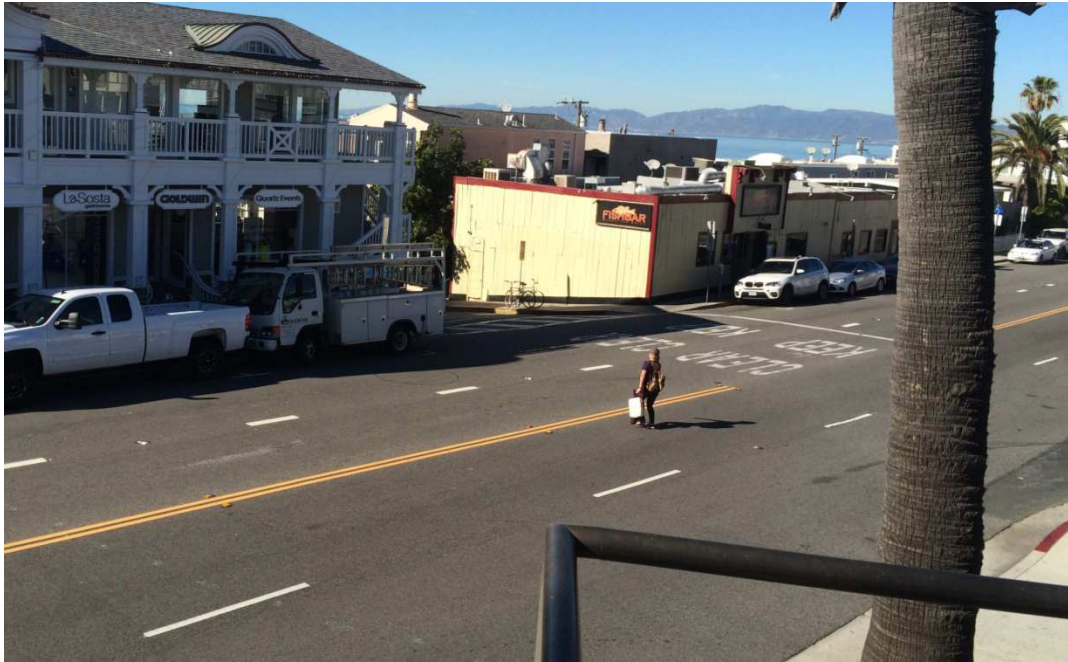
EXHIBIT J  
PEDESTRIAN CROSSING PHOTOGRAPHS

During field observations, pedestrians were seen crossing both at 38<sup>th</sup> Street and mid-block in approximately equal numbers. (Exhibit J) Midblock crossings were primarily oriented between the public parking lot on the east side and the businesses on the west side of Highland Avenue. All pedestrians crossed after checking for a gap in traffic in both directions, but many ran or stopped in the middle of the street to avoid cars. Midblock crossings were not as prevalent north of 38<sup>th</sup> Street, probably due to fewer retail businesses. Pedestrian crossing volumes are higher at mid-day and in the early evening hours. As noted above, these crossings at and between intersections that are not controlled by traffic signals are legal. One concern is that pedestrians would continue to cross mid-block even with a marked crossing, unless physically prevented from doing so.
