Comprehensive Energy Audit
for
City of Manhattan Beach

15 October 2009

The following paper reports on the findings from PE Consulting's Comprehensive Energy Audit. The report details existing conditions and suggests cost effective measures that will reduce energy use and costs as well as help the City of Manhattan Beach meet their emissions reduction target.

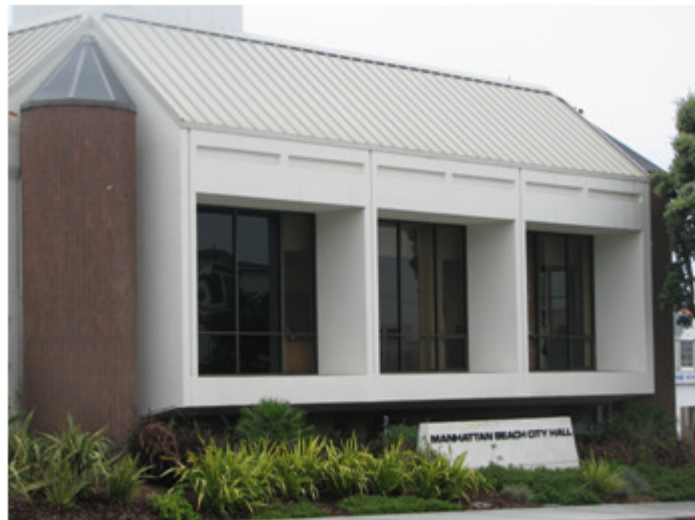
The City Hall building is of masonry construction. The upper floor walls are constructed of reinforced clay block and do not have any insulation. The lower floor, where exposed, is of 8-inch reinforced concrete with brick veneer. The roof deck is constructed of 1-1/2" steel decking with concrete topping, 1-1/2" rigid insulation, and single-ply membrane roofing. Windows throughout are single pane with bronze tinting.

View of Exterior Walls and Windows

1. **Replace West-Facing Glass:** Replace west-facing single-pane glass with energy efficient, low-e, solar control, double pane windows. This retrofit measure will have a significant effect on the overall cooling load of the building and will even allow a later start time for the air handling system serving the first floor. This will result in reduced fan energy and heating and cooling requirements.

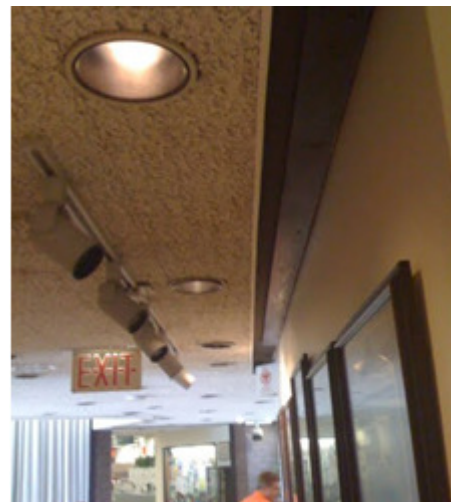
Lighting in City Hall is primarily, 2-lamp (L) T8 32 W recessed, ventilating fixtures with electronic ballasts. Many desks throughout the facility have 2X1 17W single lamp T5 fixtures with electronic ballasts built-in as task lights. Lighting is controlled by switches in the majority of the spaces.

At the west City Hall reception desk entryway, there are 28 recessed “can” lamp fixtures with 9W CFLs. These lamps are too high in the cans, so the majority of the lighting is not being cast into the space, thus wasting light energy. These lights are controlled by switches and are turned on during office hours and off late in the evening when the cleaning crew is finished.

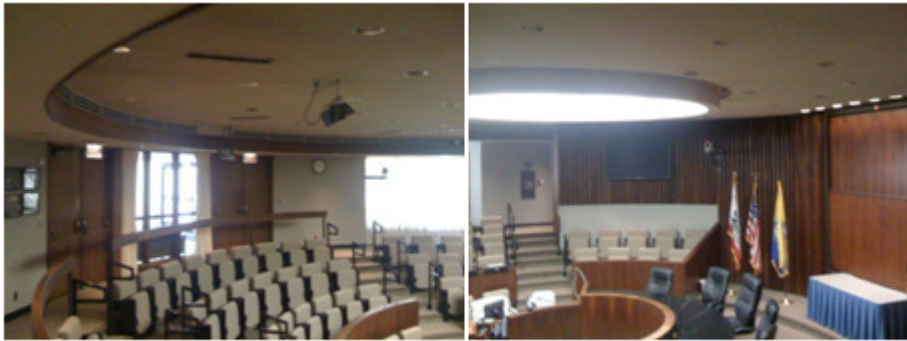
The Council Chamber lighting is outdated and needs replaced. In the chambers, there are an estimated 28 1L 40W T12 fixtures with magnetic ballasts. In addition there are several 1L 65 incandescent lamps. When all the fixtures are turned on in this room, the room is still quite dark and the light quality is poor. These fixtures need replacement immediately. Recommended changes are provided in the energy efficiency measure section below.

Council Chamber Lighting

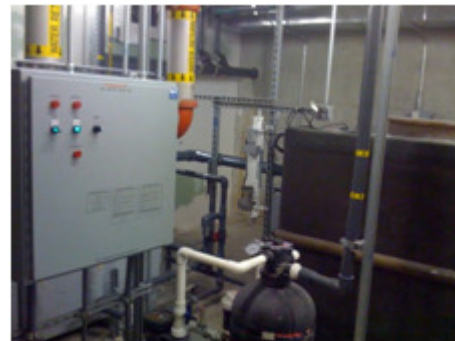
A third unit, located in a basement mechanical room, serves the south portion of the basement level, which houses the engineering department and a portion of the finance department. This unit has a hot water coil for heating and a separate air-cooled condensing unit located in an adjacent areaway. Within the last few years, a portion of the basement has housed the City computer room, which requires air conditioning on a 24/7 basis, thus necessitating that this unit run continuously.

City Hall Mechanical Room

5. Redesign Basement HVAC System: A few years ago, the City’s data center system was installed in a space located in the southeast corner of the building. It was connected to the 15-ton split system air conditioning system serving the basement; however the computer space requires cooling 24 hours per day, 7 days per week. Thus, this unit has to run continuously, even though 90% of the space it serves is only occupied 8 am to 5 pm, 5 days per week.

This measure recommends installing a new split, dedicated air conditioning system for the computer room and freeing the existing basement supply unit for use just to serve the regular office spaces in the basement. It is recommended that a duct connection remain, however, to serve as a backup should the dedicated unit go down for maintenance. The existing basement system should be re-designed to include standard

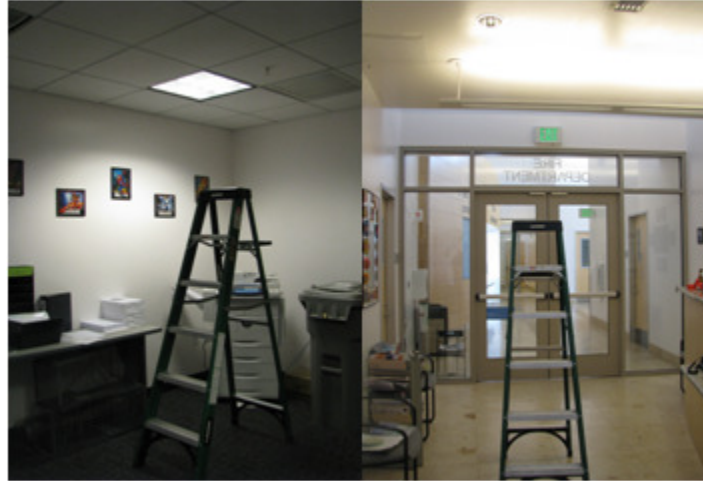
occupancy sensors are not calibrated correctly and need to be tuned. This should be done to all occupancy sensors in the building, as recommended below.

Police and Fire Lighting

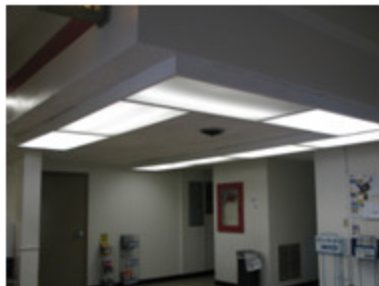
Lobby Lighting

Main Lobby. The fixtures in the Post Office section are primarily 2L 32 W with electronic ballasts. Just off of the lobby are two small restrooms, each with a single 13W CFL fixture outside the door, a single 4L 32W T8 fixture, and a single 2L 17W T8 fixture.

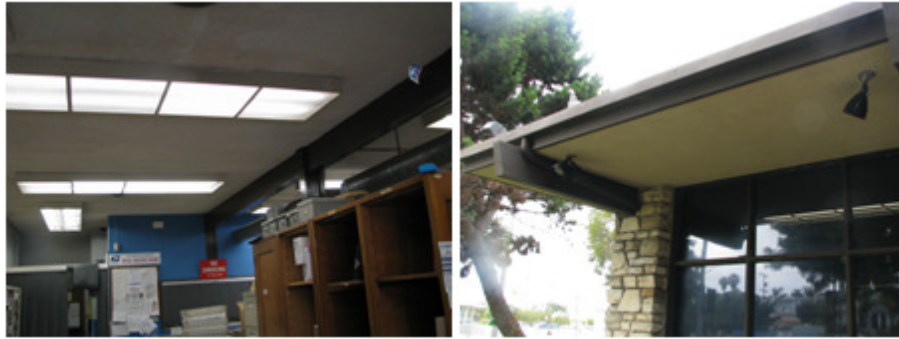
Post Office. Lighting in this area is primarily 1X8 T8 2L 59W fixtures. Approximately half of the fixtures in the back half of the post office are left on 24 hours a day.

Post Office

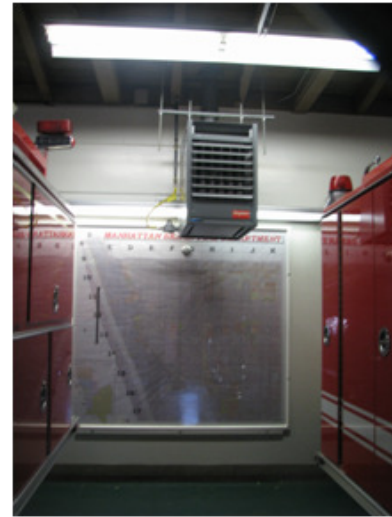
The fire truck bay has a gas-fired Dayton unit heater, which is used to heat the garage. The use of a unit heater is inefficient for this space since the fire truck garage doors are frequently open when the heater is on. When this happens, the warm air produced by the heater escapes out the garage door.

Fire Truck Bay/ Exhaust Fan

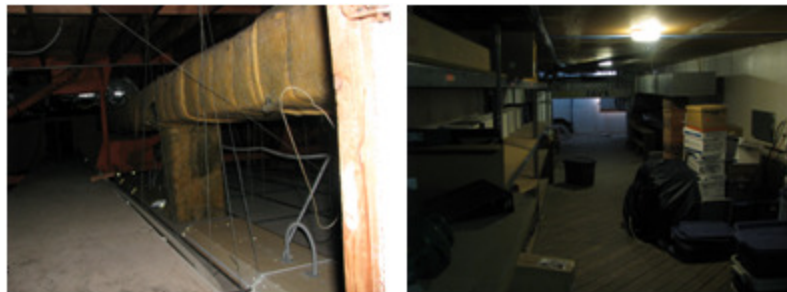
This building has 2x4 stud walls with R-11 insulation and plywood deck roof over open web joists with R-19 insulation. It also has single-glazed windows with inside curtains.

Attic Space in Joslyn C.C.

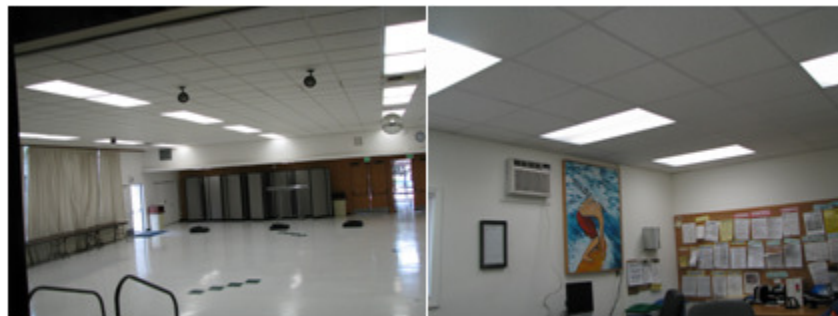
Lighting in the Joslyn Community Center is a mixture of 2 and 4-lamp 32W T8 fixtures with electronic ballasts and low wattage CFLs. Even though natural daylight is brought into the lobby and the oasis room of the facility, lighting levels remain high because it is used as a senior center and the lights are on for their safety. Lighting is controlled by switches throughout this facility.

Joslyn Typical Lighting

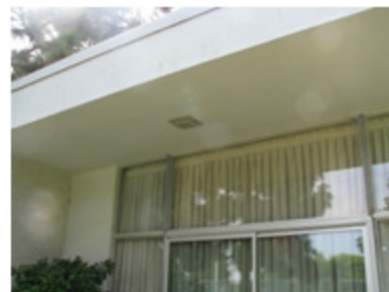
Joslyn Exterior Lighting

On the outside of the building there are over 25 1L 23W CFL fixtures that are controlled by photocells.

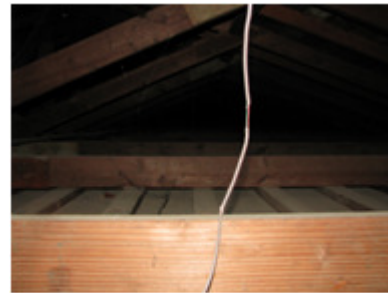
Attic Space in the Scout House

The Scout House date of construction was not provided. It appears to be 1950s or 60s vintage. It is a wood frame building with no insulation in the walls or attic. The windows are single pane with no shades, but the porch overhang and nearby trees shade the building from direct sunlight the majority of the time. The roof is wood frame with composition tile shingles.

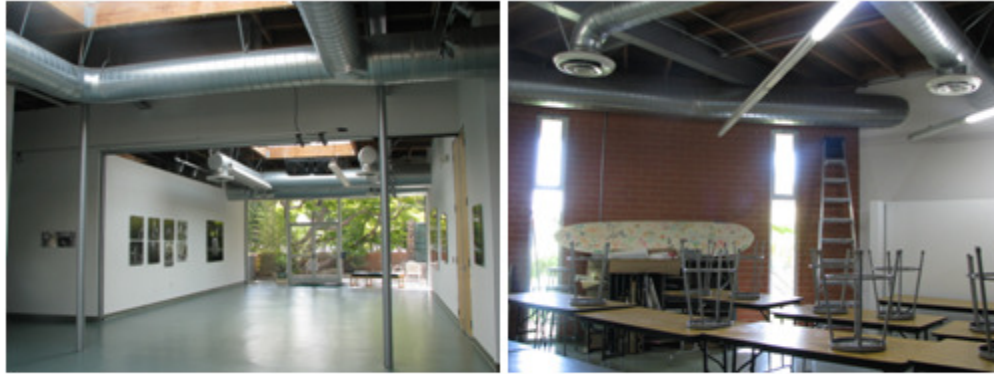
Main Hall with Natural Daylighting

The gallery space down the center of the building has ample natural lighting through skylights and large glass windows and doors at both ends. There are also 2' wide, floor-to-ceiling windows in the two art classrooms. Classroom lighting is supplemented by clerestory windows which permit the light from the central gallery into the classrooms.

During the site visit, there were three employees in the building, and all of the lighting inside the facility was off with the exception of the kitchen where there was an occupant and there is not any natural daylight. Occupants informed us that the lights remain off for the majority of the day when the building is not open to the public. When the building is open to the public, the main gallery lights are typically on showcasing the artwork on the walls. The classroom lights are on typically only during classes, which is intermittently throughout the week.

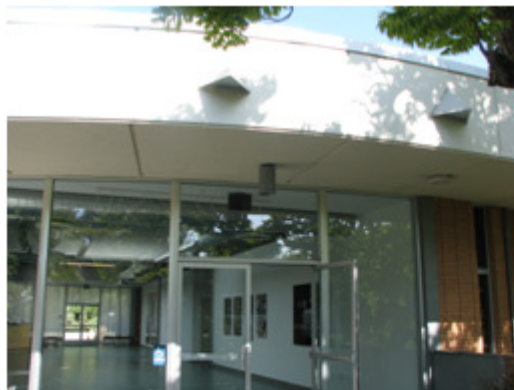
Outside the building there are round pole fixtures each with 2L 13W CFLs that are controlled by photocell sensors. In addition, there are a few 14W uplights and five 42W CFL security lamps.

Exterior Lighting

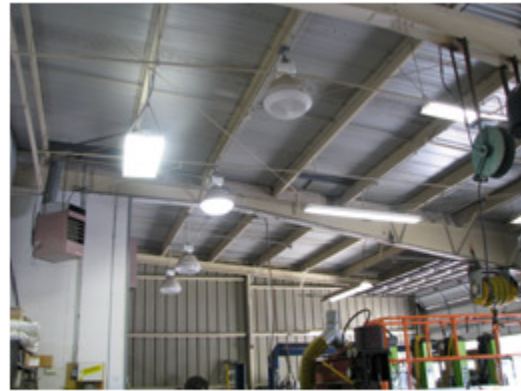
Interior lighting at the Public Works Yard is a mixture of 1, 2, 3, and 4-lamp, 4 foot, 32W T8 fixtures with electronic ballasts and some 2 and 4-lamp, 8 foot, 59W lamps with electronic ballasts. The Public Works Department is experimenting with a few other types of fixtures and currently also has approximately 20 - 250W Metal Halide fixtures suspended from the ceilings in the welding shop, mechanical shop, and tire shop. The mechanical shop also has 1 - 6 lamp T5 fixture installed for testing for light quality. Only one occupancy sensor was found during the site visit; all other fixtures are controlled by manual switches. CFL fixtures are found in the restrooms and storage closets.

Sample Fixtures
250W Mercury Vapor and T5 Fixtures

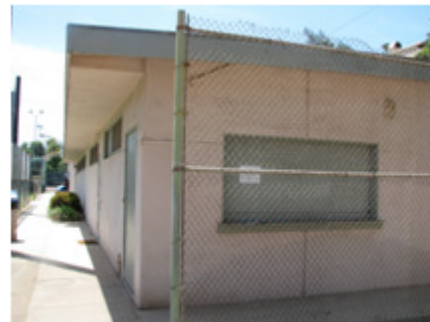
Recreation Hall

Recreation Hall. This is a lathe and plaster building with stucco exterior, operable, single pane windows, and Tremco roll roofing.

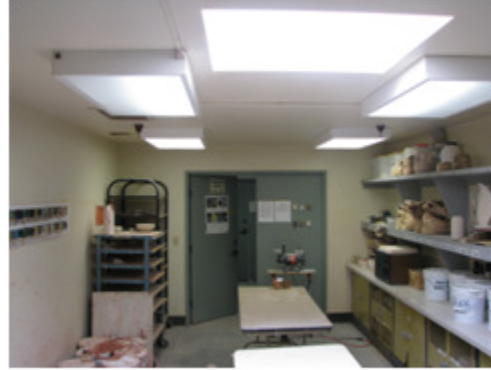
Multipurpose Building. The ceramics room has a combination of skylights, 2L 32W 4' T8 fixtures with electronic ballasts, and unused 13W CFL fixtures above the back counter. Occupants expressed the desire for additional skylights because natural light improves an artist's ability to experiment with colors.

Ceramics Room with Skylight

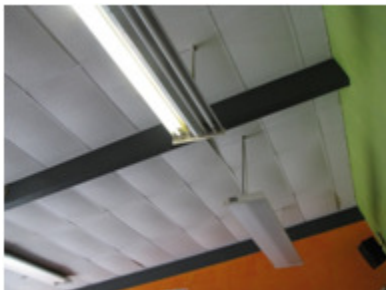
Community Center. The lighting in the Community Center is outdated. The majority of the fixtures are 8' 4L 59W T8 fixtures controlled by switches. Several of the lighting lenses are broken and yellowed. There are some 4' 2L and 4L 32W T8 fixtures with electronic ballasts in the restroom, main office, and the front foyer. The exterior lights are a mixture of 13W CFL recessed fixtures and flood lights.

Recreation Center Lighting

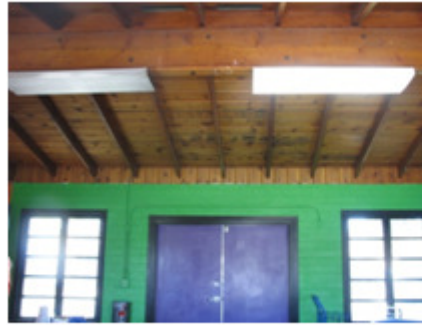
Restroom Bldg/Playground Room

Restroom/Playground Room. This building has both men’s and women’s restrooms and a playground shed/office where playground equipment is kept. There are two 14W CFL fixtures in each restroom. In the playground shed/office there is a 14W CFL fixture, two 23W CFLs, along with 1 inefficient 4L 6’ T12 fixture. Outside this facility there are ten 13W CFL fixtures.

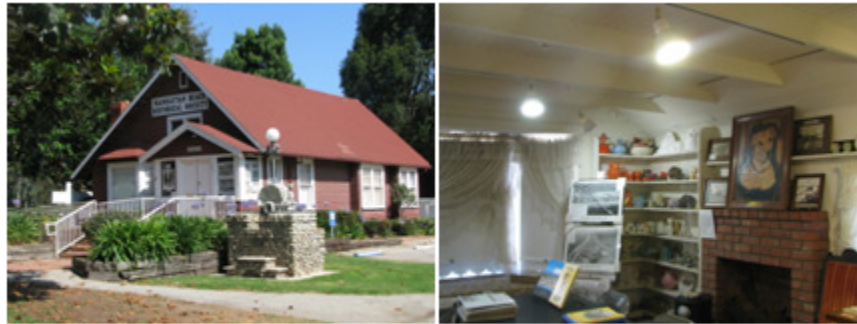
Historic House. The Historical Society makes its home in the City's oldest beach cottage which was relocated to Polliwog Park in 1970 and refurbished. The 984 square foot house is of wood frame construction with no insulation. The windows are old, single warped-pane glass. The roof is wood frame with shingles.

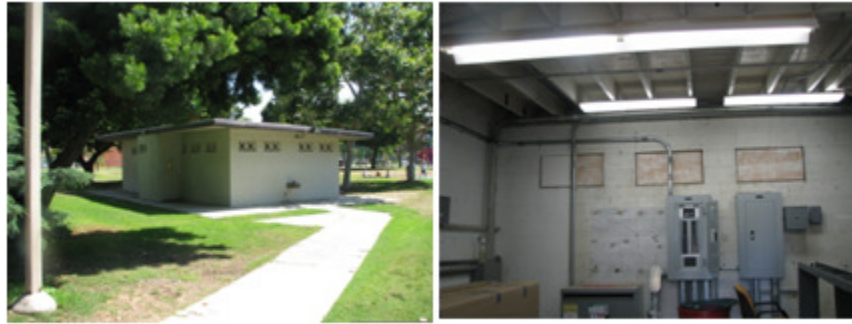
Old Restroom turned into Offices and Storage

Old Restroom/New Office & Storage Building. The original 767 square foot restroom built in 1980 is of concrete block construction and has metal chain (no glass) openings for ventilation. The roof is flat with tar and gravel. The restroom facilities have been removed from the building

and now the building is used as the Park Patrol office and summer camp / Historical Society storage facility.

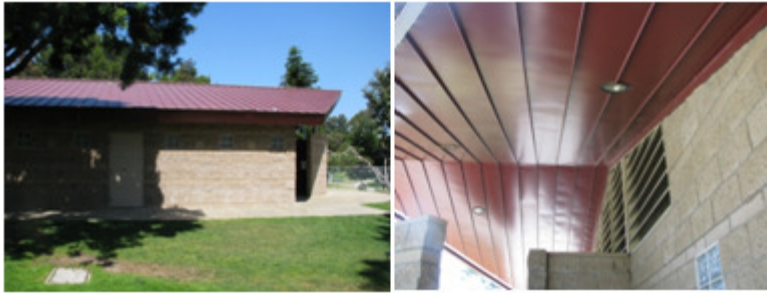
New Restroom Facility

New Restroom. The new (2003), 1400 square foot restroom is of concrete block construction, has metal chain openings for ventilation, and a metal roof.

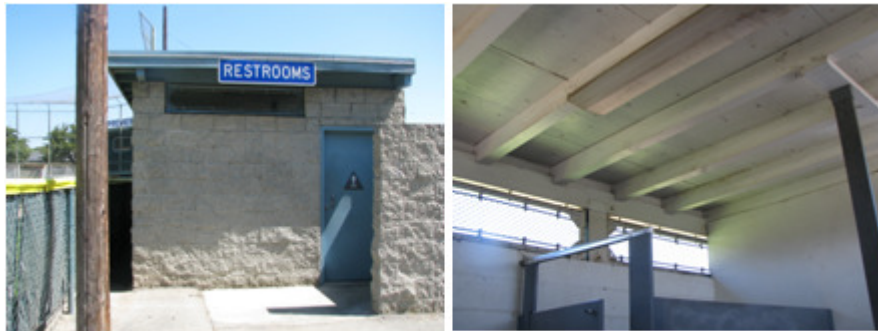
Premier Park Restroom

The 348 square foot restroom, constructed in 1986, at Premier Park is of concrete block construction with a wood roof with tar and gravel. The windows have metal chain link with no glass.

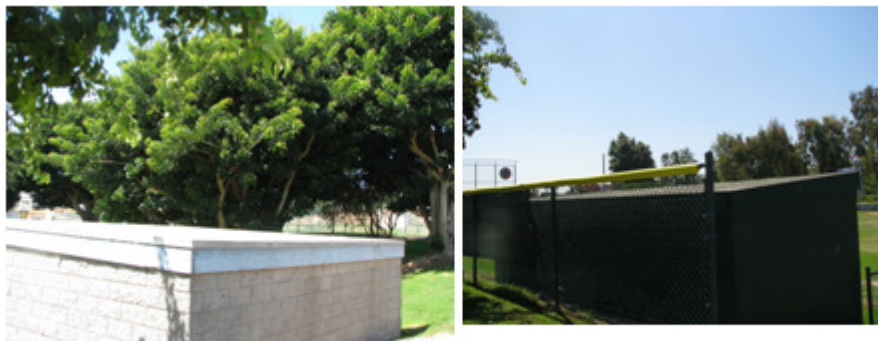
Park Storage Sheds

One storage shed is of concrete block construction with no windows. The walls and roof of the second storage shed are of wood construction. It also does not have any windows

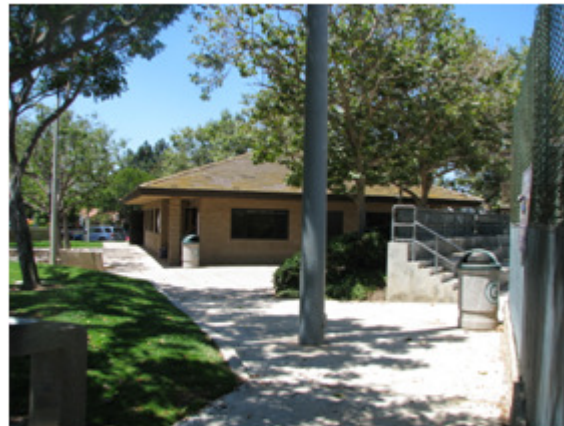
Recreation Hall

Recreation Hall. This 2,604 square foot building was constructed in 1986. The walls are 8" concrete block and the windows are tinted and single pane. The roof is sloped, has R-19 insulation, and is covered with composite tiles. Since this building is oriented closely to the baseball park, several baseballs have hit the roof, resulting in holes in the roof. When it rains, the leaks penetrate down into the office below, damaging the insulation and suspended ceiling, as shown below.

5. It is further recommended that the City suspend a metal screening, similar to a chain-link fence over the roof of the recreation hall to prevent further damage from baseballs. This would eliminate the problem of roof leaks from damage.

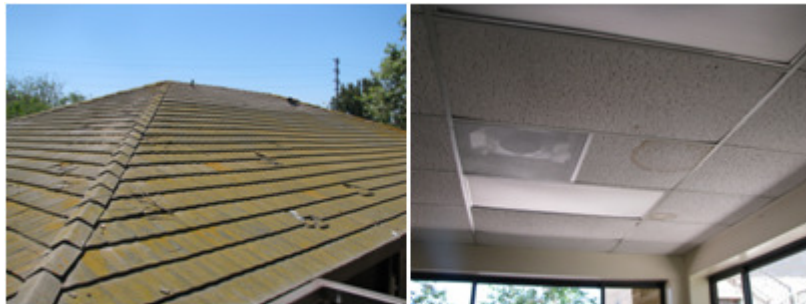
Roof Leaks due to Baseballs

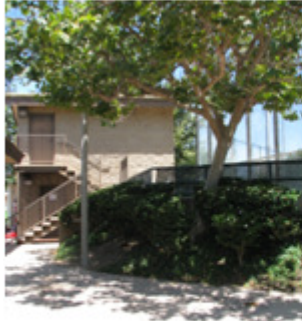
Scorer's Booth

Scorer’s Booth/Snack Shack. This two-story 480 square foot building was also constructed in 1986. The bottom floor is the snack shack and the second floor is the scorer’s booth. The walls are 8” block with operable single pane windows and a metal roof.

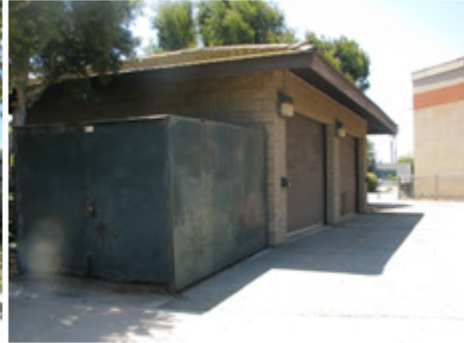
Storage Shed

Storage Shed. The 600 square foot storage shed, constructed in 1986, is used for sports equipment. The walls are 8” block. It does not have any windows; however, it has two rollup garage doors as well as a side door that provide access to the equipment. The roof is sloped and is covered with composite tiles.

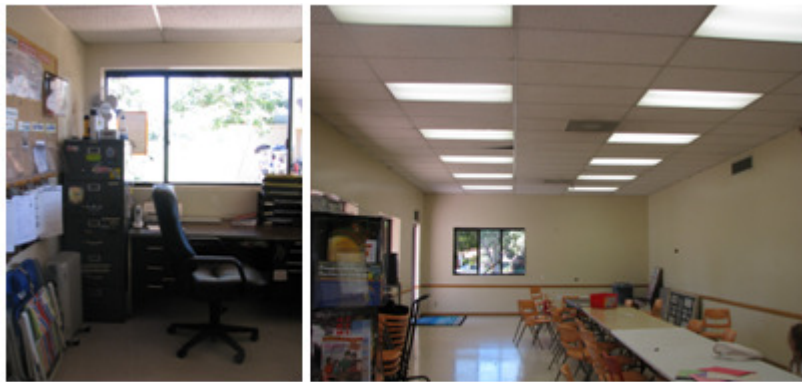
Recreation Hall. The fixtures in the recreation hall are primarily 2L 32W 4’ T8 fixtures with electronic ballasts that are controlled via switches. During the site visit, a few of the rooms were unoccupied and all the fixtures were turned on. Occupancy sensors would be beneficial in this space. On the outside of the building there are 14W CFLs that are controlled by photocell sensors.

Recreation Hall Lighting

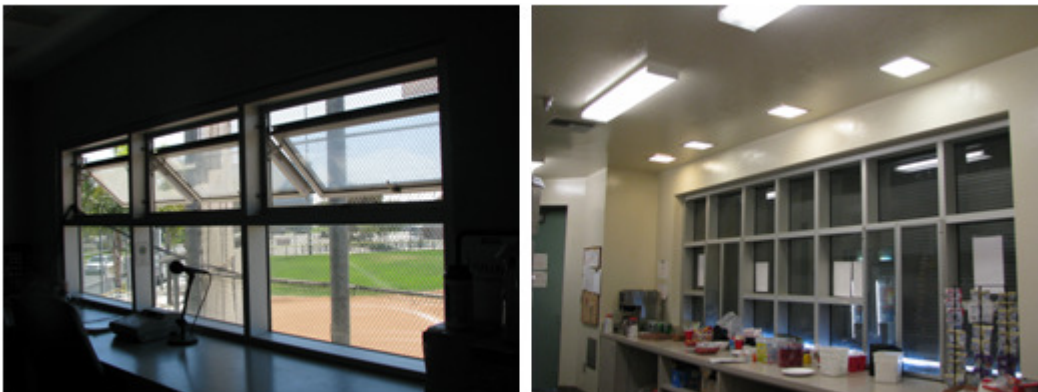
On the exterior of these buildings there is a combination of 26W CFL fixtures covered by circular lenses below the roofline and 32W CFL wallpack fixtures around the outside of the building. Exterior lighting in the baseball fields is provided by 1500W Metal Halide fixtures. These fixtures are turned on and off for games and practices as needed.

Scorer's Booth Operable Windows and Snack Shack Lighting

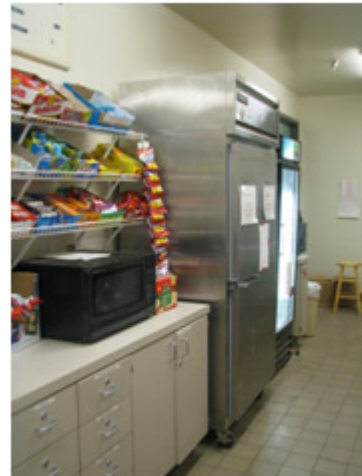
Miscellaneous loads at this site include the refrigerators, freezers, microwaves, and other kitchen equipment found in both snack shacks as well as the microphone equipment in the scorer's booths.

Snack Shack Plug Loads

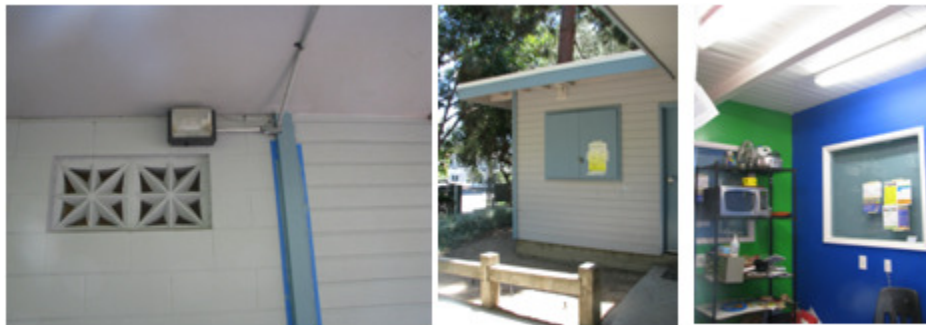
Restroom/Office

The site only has one 675 square foot building restroom/office facility. The restroom, built in 1965, is constructed of concrete block and has a few no-glass windows. It has a Tremco, roll roof with no insulation. The office side of the building is an add-on. The walls are wood frame with plywood and sheetrock. There are four-single pane windows in this section of the building.

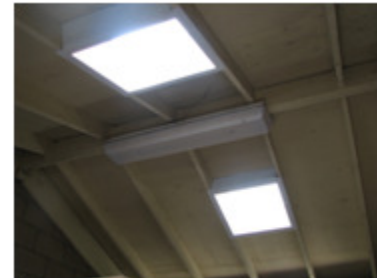
Restroom Skylights

Inside each restroom there are two skylights as well as one 4' 2L 32W T8 fixture with an electronic ballast. The lights are controlled by switches. During the site visit, the lighting in the restrooms was off; the skylights provided adequate light.

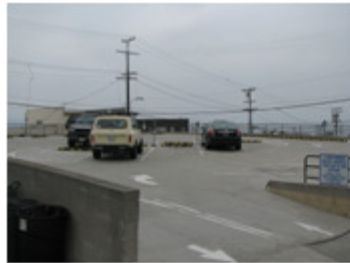
Upper Level

The first story of the two story parking garage is covered. On this floor, there are 21, 2-lamp 4' T8 fixtures with electronic ballasts. During the first site visit at approximately 7 pm, the west facing, outer row of fixtures was off. During the second site visit at approximately 8 am a few weeks later, the outside row of fixtures was turned on. It was foggy that morning but there was adequate daylight. Assuming this row of fixtures is controlled by a photocell, it is recommended that the photocell be calibrated and/or replaced to ensure unnecessary lighting is off during daylight hours. There were not any City-owned, outdoor fixtures on the roof of this garage. There were, however, two SCE-owned street lamps. The lighting at this site is in poor condition and should be replaced in the next few years. .

1. Remove the existing T8 fixtures and replace with 40W induction garage box fixtures.
 - a. Next time several of the garage T8 lamps need to be replaced, remove the T8 fixtures and install 40W shoebox style induction lighting in the garage.
 - b. For every one T8 fixture, one new induction fixture should be installed.
2. Install a new photocell sensor to turn off the outer row of fixtures from dawn until dusk.
 - a. Recalibrate or replace the photocell controlling the outer row of fixtures in this garage so that the outer row of fixtures shuts off during daylight hours.
3. Install a solar photovoltaic parking structure on the roof of the garage.
 - a. For detailed information about the proposed solar photovoltaic system sizes, tilts, and costs, please see the Appendix.

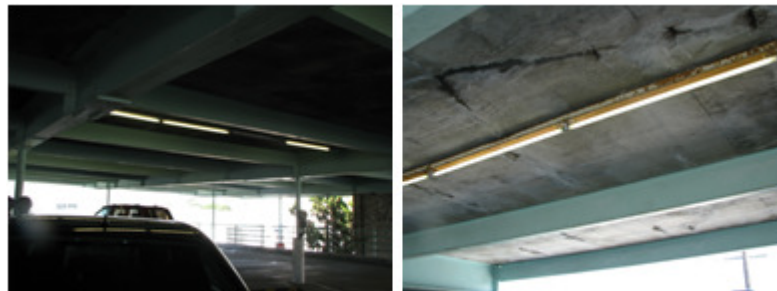
Dark Garage with Rusty Fixtures

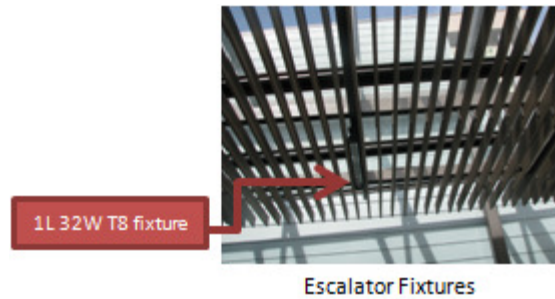
Escalator Fixtures

One location where lighting is particularly difficult to replace is in the wooden/glass cover above the escalator. As illustrated in the photograph, there are six 1L 32W 4' T8 fixtures mounted between these decorative wooden boards. Since these fixtures are directly above the escalator, they are difficult to access, and since they are fluorescent fixtures that are on 24/7, they need to be changed frequently. The City requested that a more sustainable, long lasting fixture be recommended for this location. LEDs are a good alternative, which we describe in the energy efficiency section below.

1. Replace the T8 fixtures above the escalator with either 40W Induction fixtures or LED fixtures.
 - a. These fixtures are currently very difficult to access, especially when lamp replacement is needed every two or less years. As such, it is recommended that either LED fixtures or induction lamps be installed above the escalators to extend lamp life from approximately 20,000 hours to 100,000 hours.

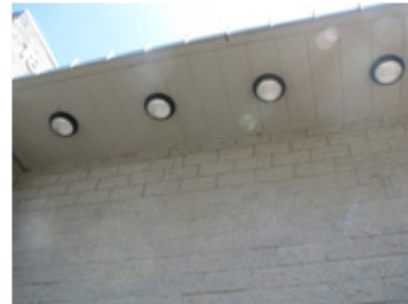
Exterior Lighting

On the outside of the building there is a mixture of 2L 14W CFLs and 1L 14W CFL fixtures controlled by photocells.

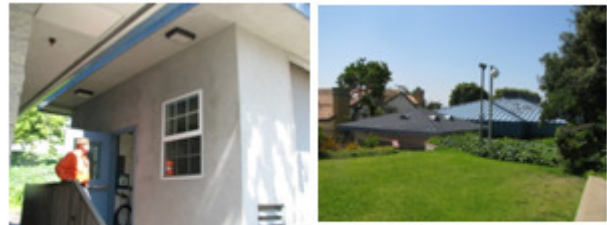
Chlorine Station

The chlorine station houses the chlorine tank. The 360 SF building is of concrete block construction. It has single pane, operable windows. The roof is wood deck with composite singles.

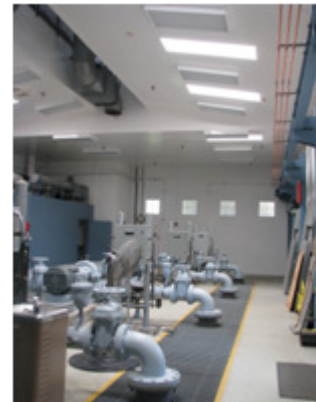
Pumping Station Daylighting

All of the fixtures inside the pumping station are T8 fixtures, primarily 3L 4X2 T8 fixtures with electronic ballasts. Since the building has both windows and skylights, there is adequate natural light in the main pump room to obviate the need for artificial lighting during daylight hours. The fixtures are controlled by switches.

1. Install wall occupancy sensors in the kitchen, restroom, and office in the main building.
 - a. The occupancy sensors will automatically shut off the lighting in the spaces when the space is unoccupied for a set amount of time. It is recommended that the occupancy be programmed to shut off the fixtures after 3-5 minutes.

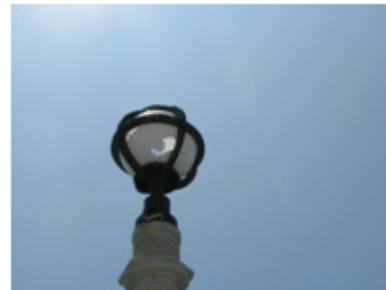
Damaged Pier Globe Lights

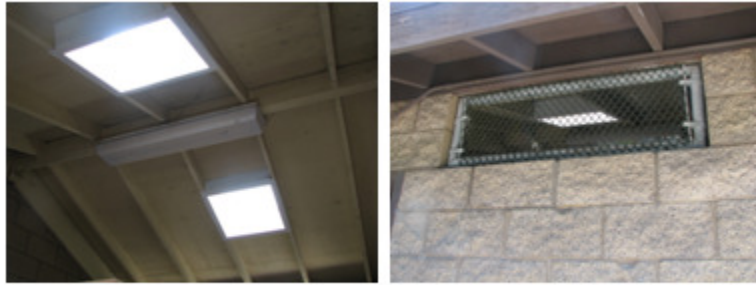
Beach Restroom Daylighting

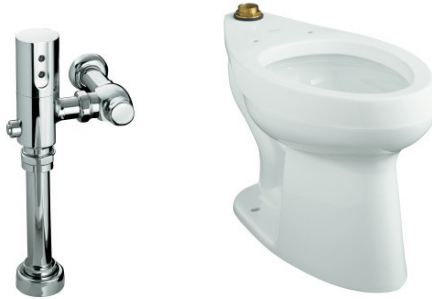
Figure 1: Low Flow Toilet Fixtures and Bowls

Existing conventional water closets should be replaced with Low Flow or Ultra-Low Flow Water Closets. While only the flush valve needs to be replaced, it is usually recommended that the bowl also be replaced because the bowl design affects how well the flush out cleans the bowl when dealing with low flow water fixtures. Advancements in low flow technology have improved flush capability so problems with flushing waste is rarely an issue.

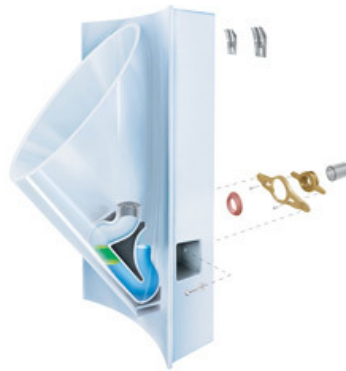
Figure 2: Waterless Urinals

Conventional urinals should be removed and replaced with waterless urinals. Waterless urinals offer a zero water use fixture. The picture below shows a typical waterless fixture. When used, liquid waste passes into the drain and through a debris-catching strainer and a sealing liquid. The sealing liquid is less dense than the liquid waste and so allows the liquid waste to pass through it. The sealing liquid settles near the drain and seals itself across the opening of the trapway, providing a barrier to block odors from the liquid waste below. The liquid waste below is routed into a waste pipe.

The fixtures are easy to retrofit. Most fixtures are designed to connect to the existing waste pipe and existing urinal collar. Daily cleaning maintenance requires typical cleaning. A bi-weekly flush out should also be done. This requires the system to be purged using water and urinal cleaner and then the sealing liquid must be replenished to ensure odors remain isolated.
