# Staff Report

## City of Manhattan Beach

**SUBJECT:** Approval of Roof Repairs for City Hall and Appropriation of \$175,000 from the Capital Improvement Fund

# City Hall Roof Repair Project

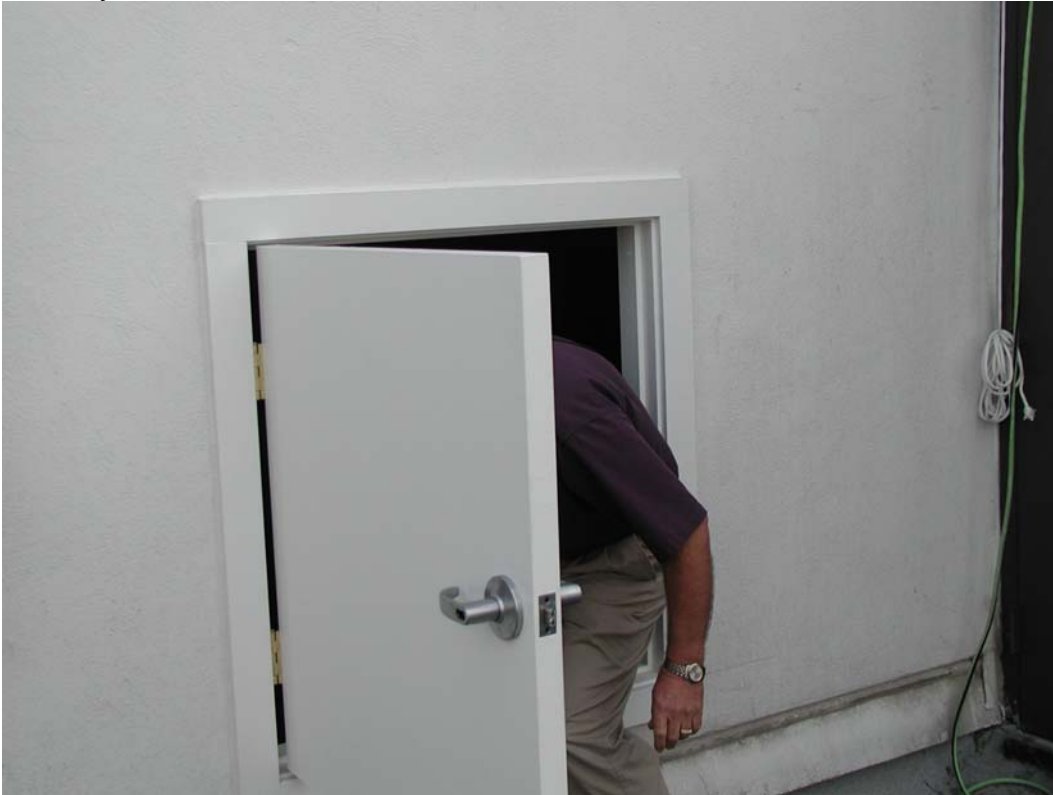
The one remaining original portion of the City Hall Roof structure is the parapet roof. This structure is the portion which is visible above the Administration portion of City Hall. This portion of the roof was constructed with light weight concrete panels that slant and connect to the parapet wall. Over the years the concrete slabs have cracked and the joints between slabs have deteriorated. This condition has allowed rain water to penetrate the interior of the area between the parapet wall and the slanting roof. Over time, with water entering the interior of the covered area, extensive damage has been done to the flat portion of the roof (see attached photos).

Corrosion from water entering the flat roof portion under the slanted roof.

The remaining unimproved portion of the City Hall roof is in urgent need of repair. Staff recommends installing a standing seam metal roof as a repair method for the slanted portion of the roof. High quality water proofing materials are recommended to be applied for the flat portion.
