SECTION 10

CAPITAL IMPROVEMENT PROGRAM

10-1 GENERAL DESCRIPTION

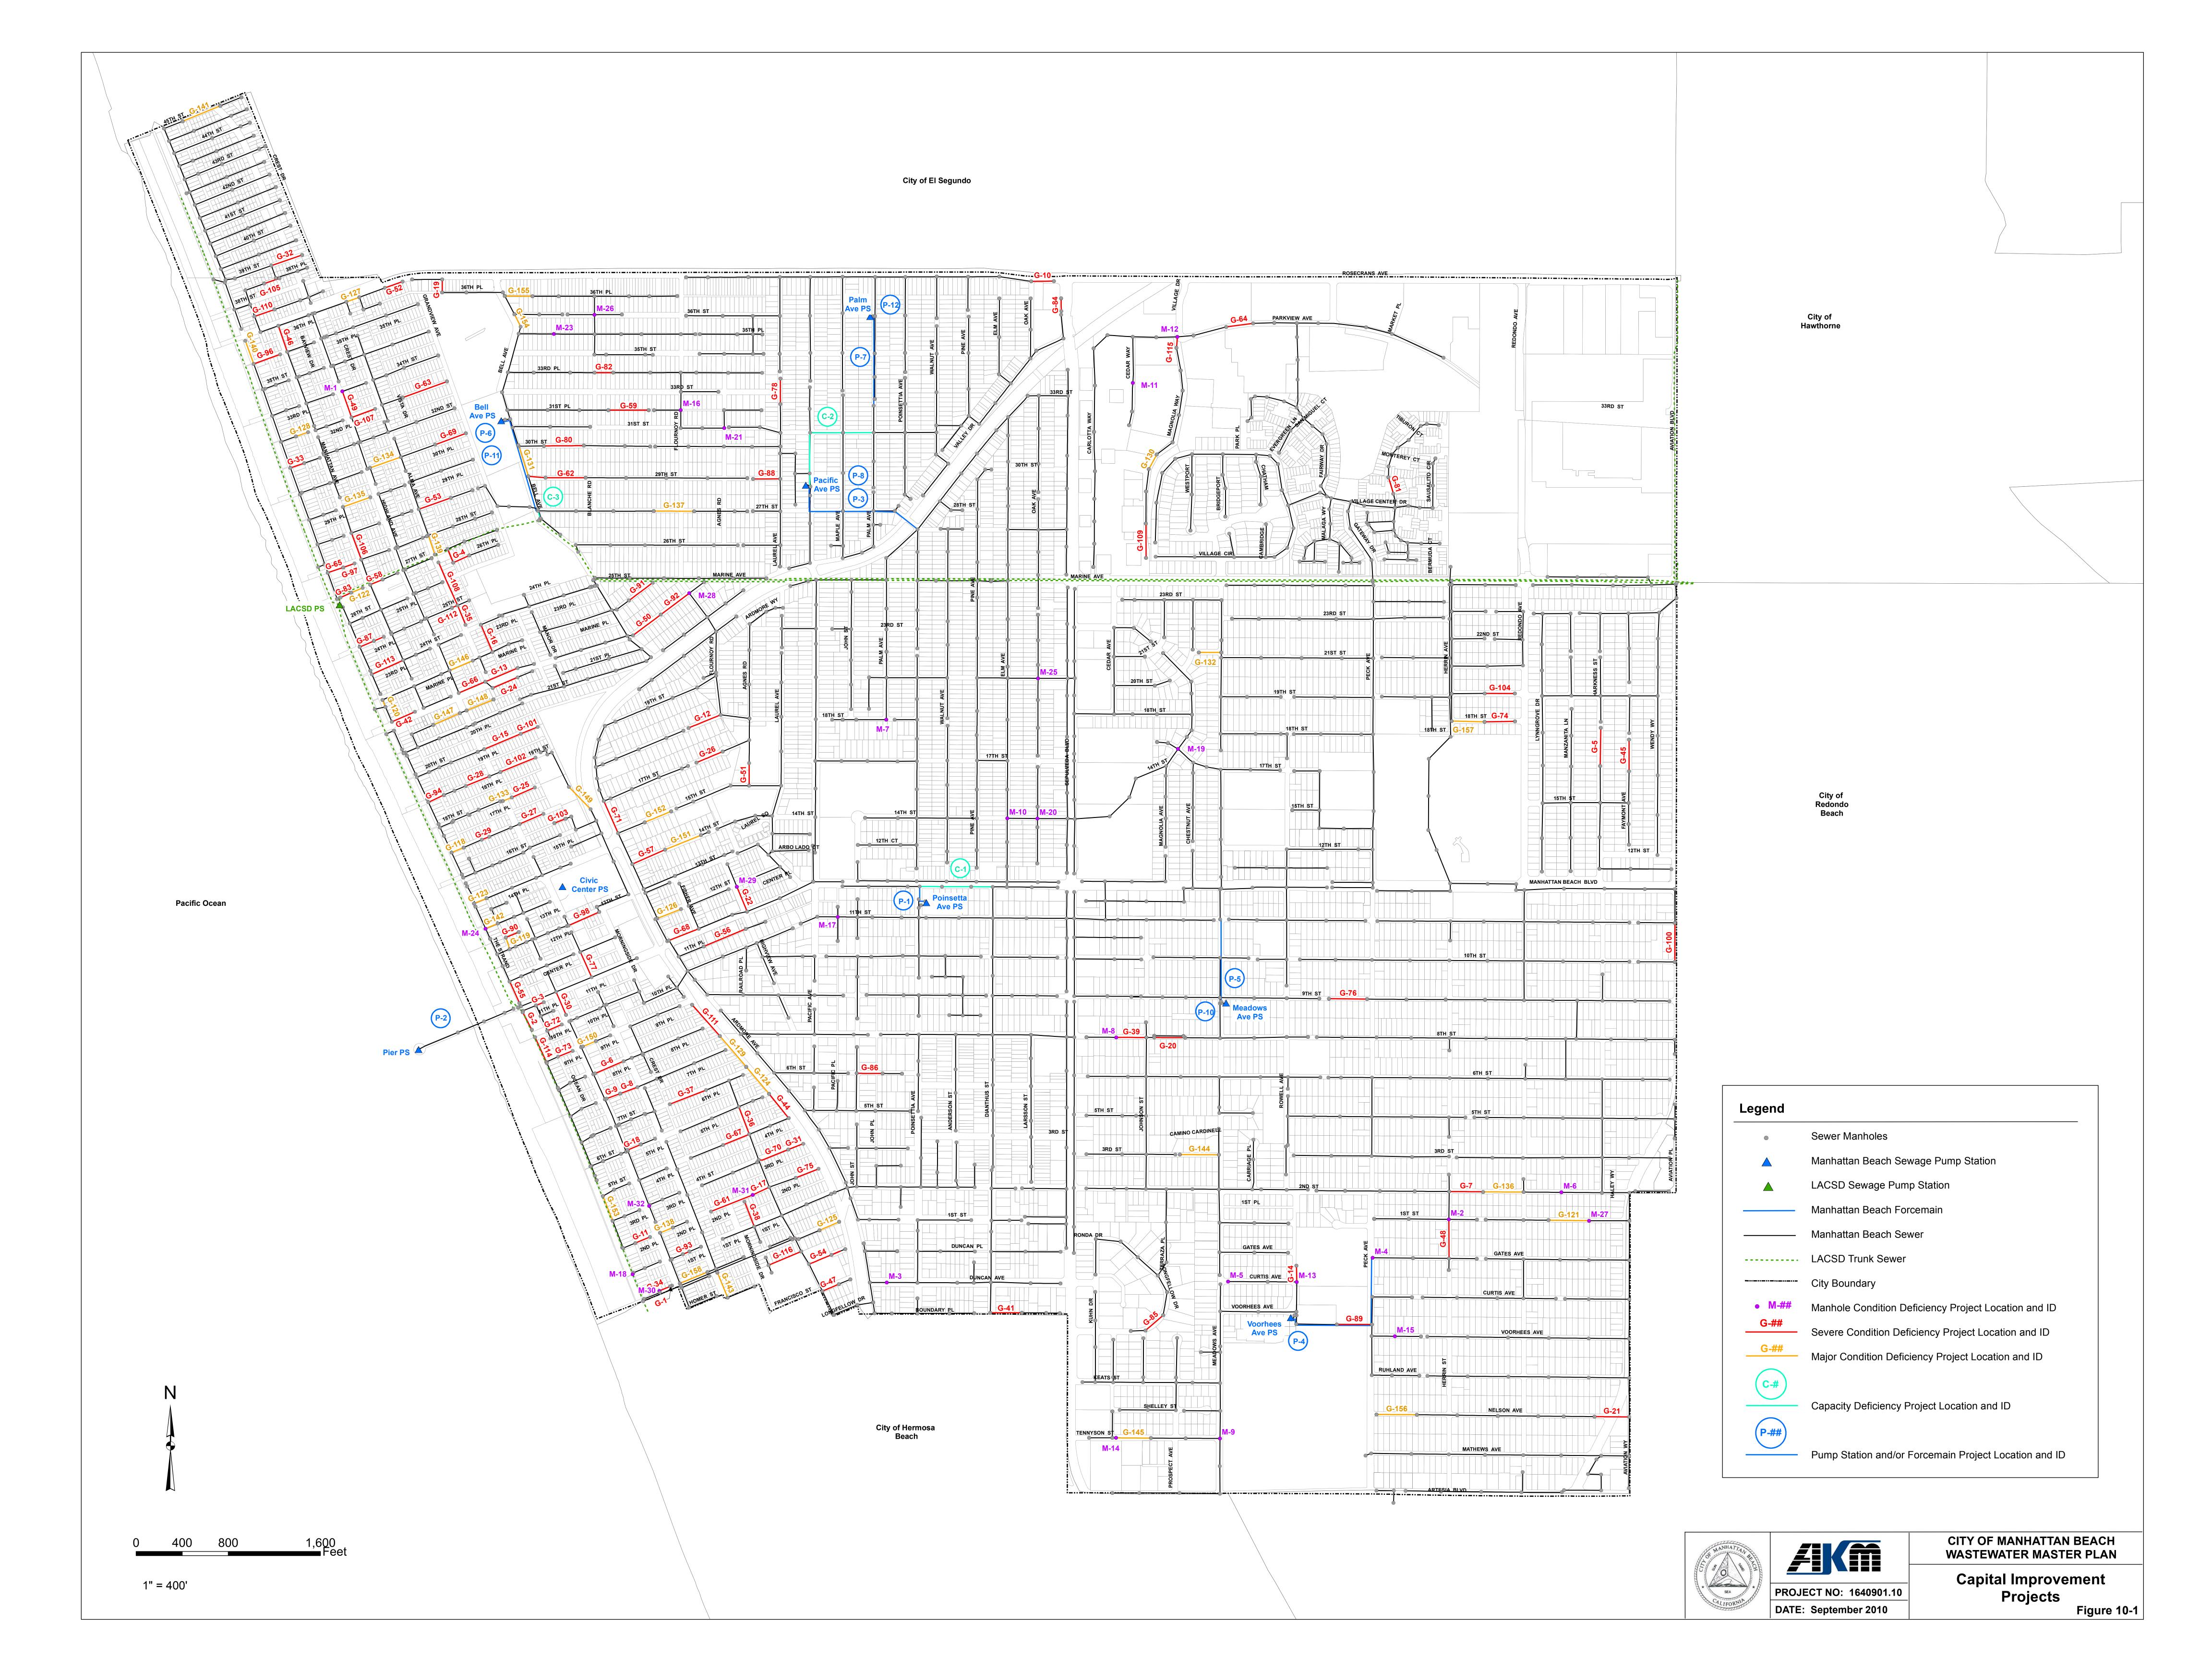
The Capital Improvement Program is developed based upon the results of the hydraulic analyses and the established priorities. The recommended improvement project locations are illustrated on Figure 10-1.
